TRANSPORTATION SAFETY
BUREAU

FINAL REPORT

2007-0047-5 SERIOUS RAILWAY ACCIDENT

**Between Almásfüzitő and Komárom stations
6 February 2007**

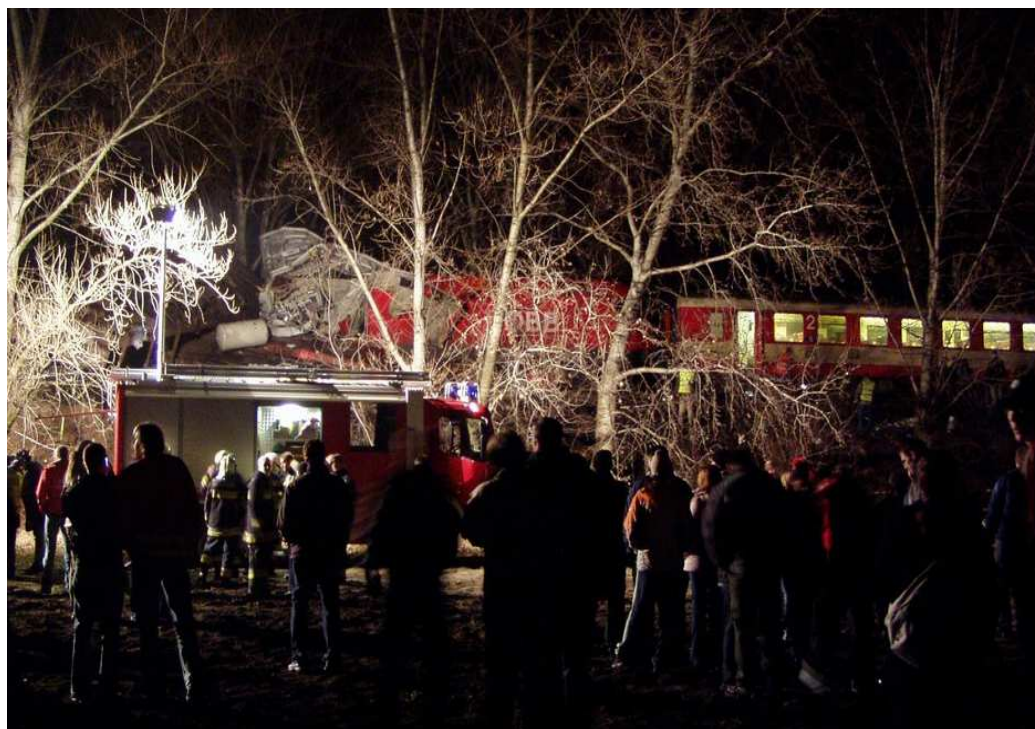
Figure 3: Site of the accident

The engine driver of the passenger train died at the site of the accident, two passengers suffered serious injuries, another four passengers, the chief ticket inspector of the passenger train and the engine driver of the freight train suffered minor injuries. The electric locomotive (registration number 1116-017) of the passenger train owned by ÖBB sustained serious damage. 5 cars of the DB-owned freight train derailed, 4 of which sustained serious damage. The right track of the railway line sustained serious damage in approximately 120-meter-length, while the left track sustained less serious damage in approximately 30-meter-length. The catenaries over both tracks broke and two catenary supports fell.

It was found in the course of the investigation that the line signal box between Almásfüzitő and Komárom stations did not operate normally and the block signals were dark at the time of the accident.

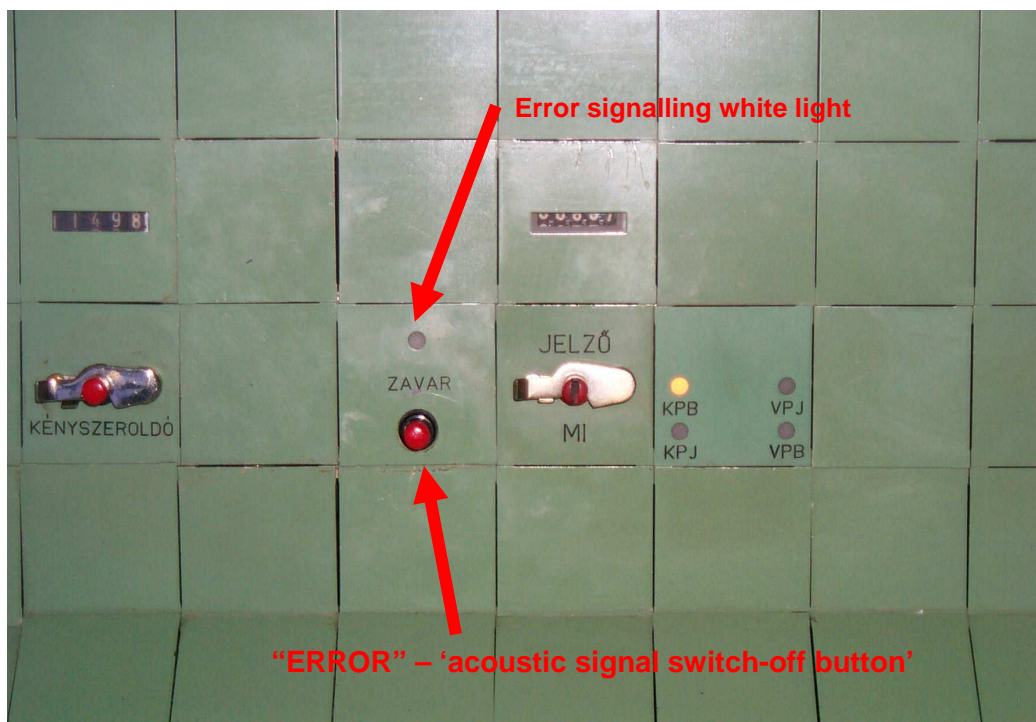
Figure 4: Control panel of Domino 55 type signal box

As the Domino 55 type signal box does not have a built-in system for registering operations, the operation and the errors cannot be checked subsequently. There was no entry in the error log regarding operational problems or errors. Presumably, the signal box personnel on duty in the morning of the day of the accident had handled the error similarly, and - disregarding the importance of the error signalling - did not inform the other signal box colleagues. Once the error signalling came on due to any error (e.g. burnt out light-bulb, etc.) and the signal box personnel switched off the ERROR button - however the white light continued to be on - a further error (in case of switching off the chargers) could not have been indicated either by acoustic signal or by another light signal – according to the construction of the error circuit. Therefore the signal box personnel could not have perceived a further error. The IC did not find entry in the error log regarding such further error.

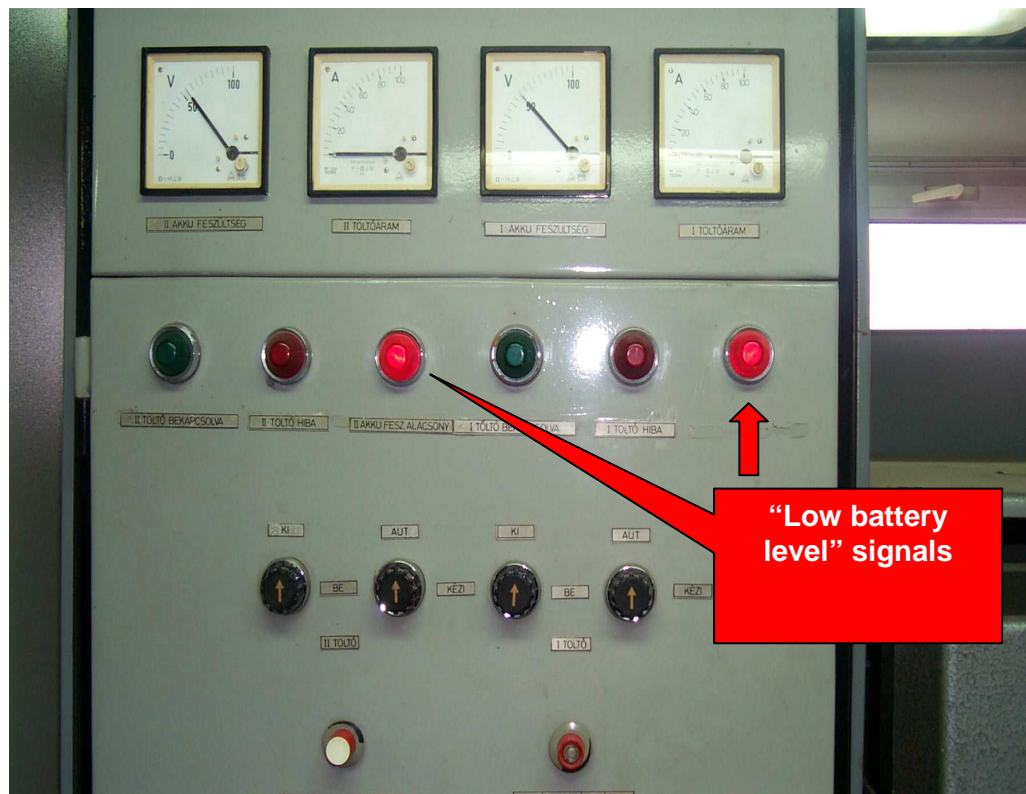
Figure 5: E-11 type battery charger

In the course of the subsequent tests (see 1.12), after switching off “E-11” type battery chargers (as a consequence of the adequate voltage drop of the storage batteries) a so called “general error signal” appeared on the control panel of Domino 55 type signal box. This general error is indicated by an acoustic signal and a white light. This light is next to the ‘acoustic signal switch-off button’ inscribed with the word “ZAVAR” (“ERROR” in English) – see Figure 4 below. The movements inspector on duty - who was also responsible for the control panel of the signal box - pressed the “ERROR” button automatically, without finding out the reason inducing the acoustic signal. However, the white light signal remained on. He was unable to answer to the question of the IC as to what might have caused the error. When the IC switched the battery chargers back on, the error signal automatically ceased, that is, the white light went out.

The dispatcher at the "right side" signal box of 'Budapest Nyugat' ('Budapest West') notified the signal box technical staff of Tatabánya as well as the signal box technical staff on duty at service post XII of Komárom station about the error. The Komárom staff on duty went to service post VI where they established that the signal was dark due to no supply from Almásfüzitő station. As the error could not be corrected at Komárom station, they returned to their posts. The on duty signal box staff arrived at Almásfüzitő station to correct the error. They entered the power supply room with their own key and with the traffic staff's knowledge. One of them went into the traffic office. The exact time of their arrival is unknown as they did not take off the sealed key of the relay room and therefore neither the time of taking the key off nor the start of the troubleshooting was entered in the log. Having entered the power supply room of D-55 type signal box, they went past the two switched off ("E-11" type) battery chargers and went to the "PQ" inverter (situated left from the charger) and opened its door. The door of the „PQ” inverter opens to (in front of) the case of the battery chargers, thus after opening this door, there is even less chance to notice the "Low battery level" signals - two red lights which were on at the subsequent test also - on the battery chargers.

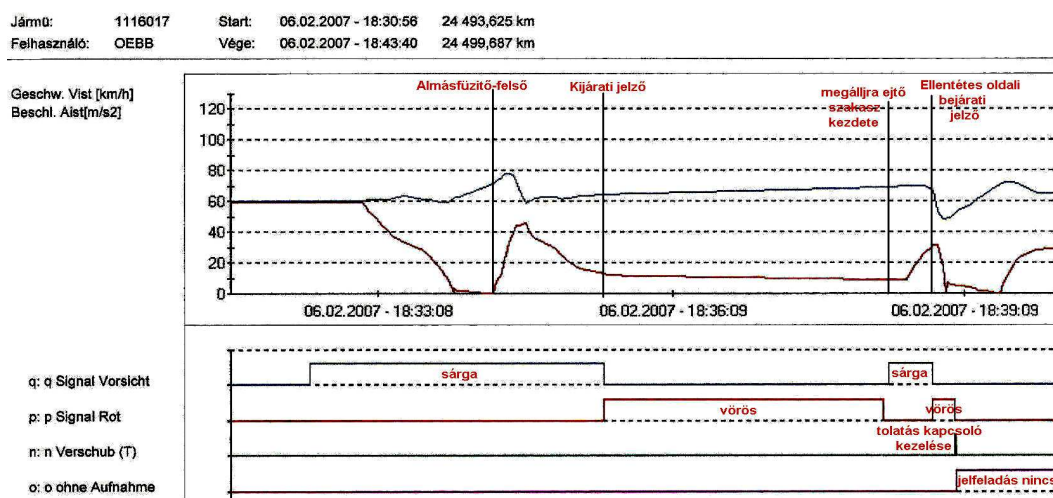
Figure 6: Recordings of the strip chart recorder of the locomotive (registration number 1116-017)

Based on the data read-out from the data recorder of the locomotive, it can be expressly established that 4 minutes after stopping, the train was put into 'shunting mode' (by applying the 'shunting mode handle' which is located in the driver's cab behind the engine driver on the left) for one minute, and then it was set back to 'train' mode. Consequently, the train control installation of the locomotive "forgot" the 15 km/h speed limit and further on it operated as if the train was running on a rail track section built without continuous signalling, and it did not serve its speed limiting function.

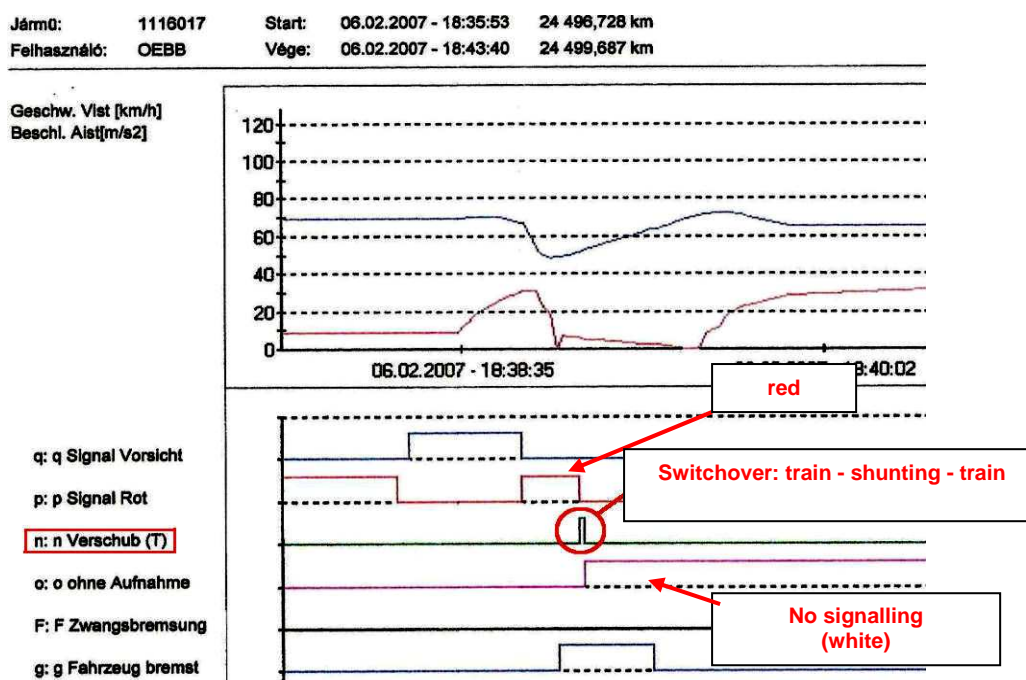
Figure 7: The train/shunting/train' switchover signal indicated on the recordings of the strip chart recorder

The direct cause of the occurrence of the accident was the switching the “EVM 120 vigilance warning device and train control installation” of the locomotive of train no. 9438 over to shunting mode and back to operation. As a result of this act, the train control installation stopped functioning as a speed limiting device and therefore the train exceeded the speed limit six-sevenfold.

BA2007-0047-5-03: The IC recommends railway undertakings operating traction vehicles to work out a solution to be able to control switchovers from train mode to shunting mode on the train control installations of locomotives and other traction-vehicles by checking the recordings of strip chart recorders – automatically where possible. This way, engine drivers would be obliged to operate the installation as prescribed.

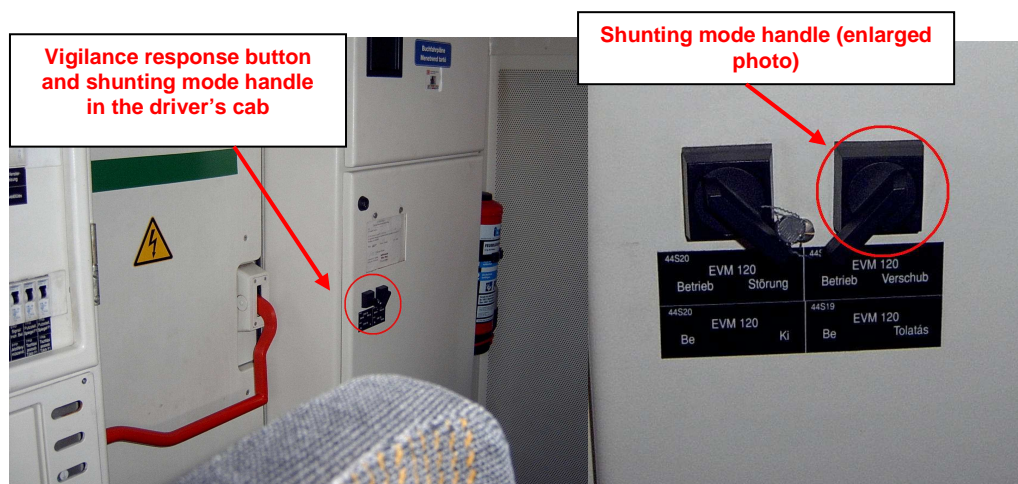
Figure 8: The location of the shunting mode handle in the driver's cab

This switchover can be done in the front driver's cab - where the engine driver was - by a definite movement, which excludes the possibility that the switchover happened owing to circumstances beyond the engine driver's control.

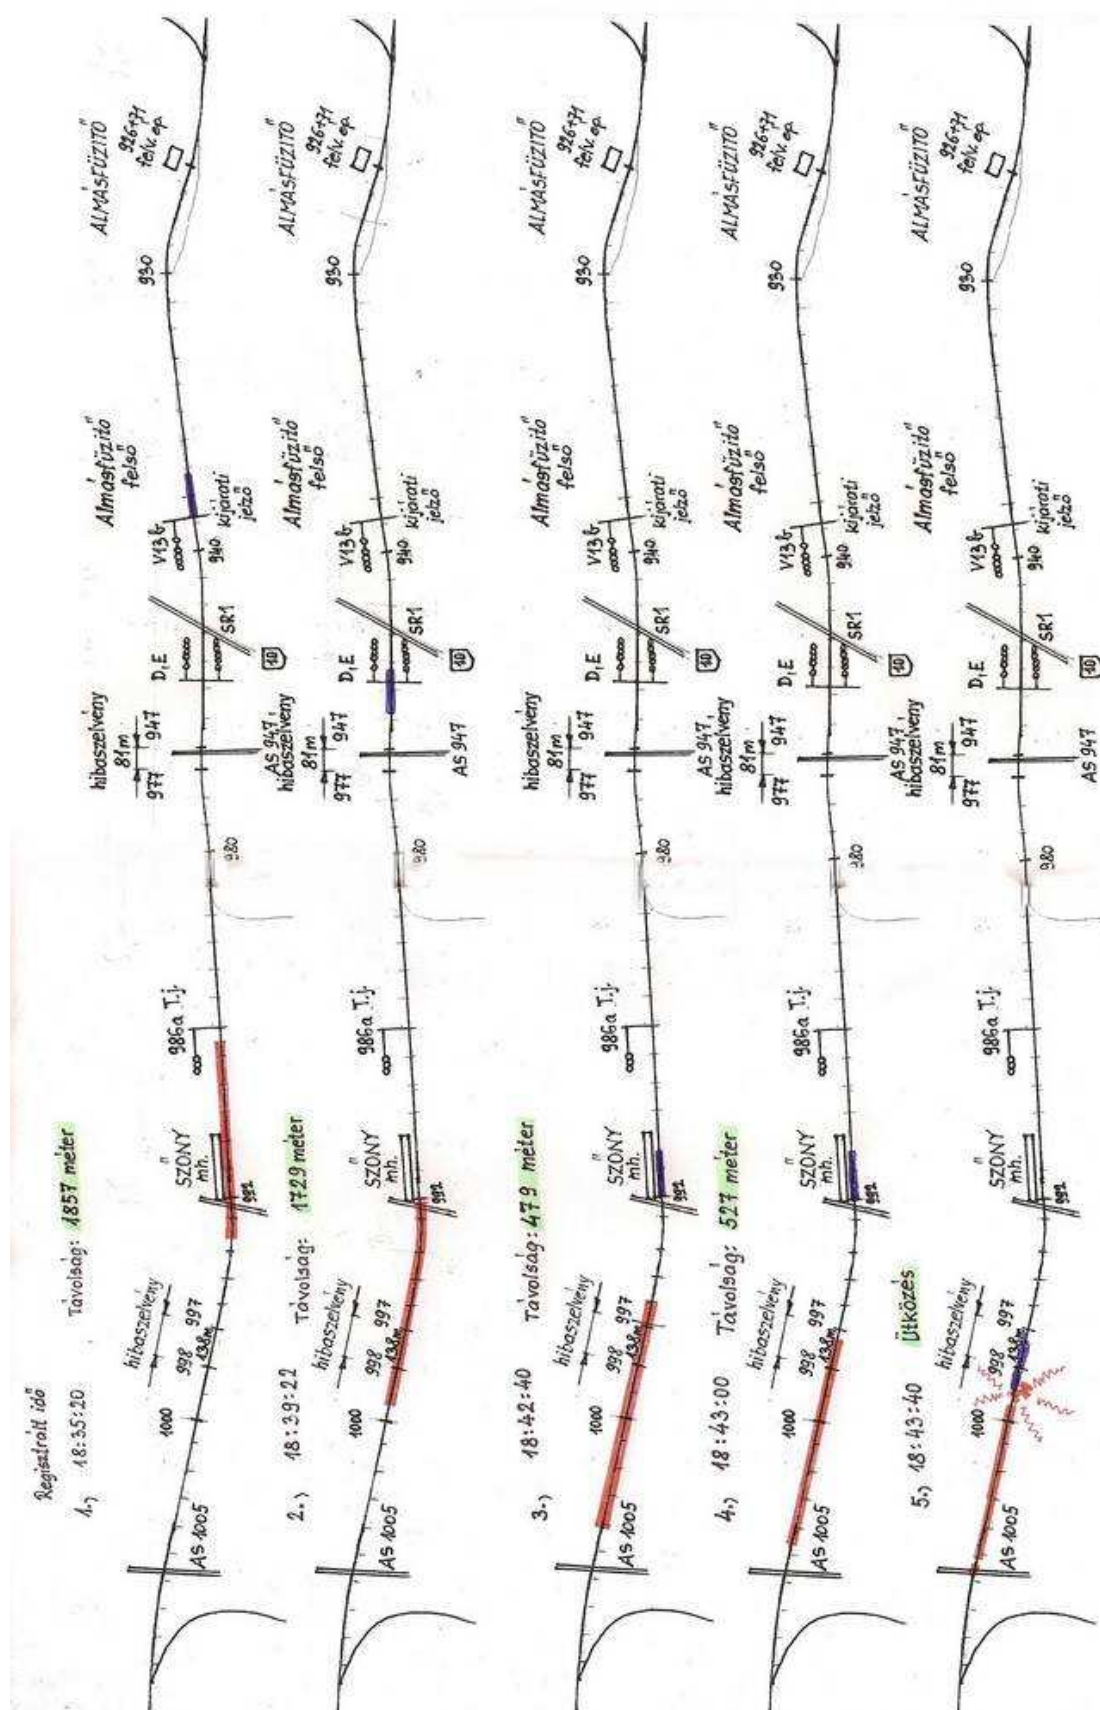
Figure 10: The position of train no. 45224 (red) and train no. 9438 (blue) prior to the accident

Having evaluated the recordings of the data recorder of the locomotive (registration number 1116-017), the IC established that the engine driver stopped the traction approximately 34 meters before the collision. Based on the above described active, definite movements of the engine driver, it can be stated that the engine driver could not have become inert prior to the accident.

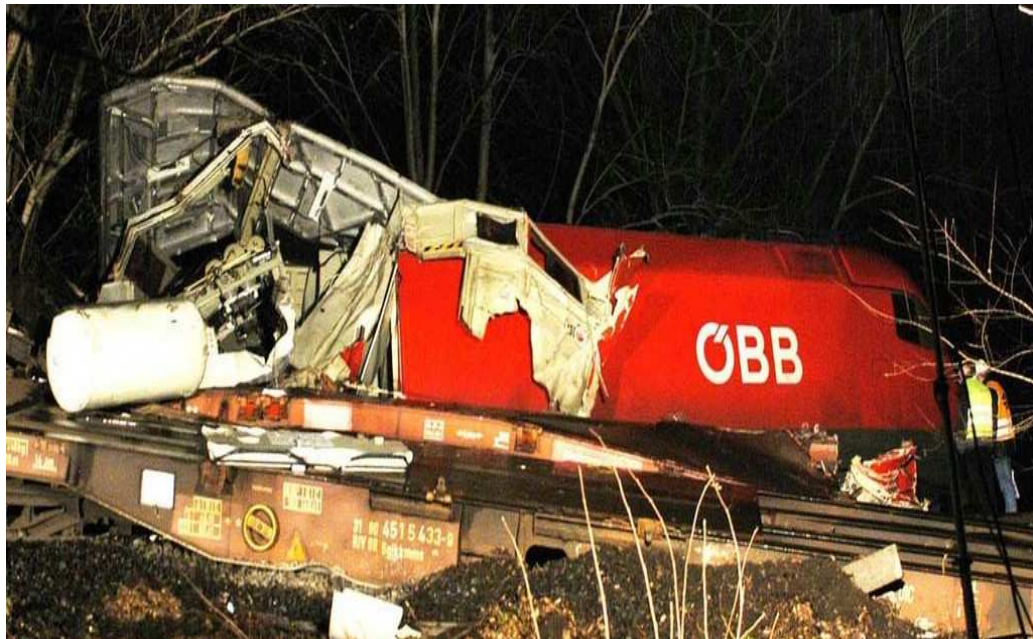
Figure 11: Consequences of the accident

- The electric locomotive of **ÖBB** (registration number 1116-017) sustained extensive damage,
- **Damages to the freight train:**
Reg. no. 31 80 495 4752-0 flat car derailed, and
Reg. no. 31 80 356 0015-0,
Reg. no. 31 80 451 5433-9,
Reg. no. 31 80 453 6061-3,
Reg. no. 21 80 442 6644-1 flat cars derailed and sustained extensive damage as they heaped up on one another and on the locomotive.

- The right track of the railway line sustained serious damage in approximately 120-meter-length, while the left track sustained less serious damage in approximately 30-meter-length.
- The catenaries over both tracks broke and two catenary supports fell.
- The environment did not suffer damage. The trains did not transport dangerous goods.
