2008-302-5

Railway accident

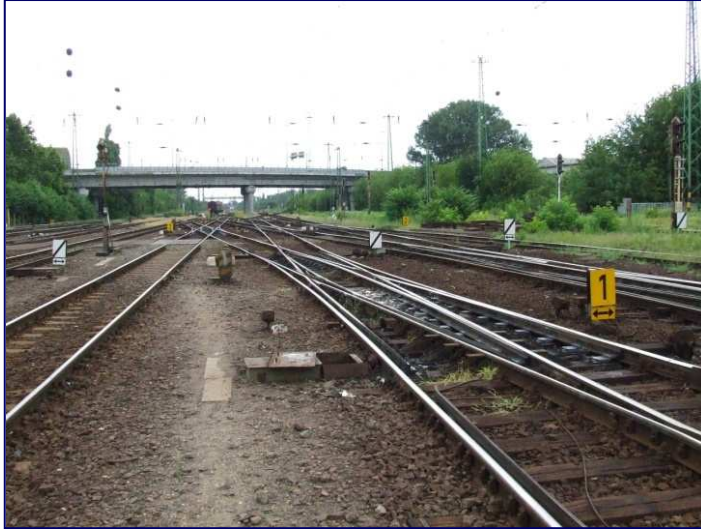
Two track repairers began to repair the track - with permission - at points early evening, in dark. While doing their work, a locomotive - running towards a depot - ran over them. One of them died at the site of the accident, the other suffered serious injuries.

When performing such work at the points, no vehicles should have been running on the given track, however, the track repairers had not

asked for track closure.

The locomotive was permitted to run (shunt) on the points being repaired by the workers. The engine-driver was not informed about the repair work.

The accident could have been avoided if the engine-driver had kept the speed limit and paid more attention. The workers should also have been more attentive.

The working area was not secured and signposted with the required signs. The set speed limit was not in harmony with the signalling regulations.
