2008-335-5

On 2 August 2008, 4 carriages of a passenger train derailed between Kurd and Szakály-Hőgyész stations, one of which toppled to its side. The rail track sustained substantial damage on a 200 metre length.

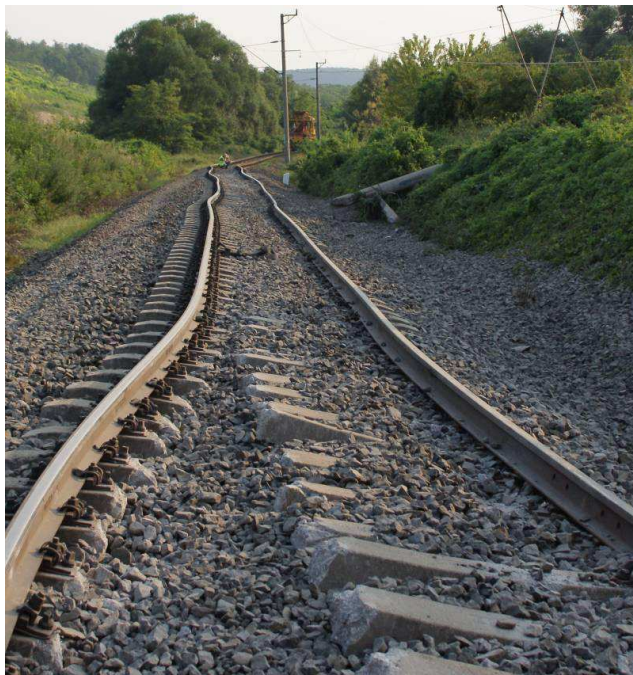
- There was no drainage at the site of the accident.
- The upper part of the bedding got soaked; its supporting capacity was significantly reduced.

- The last rail track works when the rails were detached were performed in the autumn on 2006. The actual neutral (safe) rail temperature was set then. According to the information available for the IC, the powered-down status of overhead lines and the setting of the right rail temperature were not checked.
- Other rail track works in 2007 resulted in the decrease of the arch length and of the

- Local rail track defects were found at the last rail track inspection.
- The track became defected when the previous train ran on it.
