The full, official version of the final report is only available in Hungarian language

2008-401-5

Railway accident

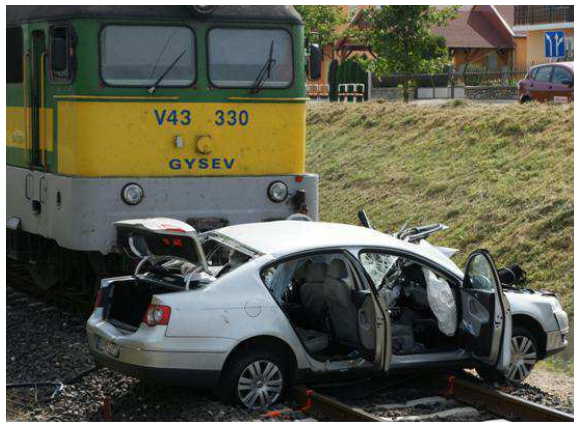
On 6th September 2008 a regional passenger train - upon approaching Lövő station - collided with a car at an LC which was protected by warning lights and was operating normally. As a consequence of the collision, 4 of the passengers in the car died at the site and one was taken into hospital with serious, life-threatening injuries.
