Summary Safety report

COLLISION BETWEEN 2 FREIGHT TRAINS
REMERSDAAL - 1 OCTOBER 2013

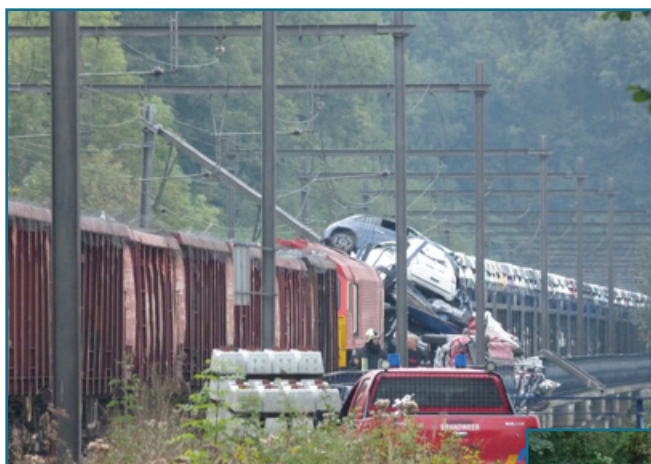
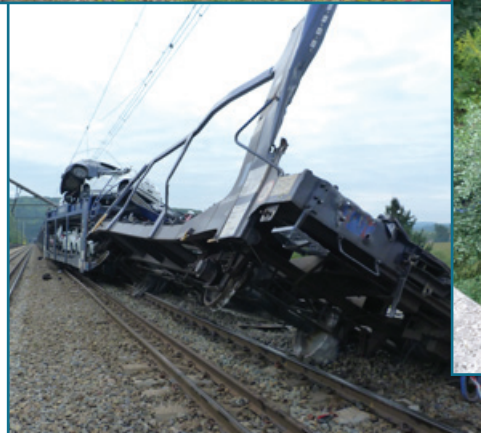
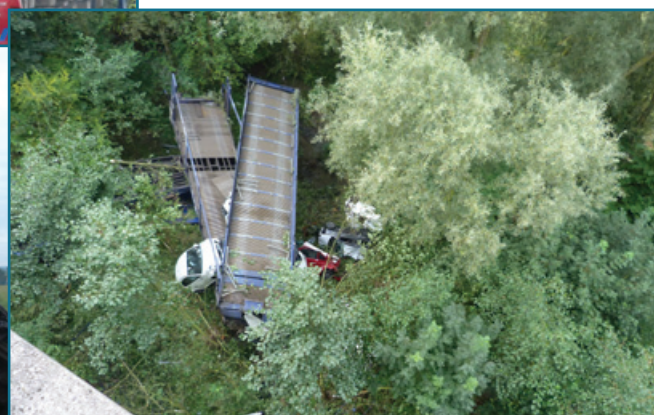
The accident caused major damage to the infrastructure and to the rolling stock but no one was injured.

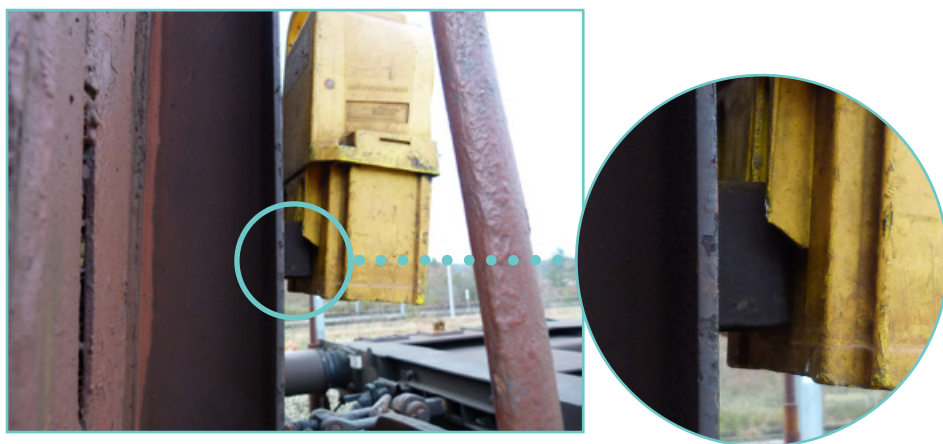
In night-time running at sight, one of the professional gestures made by drivers involves looking for the tail lights of another train. The first train was equipped with a tail lamp but, as it was seized by the police, it was not tested immediately: the investigation could not determine if it was working at the time of the accident. What is more, following contradictory comments on the draft of its investigation report, the IB decided to organise a reconstruction. The IB has thus found compatibility problems between the lamps and the lamp brackets present on certain types of wagons. These incompatibilities could result in, amongst others, the lamp failing to illuminate. The rear wagon on the first train was concerned by this issue.

Other recommendations concern measures to be taken to mitigate the identified risks of a lamp battery failure and the inadequacy of tail lamps and lamp brackets on wagons.
