# SUMMARY OF SAFETY REPORT

## COLLISION OF TWO FREIGHT TRAINS AT TINTIGNY ON 4 MAY 2012

**Investigation Body for Railway Accidents and Incidents**

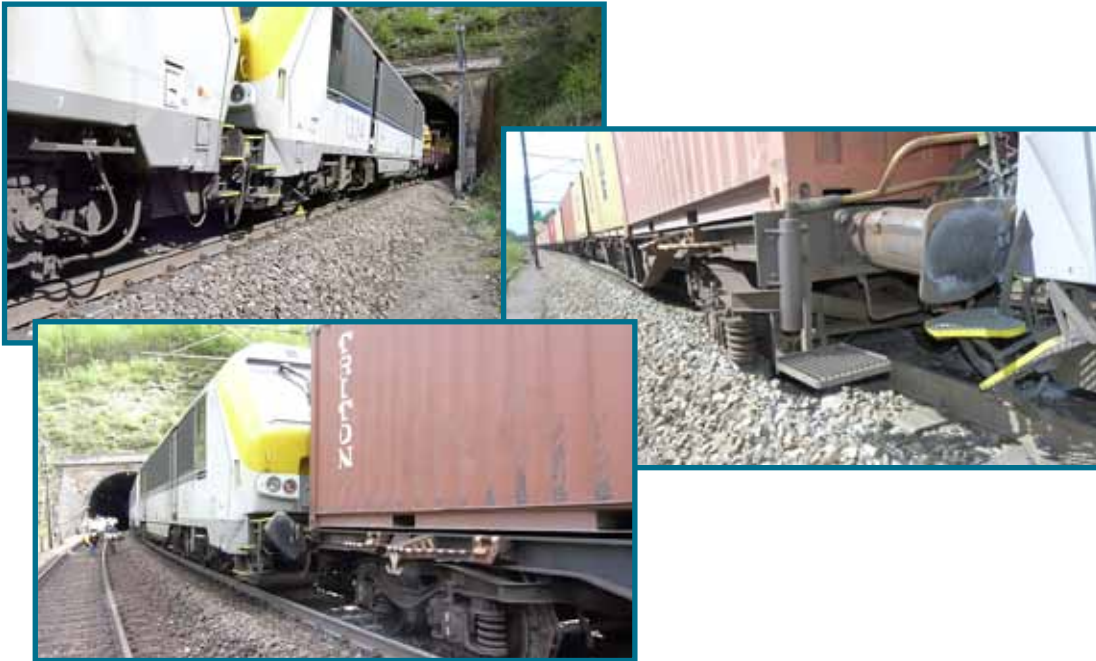
At the end of the Lahage tunnel, the driver of the second train (EE44883) saw the back of a train. He applied the emergency brake but could not avoid a collision and hit the back of the first stationary train. The driver of the first train was on the phone to the depot in Bertrix: the call was cut off by the GSM-R alarm launched by the driver of the striking train. They indicated that the last axle of the end wagon of the struck train had derailed. The two drivers consulted one other and carried out the necessary steps to ensure the two trains were immobilised. Traffic Control informed the drivers that traffic had been suspended, the signals had been put at danger and the emergency services were on their way..

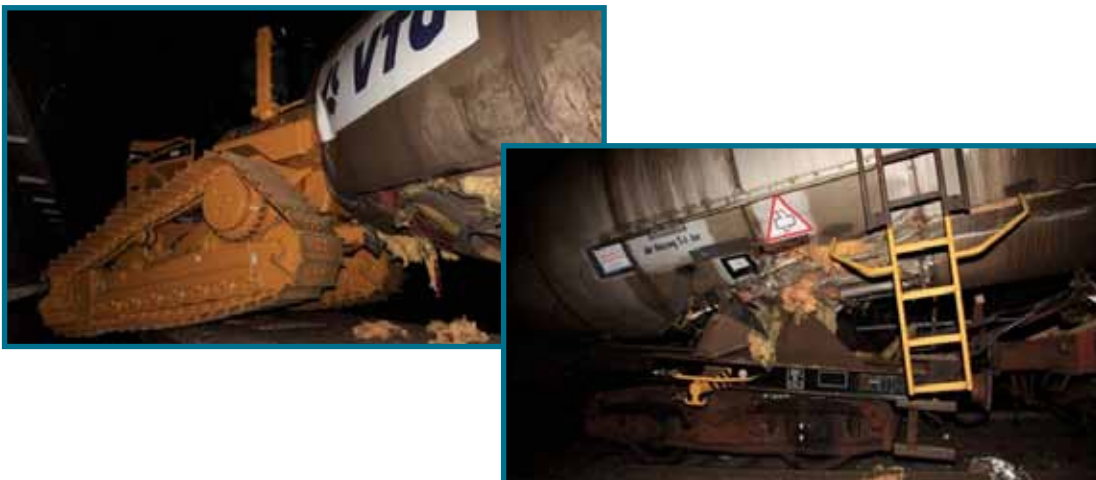
The second train (EE44883) involved, amongst others, tank wagons containing methyl acrylate (dangerous goods subject to an RID) which had not been degassed. One of the tankers was ripped from its cradle and was shifted approximately 5 metres, to then be crushed on top of the wagon in front, by striking one of the bulldozers being transported. The emptying tubes of the tanker were ripped away, producing a release of gases due to the presence of methyl acrylate in these tubes. The driver of train EE44883 signalled to Traffic Control an odour of gas in the tunnel: it was noticeable for several hours afterwards.
