Summary - Safety Report

Collision of a De Lijn bus by a SNCB train
on a level crossing in Pittem - 25 november 2015

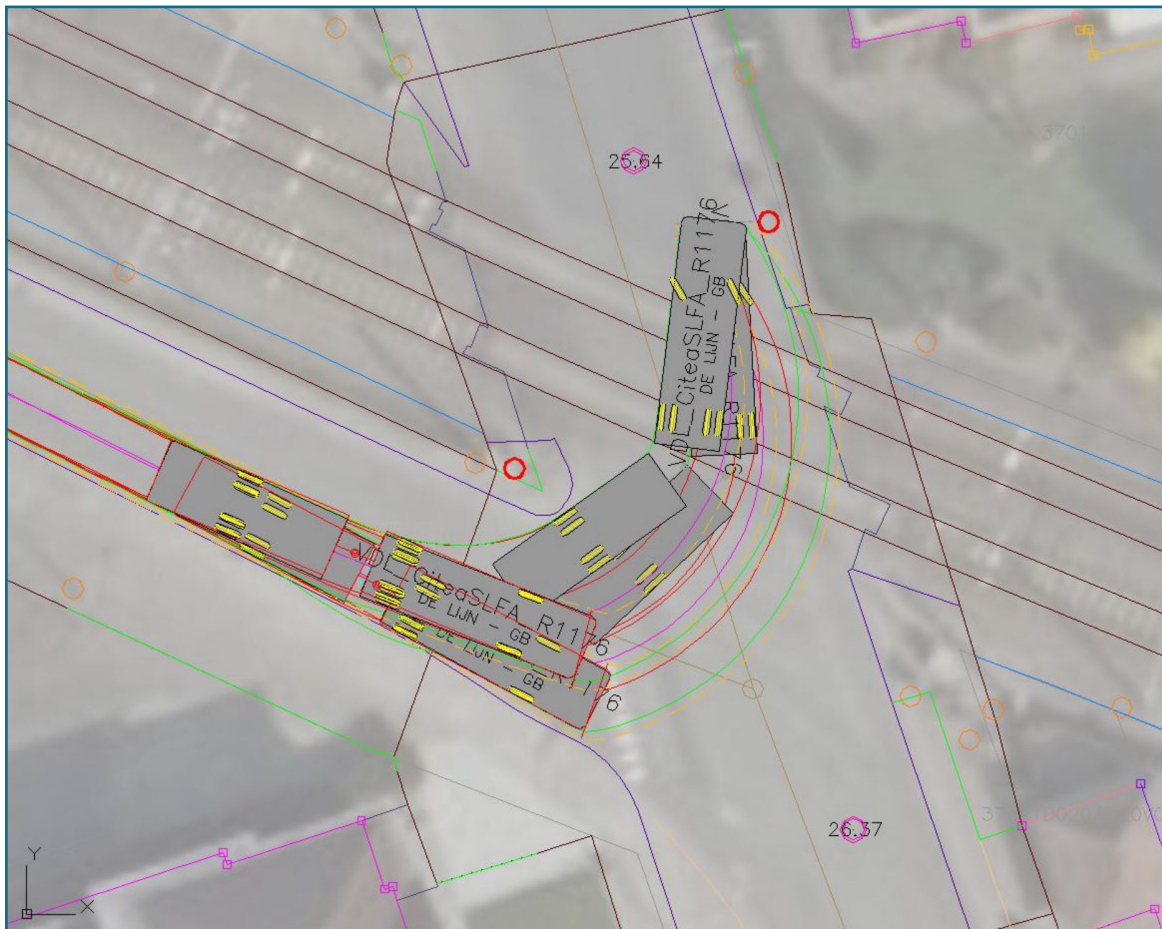
Owing to a miscalculation, the bus turned onto the open level crossing - before the arrival of the train was announced - and became stuck against the level crossing signals.

- the configuration of the roads and level crossing, and more specifically considering the bend of 135° in combination with the width of the road
- the configuration of the bus and, amongst others, the length of the articulated vehicle

The bus met the legal requirements (turning circle), but simulations show that due to the curve of the crossing, only a very limited number of starting positions could be taken.

Image : simulation with AutoRun of a turn of an articulated bus
