# Summary Safety Investigation Report

Derailment of a Lineas freight train  
Schaerbeek - 7 February 2018

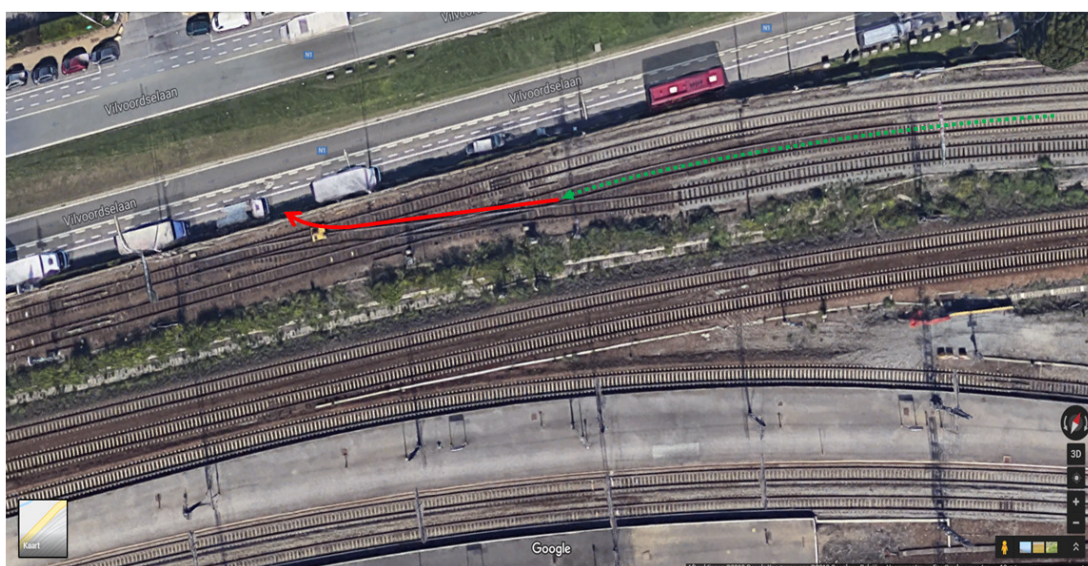
In advance of the first signal met on L.28, signal F-L.8, the track forms a curve with a switch at the end of the curve.

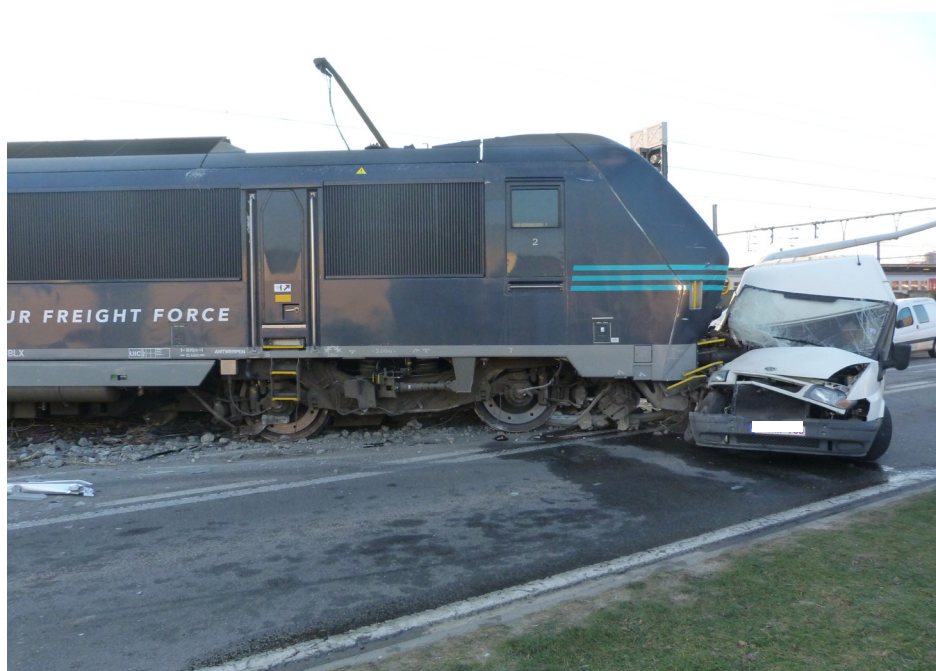
Locomotive HLE1312 derails at the end of the curve, damages the switch, crosses the adjacent track, and comes to a stop on the public road, where the locomotive collides with parked road vehicles. The first 3 wagons partially derail. During the derailment, the train driver is seriously injured.

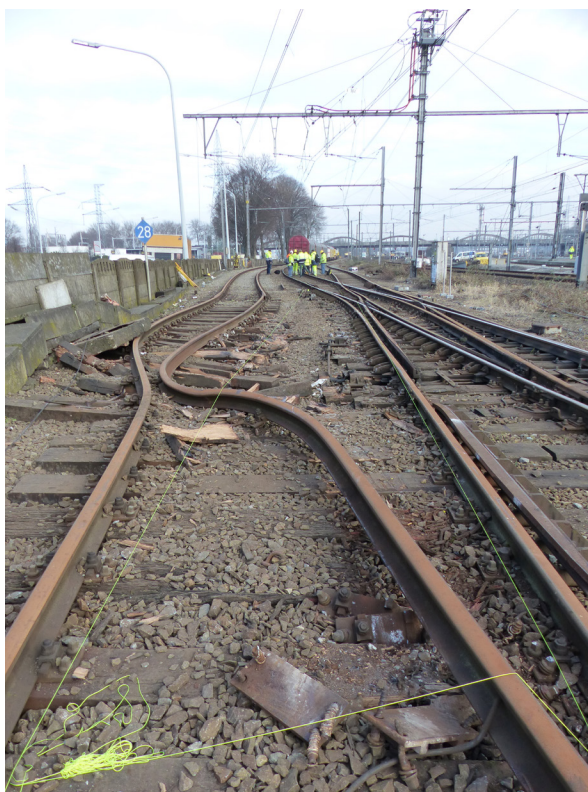
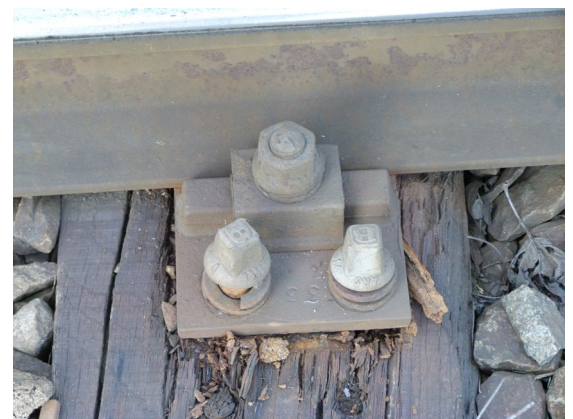
The examination of the tracks at the scene of the derailment reveals that the derailment began at the expansion joint on distance point 605, and that several sleepers and fastenings in the area just before and after this expansion joint show defects (see Chapter 3.4).

The indications of derailment, shifted base plates, and inefficient sleeper screw connections are clearly visible on the left rail of the track. That is why it is decided by mutual agreement to subject the sleeper screws to a tensile test just before and after the expansion joint, in accordance with Infrabel's instructions for use.

In cooperation with Infrabel, tensile tests are performed on the sleeper screws of the left rail. The sleeper screws are pulled out of the sleepers at low tractive forces, which shows that the fastenings are inefficient.

According to the retained hypothesis, it is assumed that the direct cause of the derailment is the opening up of the track as a result of the inefficient fastening of the rails to the sleepers at an expansion joint and in a curve.

**No recommendation:** Line 28 in Schaerbeek has been renovated since the derailment.
