**FINAL REPORT**

**technical investigation of a railway accident - derailment of nine freight  
wagons of the composition of freight train No. 50601 when entering  
Dupnitsa r.w. station i.w.o. switch No. 10 on 23.01.2016**

Ministry of Transport, Information Technology and Communications,  
REPUBLIC OF BULGARIA  
Railway Accidents Investigation Unit - RAIU

April 2016

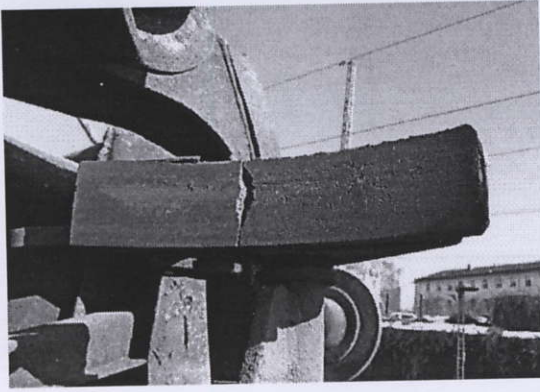
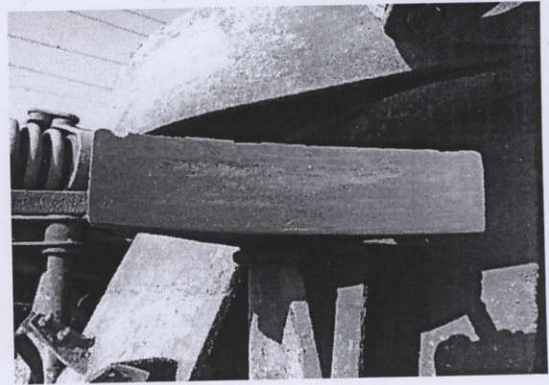
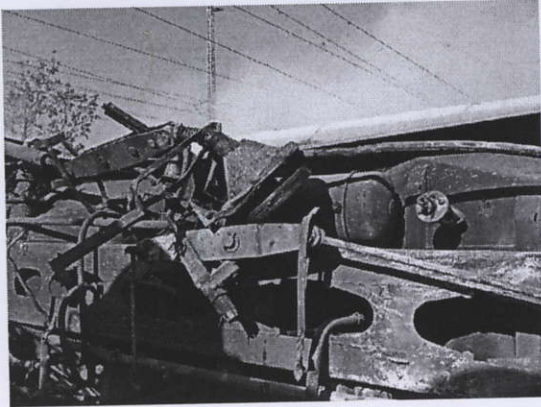
table with activated braking systems. The brake of freight wagon No. 31529326281-4 - sixth after the locomotives acted (Fig. 9, 10, 11) and that of freight wagon No. 31521811065-0 - eighth after the locomotive was isolated at the station Iliyantsi origin station (Fig. 12, 13). Wagons 9, 10 and 11 after the locomotive were not available at the inspection at Dupnitsa station and the state of their brakes was unable to be assessed. From the examples and calculations made, it became clear that the train was not provided with brake mass in its departure from Delyan station to Dupnitsa station, even assuming that the missing freight wagons were running with brake systems.
