FINAL REPORT

**Technical investigation of railway accident – derailment of freight train No 50501 in
Voluyak – Hrabarsko interstation on 03.09.2016**

February 2017

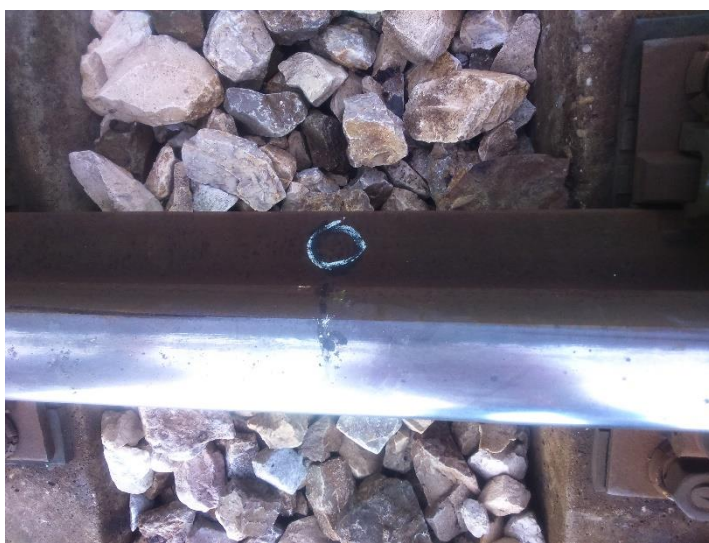
Фиг. 1

From the performed inspection on site on the place of derailment at km 14⁺⁰⁵⁵ was found that the flange of the right wheel did not leave a trace on the working side of the rail head, which proves, that wheel got over the right rail (fig. 1-фиг. 1).

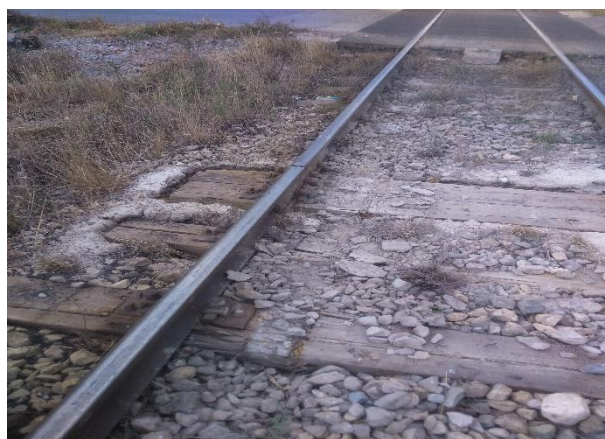
Фиг. 2

The distancing to the right of the derailed wheelset is a cause after 1,10 m to derail the second wheelset of the first bogie in the gauge, leaving clear traces to the right from the rail and traces in the gauge (Fig. 2-Фиг.2).

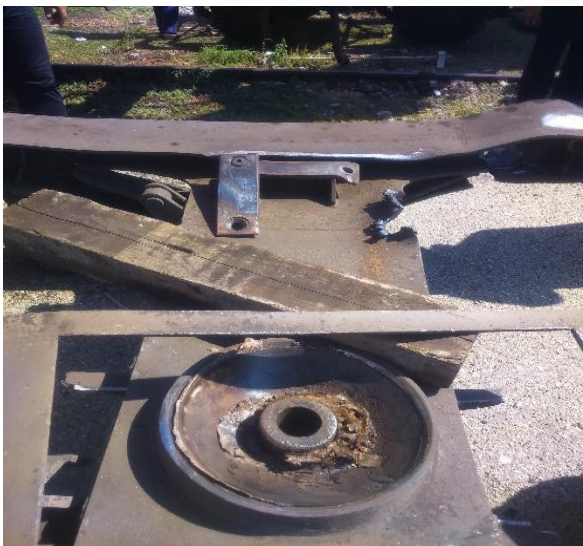
Фиг. 3

Within dismantling of the derailed first bogie of wagon No 31526651221-1 was found that the insert of the central bearing was deformed and cracked and did not bear regularly (Fig.

3-Фиг.3), and the slidings of the bogie were strongly worn with changed color.
