**RAILWAY ACCIDENT INVESTIGATION UNIT  
AT THE MINISTRY OF TRANSPORT, INFORMATION TECHNOLOGIES AND  
COMMUNICATION**

**FINAL REPORT**

**technical investigation of railway accident – derailing of electric locomotive Nr. 86018.9  
from the composition of freight train Nr. 30690 upon entrance in Pirdop station on  
04.05.2017**

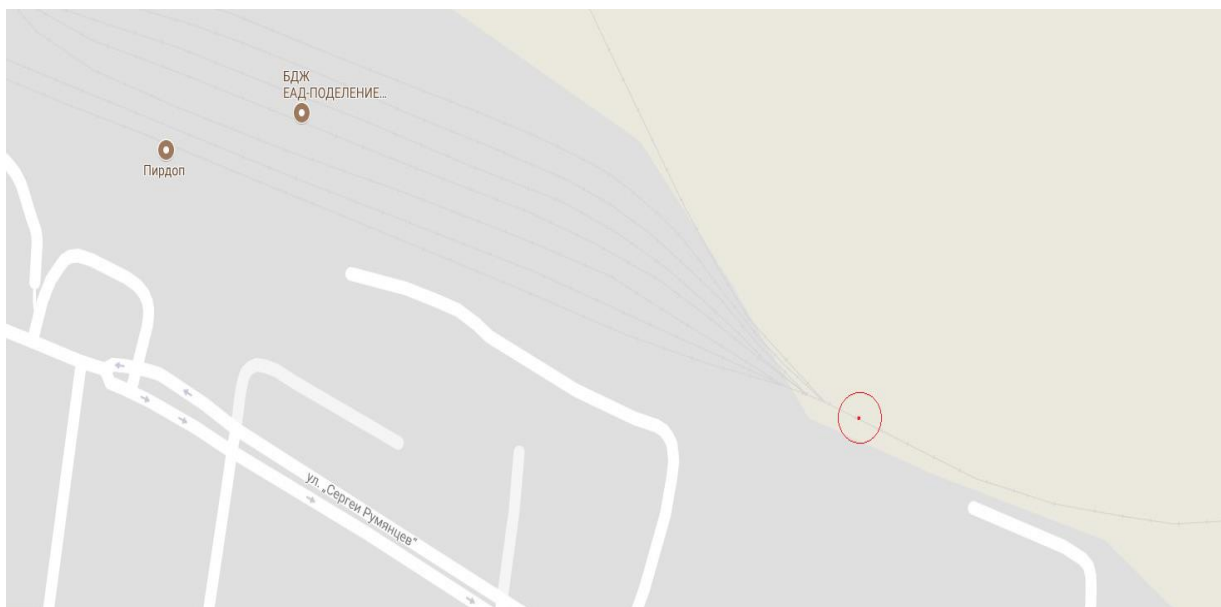
Fig. 1

of travel the train stopped at km 84<sup>+550</sup> (Figure 1).

After final stopping of the train, the locomotive drivers performed examination of the running parts of the locomotive and established that the train had derailed with its first wheel axis in the direction of movement. Thereabout they informed the carrier's dispatcher on duty and waited for the relevant instructions. The locomotive was in a stay-still from 07:10 h. till 11:30 h.

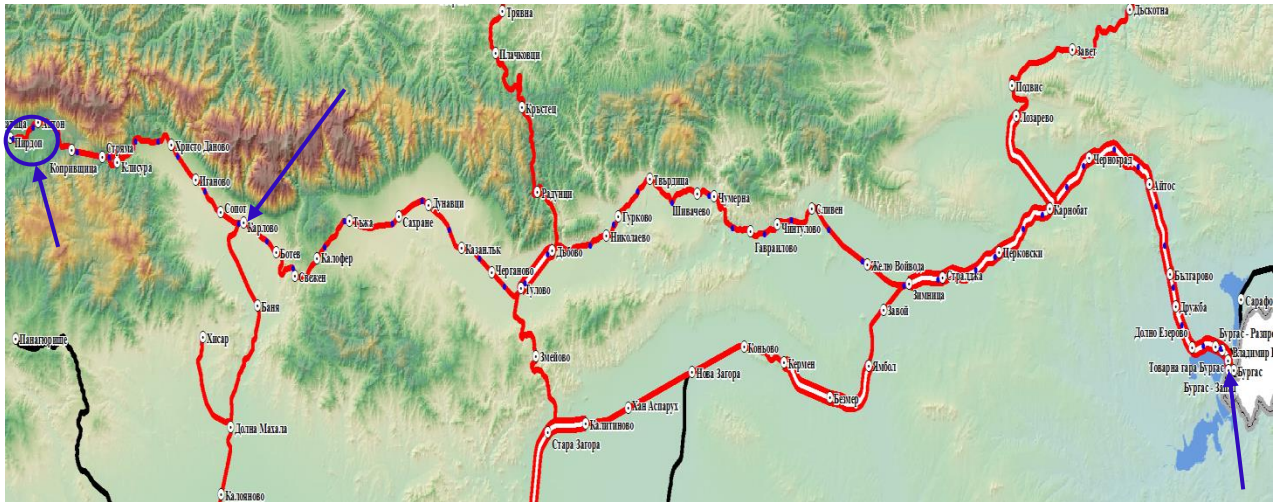
Fig. 2

3.3. By order of "D. B. Cargo Bulgaria" EOOD, the National Railway Infrastructure Company (NRIC) developed an operative schedule for trafficking of freight train Nr. 30698 on the route of Burgas – Karlovo. From Karlovo station to Pirdop station a new operative time schedule for the same train was elaborated and the train departed under Nr. 30690 (Figure 2).

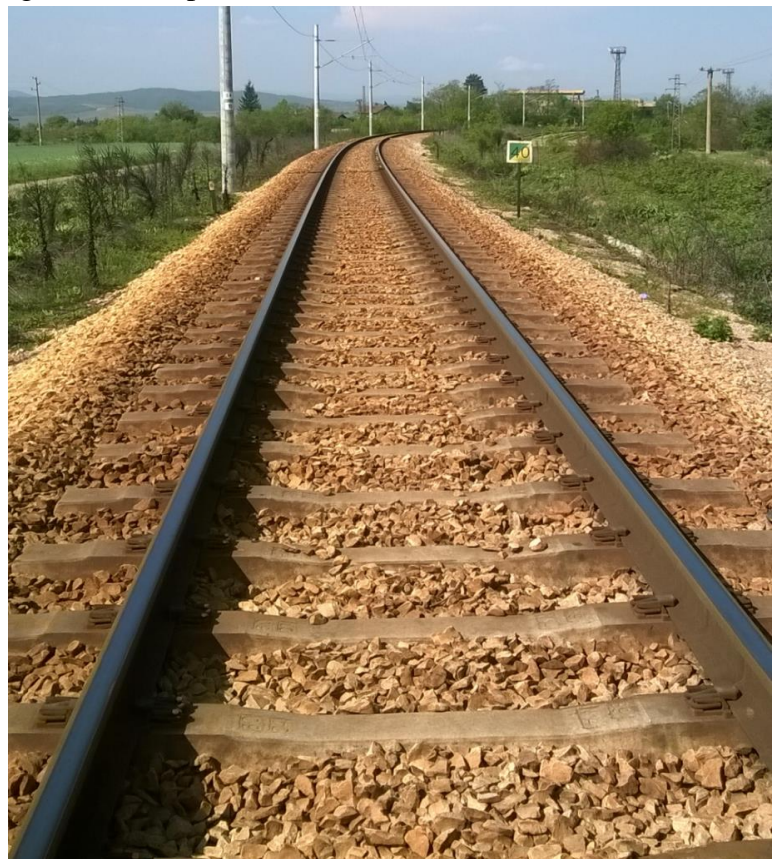
**Fig. 3**

The place of derailing is found in a transitional bend with radius  $R=500$  m and length  $L=523$  m, including two transitional bends of length 120 m each and a circular bend 283 m (Figure 3). The surpass height in the circular bend is  $H=40$  mm, with transitions of surpass height 1:3000 in the two transitional bends. The railway line profile in the section between the stations in the direction to the station is of 12.73 ‰ inclination from km  $84^{+256}$  to km  $84^{+415}$  and 13,40 ‰ from km  $84^{+415}$  to km  $84^{+905}$  upon descending. Per type of structure, the railway line is jointless, made of rails of UIC 60 type clad on reinforced concrete sleepers, complete with fixing units, “PANDROL” type. The point of derailing of locomotive Nr. 86018.9 is at km  $84^{+790}$ , located at 230 m before the entrance signal of Pirdop station, at the side of Anton station.

Based on the performed technical measurements of the railway line in the area of derailing it was established that the condition of the rail and sleeper's grid and the ballast prism is in conformity with the technical norms and standards. In respect of distance between rails, cross-wise and longitudinal level, as well as per its central line, the railway line is within the prescribed norms. There are no absent or loosened fixing units. The railway line is in conformity with the requirements of the Instructions on the arrangement and maintenance of the upper structure of the railway line and the railway points. This is also confirmed by the measurements registered in the Protocol of Findings on the status of the railway line, submitted by the representatives of the Operative Team.

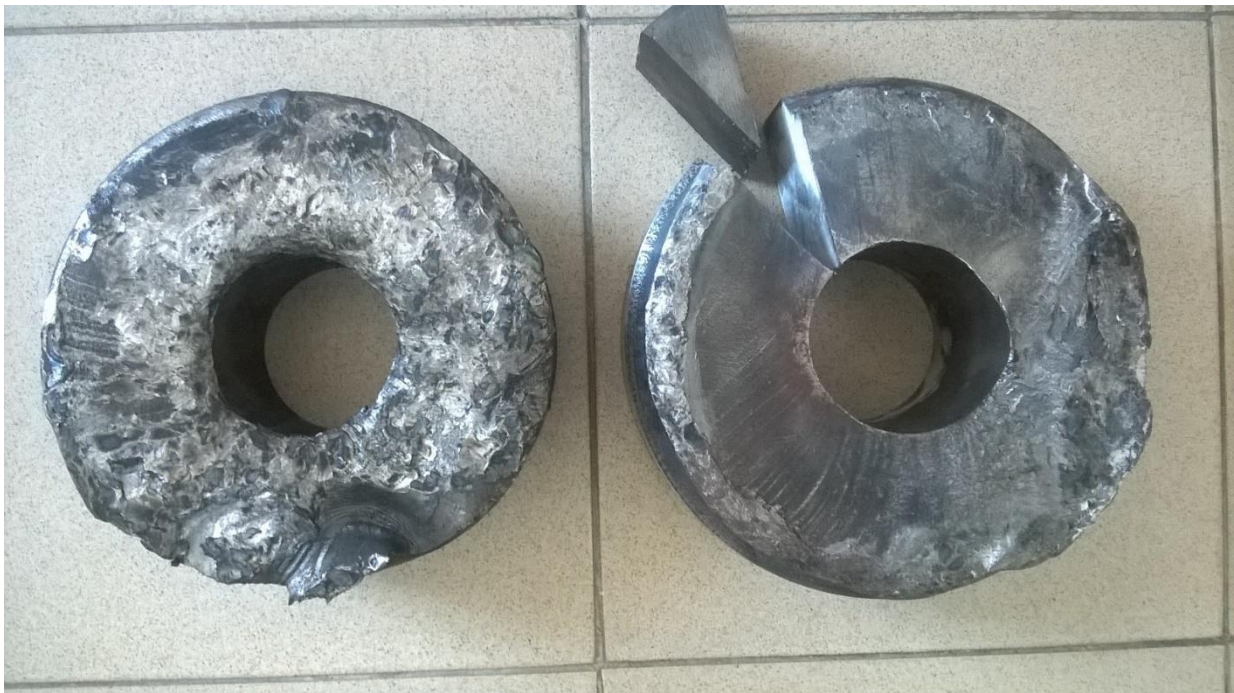
**Fig. 4**

After dismantling and survey of the axis at “Express Service” OOD, it was established that the surfaces of its two parts are not in a good state. Visible on the surfaces are crashings obtained during trafficking from the moment of breaking of the axis till the moment of stopping of the locomotive. Nevertheless it can be definitely stated that breaking of the axis has resulted from fatigue of material. This is proven by the presence of clearly expressed areas of wear and

tear, comprising about 60 – 70% from the cross sectional area of the axis, obtained from the development of the crash in the axis, and an area of a granular crash obtained from the sudden destruction, which is the last stage of destruction of the structure (Figure 4).

The observed cracks and their development result from external impacts and deterioration of the physical characteristics of the detail in the process of undergoing permanent operational impacts.

The third recommendation is addressed to the railway company “Express Service” OOD, requesting increasing of preciseness upon the performance of ultrasonic NDT of locomotive wheel axes and axes, as well as better préising of technology for complete setting of locomotive wheel axes.

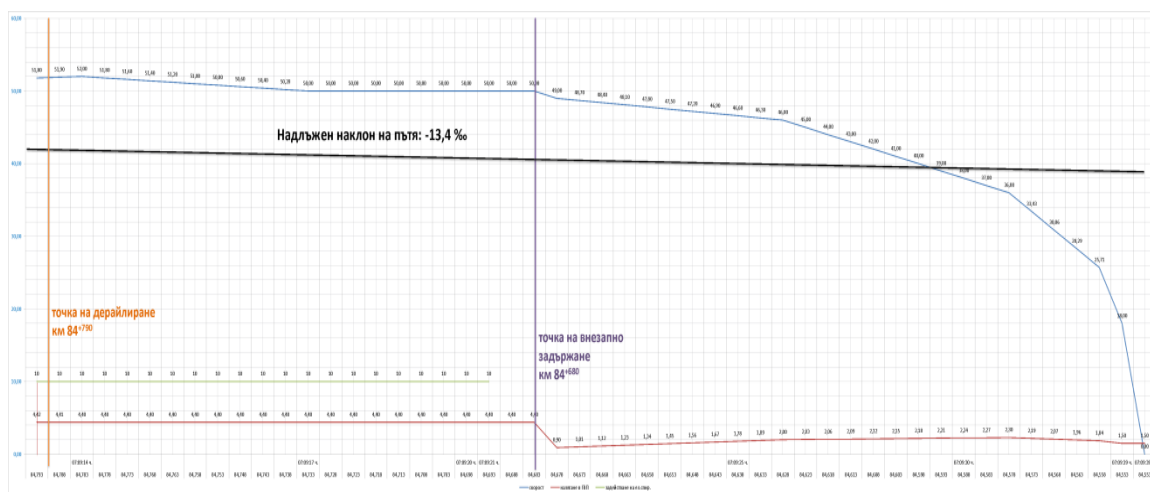
**Figure 6**

As a result from the extreme hold up, at km 84<sup>+550</sup> the train stops finally.

The locomotive engine driver has carefully followed the trafficking situation and the status of the train, has timely reacted and has acted correctly according to the existing situation (Figure 6).
