FINAL REPORT

from
Technical investigation of railway accident–
fire occurred during movement in electrical locomotive No 44141.0, which serviced
fast train No 4681 in Mihaylovo – Svoboda interstation on 08.07.2016

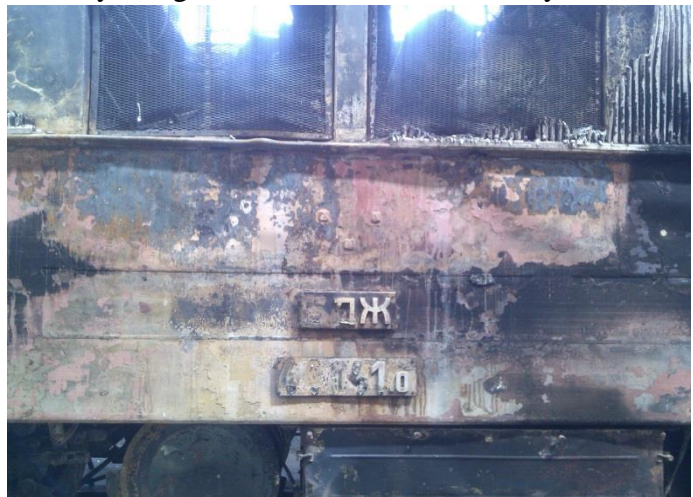
Fig. 1

Cause for the accident – fire occurrence in electrical locomotive No 44-141.0 during movement is, **rupture of the shell of the autotransformer switch (ATS) due to occurrence of or voltaic arc between the fixed contacts and the rollers of the switch on grades**, due to broken chart of the apparatus switch – displayed on (fig. 1).

The voltaic arc caused the ignition of the oil, located in the internal part of the switch which from its side led to the ignition of the other elements and aggregates in the machinery compartment of the locomotive.

First hypothesis, the ignition was caused by sparks obtained during the train stopping, due to the friction between the brake blocks and the wheels of the locomotive. The probability the ignition to appear due to that cause is *pretty insignificant*. It is true that the draft gear of the locomotives is rather dirty as the dirt is caused by dust, accumulated during movement of the locomotive, adherent to oiled elements of the underframe aggregates and the bogies of the locomotive. In the practice there have been observed many cases of similar ignitions of rail rolling stock (RRS), caused during the stopping process, when because of the friction between the brake blocks and wheels appear sparks, which could be a cause for ignition of accumulated dirt. It must be noticed that during the stopping process of train composition are used the brake systems of the coaches and only in exceptional cases this is performed by using also the locomotive brake system. In our case the locomotive brake was used, but for a short time, which could not cause sparks and temperature increase, leading to ignition. Even if there is a spark, which to ignite the accumulated on the frames of the bogie and the frame of the locomotives layers of dust and oils, it would ignite (possibly) the cables of the horizontal fan under the body-shell, but the flames could not transfer to the machinery compartment (fig. 1), (which was found from the Commission) moreover that during the usage of the fire-extinguishers the fire was not overcome and ignited immediately after the fire-extinguisher

was directed in another direction (from the locomotive driver explanations), consequently the **occurred outbreak of fire was not under the frame of the locomotive**.

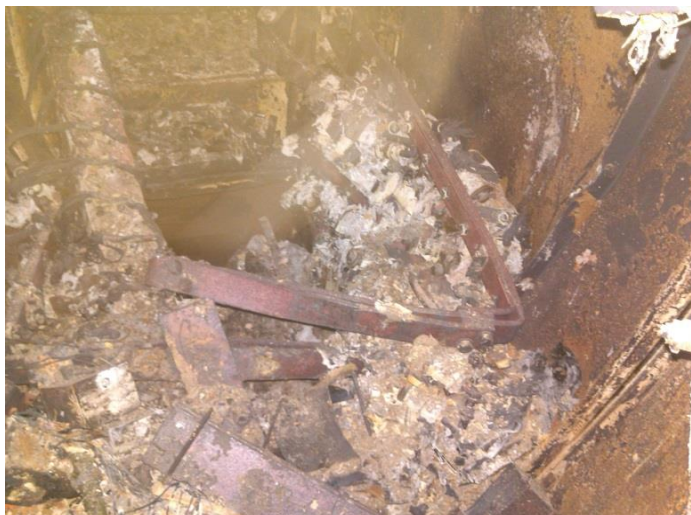
Fig. 2

Second hypothesis, the ignition occurred from some of the rectifying units from both traction groups. In principle these aggregates are with low level of fire hazard and are not frequently met reason for the locomotive ignition; however the practice is aware of similar cases. The Commission considers the probability the rectifying units to be a cause for the ignition in the case as insignificant mainly because of the fact that the two cabinets, which service the two separate traction groups were burned to equal extent (fig. 2). That may happen or in case that the fire started from the both groups in parallel, which is practically impossible, either that they are not source of the ignition. As an additional argument may be indicated the fact that during ignition of the rectifying cabinets from the horizontal fans under the body-shell comes fire – occurrence that during and before the fire have not been noticed. All these evidences display that the **rectifying cabinets are not source of the locomotive ignition**.

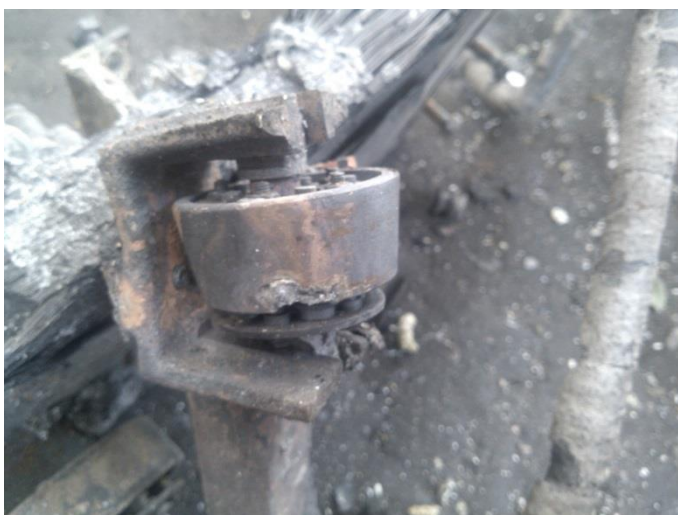
Fig. 3

Third hypothesis, which the Commission considers as the *most probable*, the ignition of the locomotive was caused from ignition of the oil in the autotransformer switch (ATS) as a result from destruction of its shell. Arguments for the statement, gives the progress of the case just before and during the ignition itself. During the train entrance in Mihaylovo station the locomotive driver heard strike from the inside of the locomotive (as per his explanations), which (at his discretion) came from the draft gear. That made the two locomotive drivers to perform a brief inspection of the draft gear of the locomotive during the short stopover in Mihaylovo station, however they did not find anything irregular, due to which continued their movement under the schedule. When the locomotive driver was asked the question whether during hearing the strike he felt the typical inclination ahead of the locomotive in case of failure of the draft gear, he answered in a negative manner. Those circumstances give grounds to be considered that most probably the heard noise (taken as a strike in the draft gear by the locomotive driver) is a result from rupture of the ATS shell, which led to oil leakage in the machinery compartment. The very ignition of the oil was caused by voltaic arc, occurred in the switch due to a broken working chart, which led to the shell destruction (fig. 3). After departure from Mihaylovo station, the train-master felt smell of burnt diesel fuel (naphtha), (evident from his explanation). That was the first sign for the presence of ignition in the locomotive. As the transformer oil is with very similar to the diesel fuel indicators during burning, having in mind the train-master is not a specialist and it is absolutely possible to be wrong. The train passed few kilometres after its departure from Mihaylovo and under the frame of the locomotive started to emit grey-white smoke – a sign that oil was burning. In the case the transformer and the ATS oil. The oil is pretty strong source of heat in case of burning as in the meantime it has possibility to maintain continuous burning due to its significant quantity of viscosity. That was reason the shell of the ATS, which was produced in aluminium to

melt and its smelt to start gathering on the floor of the machinery compartment. As a result from the high temperature, obtained from the oil burning, were deformed the floor sheet metals of the locomotive, and the melted metal started to flow along the shell of the fans under the body-shell, as it burned the insulation of the feeding cables (fig. 4). The fire expanded under the body-shell of the locomotive and burnt the frame, the floor's sheet metals from their lower side, and shells of the horizontal fans, feeding cables, rechargeable batteries and the traction engines, and frames of the two bogies as well. From the pictures taken by the train crew (conductor – trainee train-master, locomotive driver and assistant locomotive driver) is evident that the fire transferred under the locomotive and there it caused the serious damages on the aggregates under the frame (fig. 5 and 6).
