FINAL REPORT

**technical investigation of railway accident – derailing of wagon-cistern from the
composition of freight train Nr. 30582 in the section between Dalgopol & Komunari
stations on road Nr. 2 on 09 February 2017**

August, 2017

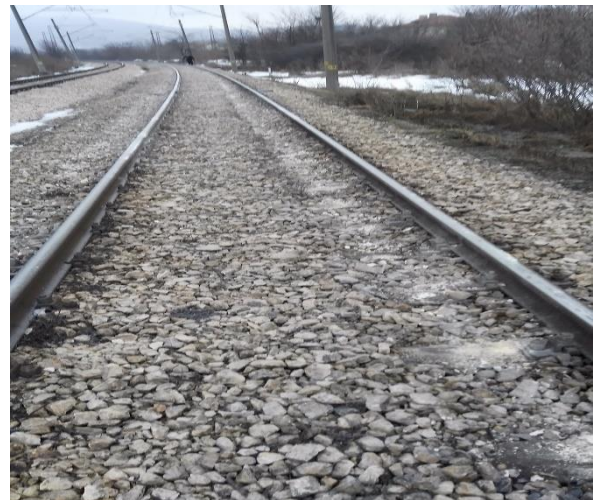
Figure 2

For establishing of the causes having lead to the derailing accident, the place of derailing was subjected to detailed survey and additional measurements in respect of the technical condition of the railway line, which is located in a bend with radius $R=800$ m in a horizontal section (Figure 2).

The joints are supported by joint timber sleepers, with the exception of a floating joint near point (-5), which has 4 joint bolts and has no vertical and horizontal overlaps between the connected rails on the two sides of the joint. The fixing sets of the railway line are found in a good technical state and no fixing sets are missing. The railway line is well ballasted, without visible mudding of the ballast prism. The major geometric parameters determining the technical condition of the railway line are: distance between rails, level (longitudinal and crosswise), situational layout of the railway line, as well as wear and tear of rails (sidedly and vertically), especially in bends with radiuses smaller than $R=500$ m on the external rail parts, which are attacked by the leading wheels of the wheel axes of the carts.

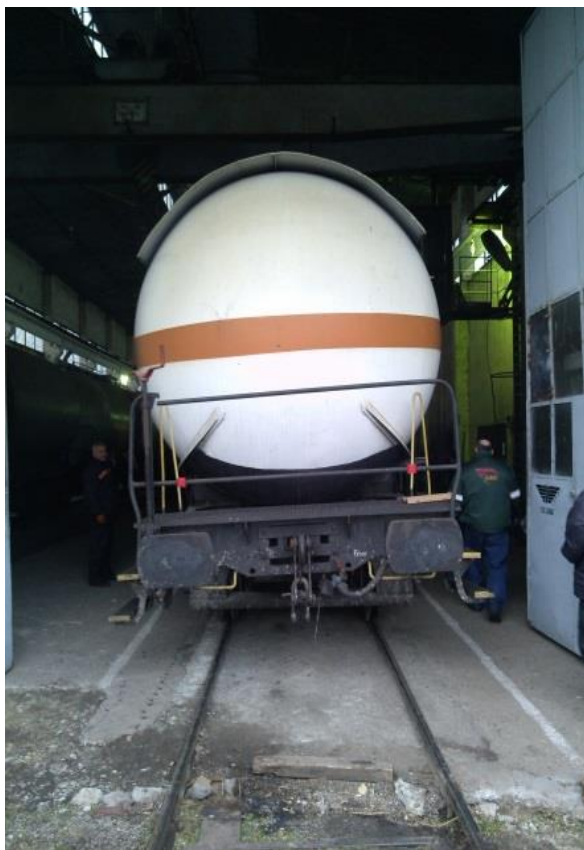
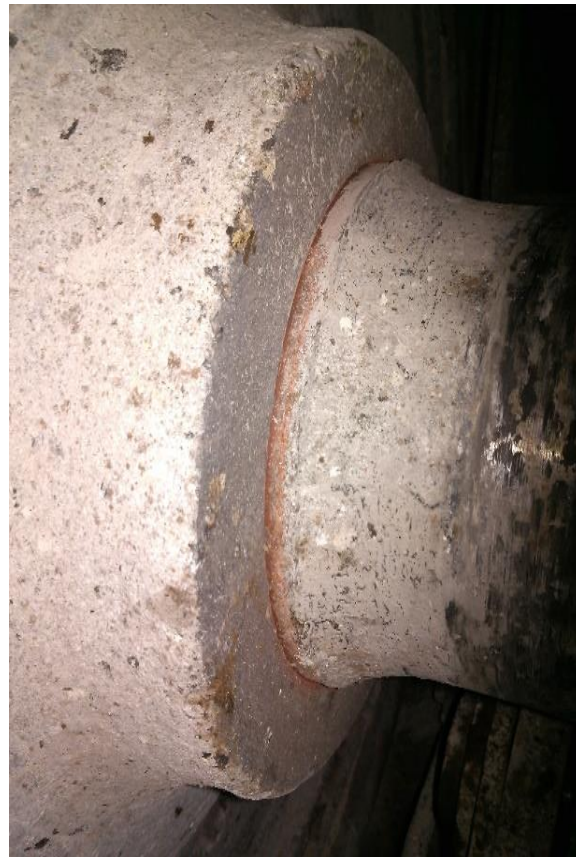
Upon front viewing of the wagon from the buffer side, while standing on a straight horizontal railway platform, it became noticeable that the car and the frame of the wagon stay inclined (Figure 3) on one side (on the left). Later it was established that this is the side where the damaged wheel is found at the first axle box of the first wheel axis (Figure 4).

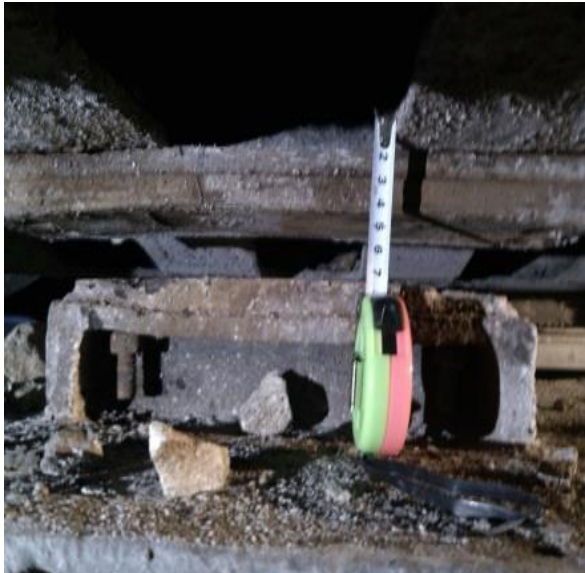
Figure 7

At the same time the gap (the distance) between the runners on the other side of the wagon is more than 30 mm, which is much more than the maximum permissible value, as stipulated by Ordinance Nr. 58 (Figure 7).

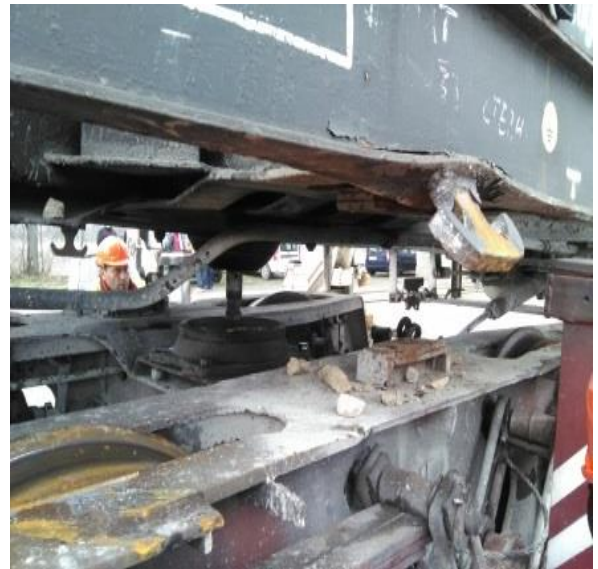
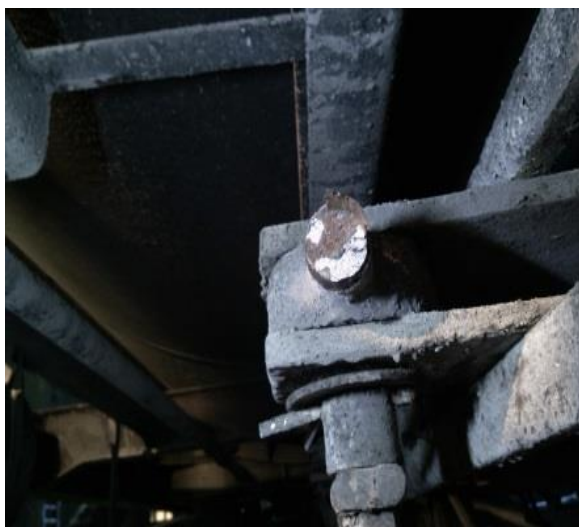
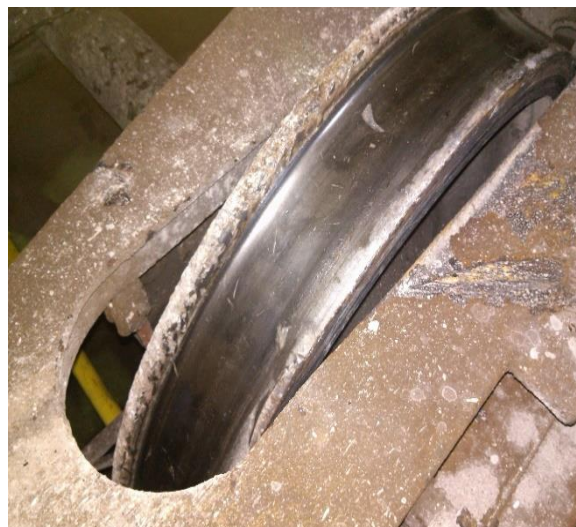
All these factors have lead to the inclination of the wagon's car on one side, and in such manner the wagon has travelled for a long time, a proof of which are the established old traces on the runners having caused their deformation. In the process of examination it was proven that the frames of the wagon and the derailed cart are covered with white-colored dust from the ballast prism. Also there were stones left on the cart's frame, there were distorted elements from the beams of the wagon's frame (Figure 8), as well as torn parts from the lever breaking system (Figure 9). All these damages are caused by the derailling of the cart and the next long travel over the ballast prism of the railway line. The Commission examined the condition of the wagon's wheel axes and proved that the ledges of the wheels of the derailed cart are hurt with the movement on the ballast prism and the sleeper' grid on the railway line, which makes them improper for operation (Figure 10). A substantial fact, proven upon the examination, was the condition of the right wheel on the first wheel axis of the wagon's first cart. It was established that the press joint which holds the wheel to the axis, has defected, as a result of which the wheel has shifted to the outside from its normal position in an axial direction at several millimeters (Figure 11).

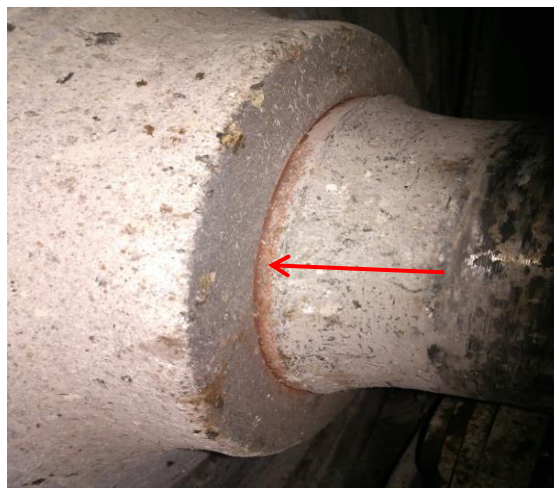
Figure 11

The cause having lead to the derailing of the cart is complex, determined by several substantial elements:

- The increased distance between the wheels of the wheel axis;
- Problematic rotation of the cart, resulting from the deteriorated condition of the runners;
- Shifted center of gravity of the wagon-cistern at crosswise direction because of the worn runners and the centrifugal force acting upon the wagon in the bend where the accident has occurred.
