**SPECIALIZED UNIT FOR INVESTIGATIONS OF ACCIDENTS AND INCIDENTS IN
RAILWAY TRANSPORT AT MTITC**

FINAL REPORT

**investigation of a railway accident – fire occurred
in electric locomotive № 46221.8 while in motion, during servicing fast train № 8602
between Svoboda station and Chirpan station on April 09, 2019**

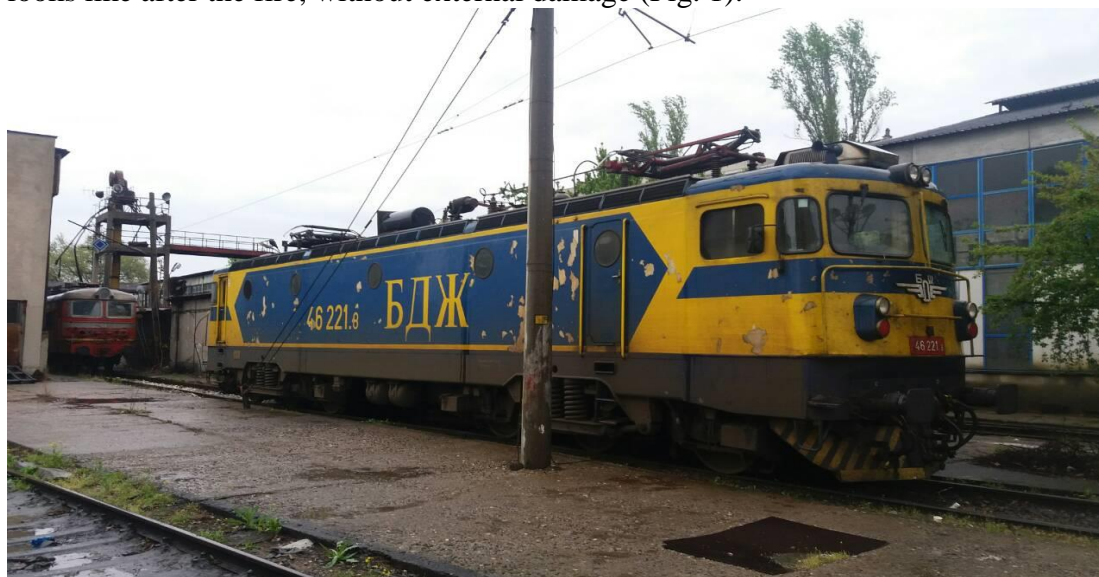
Fig. 1

The motorman enters the locomotive engine room and finds out that flames and smoke come out of the compressor. He takes off the pantograph and, together with the assistant motorman, they start extinguishing the fire with the fire extinguishers in the locomotive. This is what the locomotive looks like after the fire, without external damage (Fig. 1).

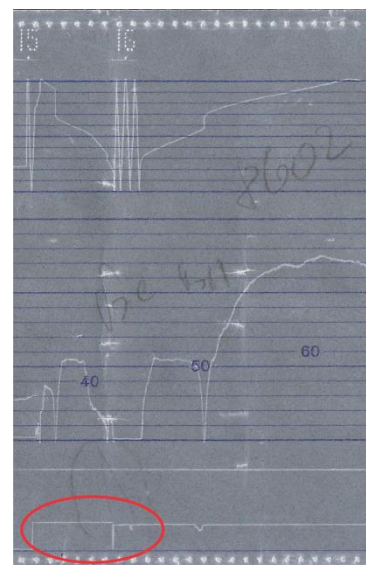
Fig. 4

The analysis of train № 8602 movement was made for the stage from Stara Zagora to Svoboda - Chirpan stage at km 69 + 480. It should be noted that the pressure marker on MAC doesn't always take the same position, which may in some cases lead to an ambiguous interpretation of the recorded information, so it is imperative to check the speedometer and the "Knorr D3" automatic, mounted on locomotive 46221 (Fig. 4).

The train moves at a speed of 140 km/h when 3100 m before Stara Zagora at 18:28 hours begins to decrease without using ABC, i.e. due to the natural resistance in movement (Fig. 5). Speed decreases to 135 km/h. In this way, it traverses 500 meters and in less than a minute the motorman triggers the brake by dropping 0.7 bar from the main air duct. The speed decreases to 110 km/h, as in this time the train travels 1300 m for about a minute. In this moment the motorman performs a second hold and releases another 1 bar and the pressure in MAC is set at 3.7 bars. The speed starts to decrease at a faster pace, and it is just 80 km/h 450 meters farther.

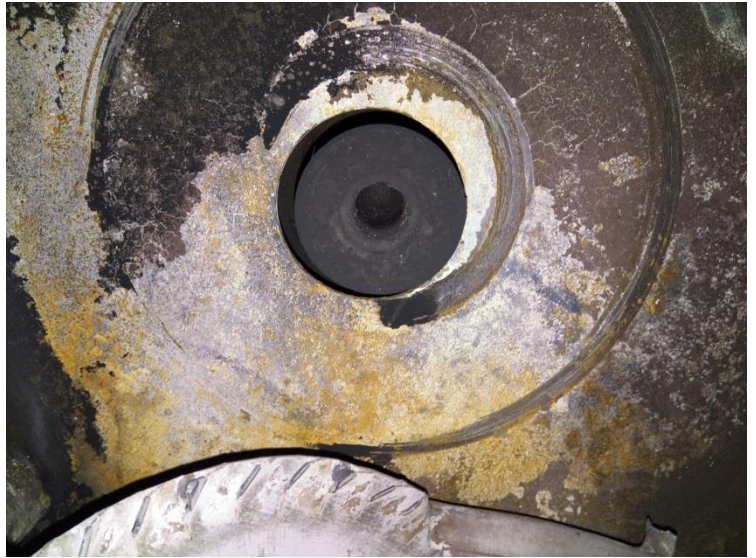
Fig. 6

The bolt heads from the disc on the back of the turbine show traces of the friction with the wall of the turbine camera (Figures 17 and 18). They have been the first elements to come in contact with the wall, which is evident both from their condition and the traces on the wall of the camera. Besides the traces left by the bolt heads, there are traces of the peripheral part of the turbine disc on the wall of the camera, which have appeared when the front impact rotation has increased (Fig. 6).

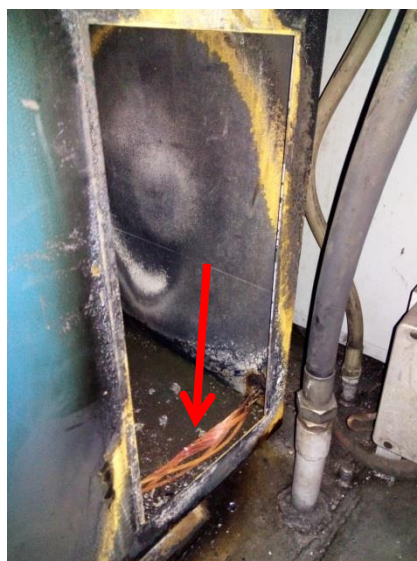
Fig. 9

The Investigation Commission took note of the factual situation and the consequences of the ignition, and after several inspections at Plovdiv Locomotive Depot and at Sofia Locomotive Depot, it was found that the main cause of the ignition has been the incoherence of the cooling turbine towards the main compressor's shaft as a result of which a front impact rotation has occurred during, which has led to its rear part being rubbed into the wall of the air outlet camera (Fig. 6). The friction between the two surfaces (steel in steel) has created sparks which have ignited the greased dust layered on the noise insulation of the inside walls of the compressor's cameras (Fig. 7). As a result, a flame has occurred and the temperature in the camera has risen. As a consequence of the flames and the high temperature, the sound insulation mounted on the inner side of the compressor unit cameras' covers (Fig. 8) is ignited. The ignited insulation has further increased the temperature which has led to the ignition of the power cable insulation supplying the compressor unit which passes through the same cameras (Fig. 9).

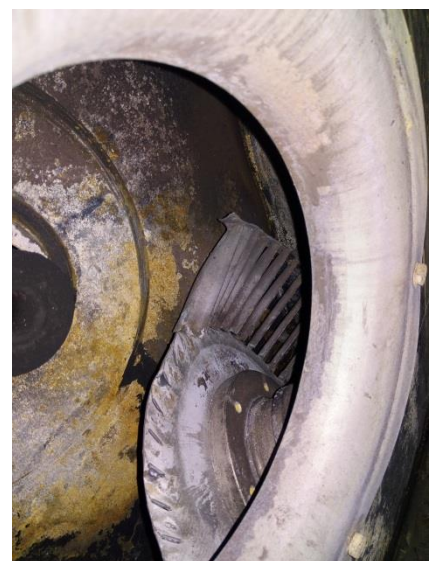
Fig. 10

Initially, the turbine exacerbates the flames and helps to feed and expand them. Subsequently, touching the walls of the compressor cameras has led to its deformation and at a moment it has ceased to perform its purpose due to falling off from the drive shaft of the main compressor electrical motor and has fallen to the bottom of the camera (Fig. 10).

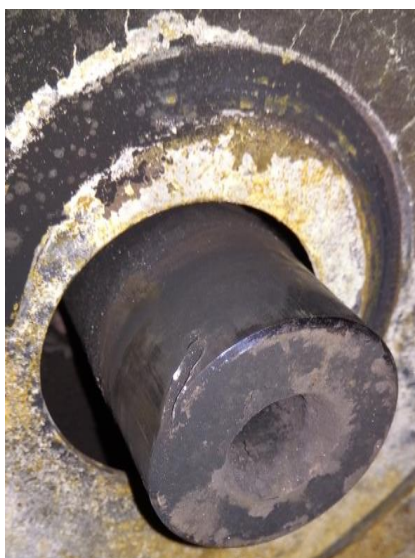
Fig. 13

The Investigation Commission took a comprehensive view of the compressor unit cooling turbine and found out blockage trace marks on the holdfast hub on the drive shaft of the compressor electrical motor. There were no missing blades, or such as dislodged by the turbine casing due to centrifugal forces (Figures 11 and 12). Deformations of the turbine blades have occurred due to the contact with the walls of the camera and there are no traces of malfunctions occurring before the accident. The fastening screw on the turbine bush is in working condition, showing signs of deformation and contact with the shaft of the electric motor (Fig. 16). Two traces were found on the locking screw of the engine shaft, one of which is a tapered depression and is assumed to be done during a previous mounting (Fig. 13). The second trace is a recess in the form of a path along the shaft. At the same time, the inside of the turbine hub shows a double trace of blockage in the form of a screw obtained from the cooling turbine falling off from the motor shaft as

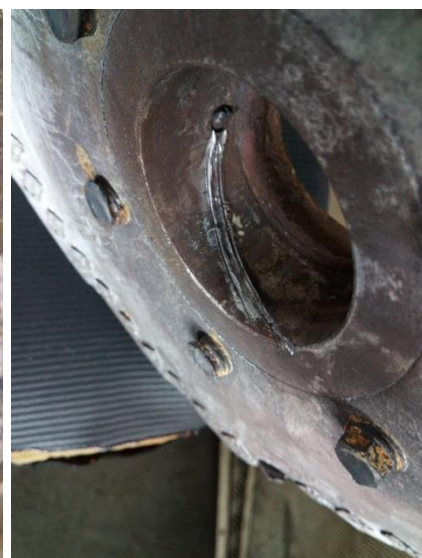
Fig. 14

a result of a contact with the injured surface of the shaft itself by the locking screw (Fig. 14). The screw also has traces of contact with the motor shaft, which is expressed in a dull tip (Figures 15 and 16.)

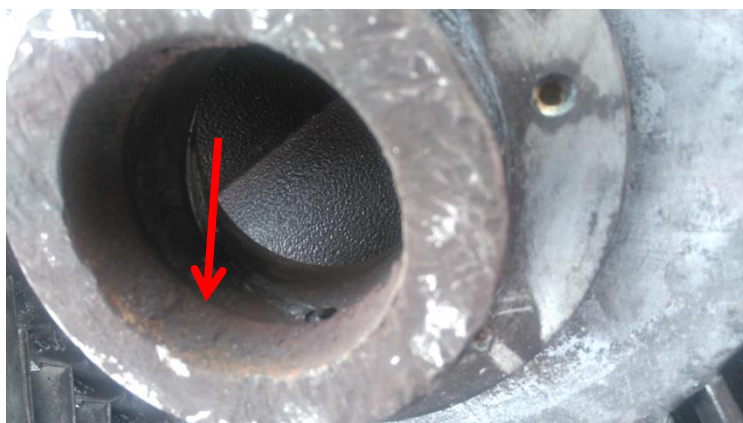
Fig. 19

During the views of the drive shaft of the electric motor, it was found that there was a hole in it with a cut thread, with no bolt in the hole. At the same time it was found that the hub is so placed on the shaft that it does not cover it with its entire length, i. e. a part of it (about a quarter to a third) remains out (Fig. 19). This further has contributed to the destabilization of the hub and the occurrence of a front impact rotation which has led to the dislocation of the joint between the hub of the turbine wheel and the shaft of the electric motor.
