RAILWAY ACCIDENT INVESTIGATION UNIT
AT THE MINISTRY OF TRANSPORT, INFORMATION TECHNOLOGY AND
COMMUNICATIONS

FINAL REPORT

technical investigation of railway accident –
derailing of freight train Nr. 90570 on point Nr. 5 upon entrance in
Hitrino station on 10.12.2016

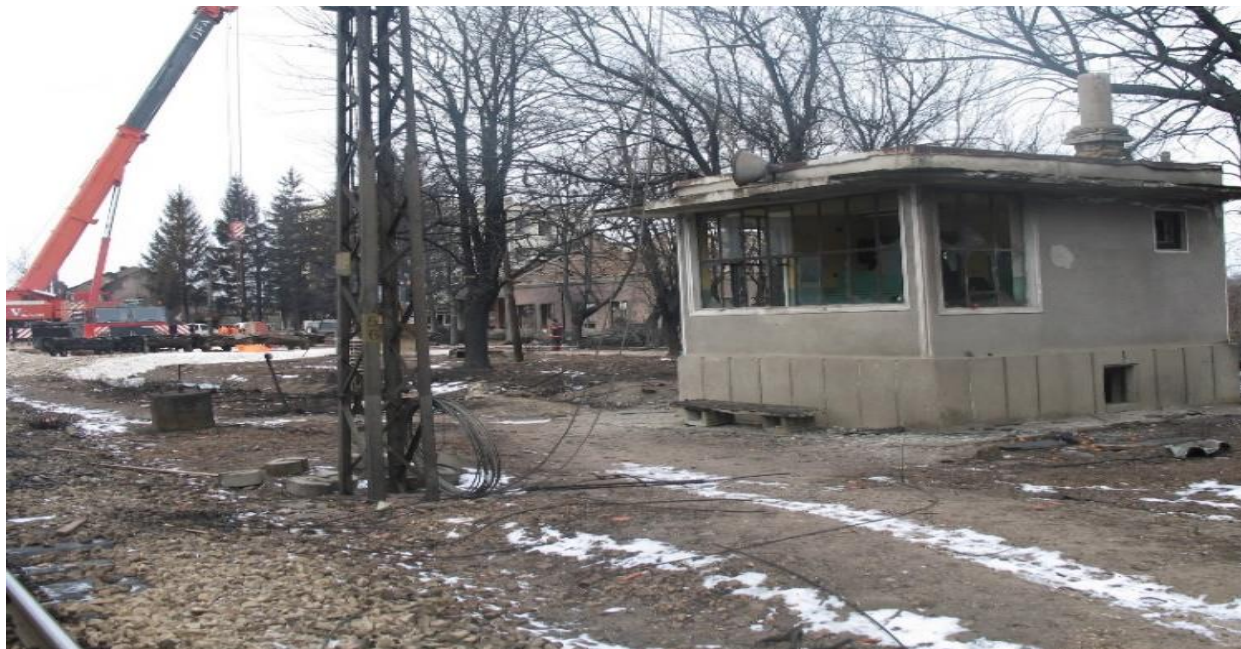
Figure 2

Destroyed are buildings and railway infrastructure in the area of Post Nr. 2 at Hitrino station (Figure 2). Many of the train's wagons are damaged.

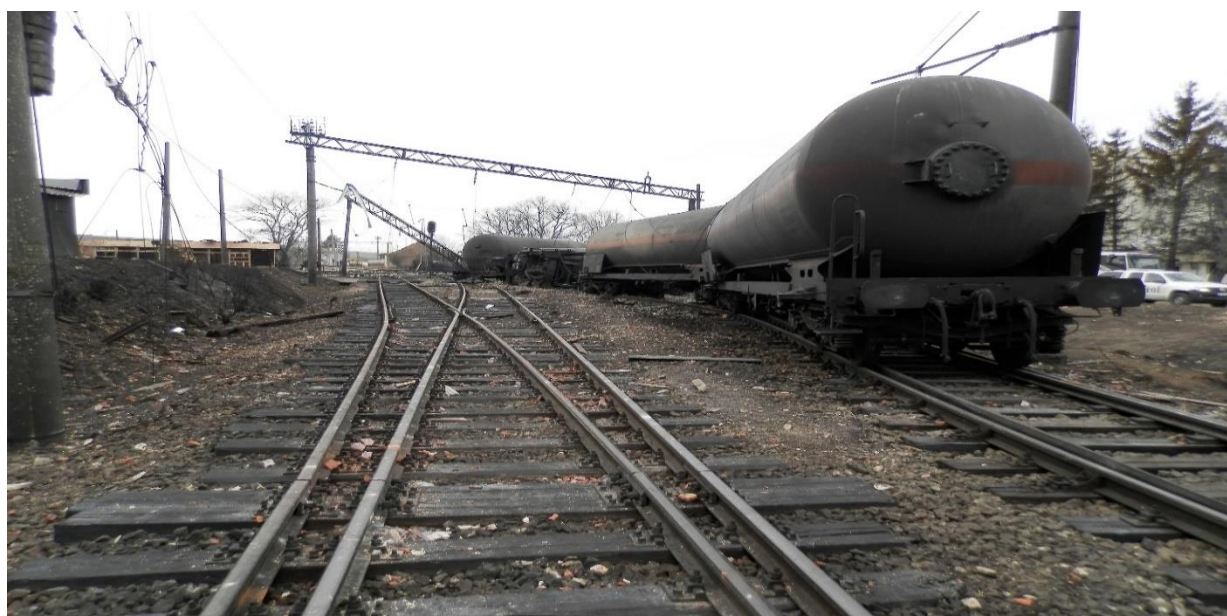
Figure 4

At the same time the post switchman at Post Nr.2 called by the station phone the traffic controller on duty to inform him that wagons from freight train Nr. 90570 had derailed in the throttle place of point Nr.5 and at the railway level crossing (Figure 4). During the call the post

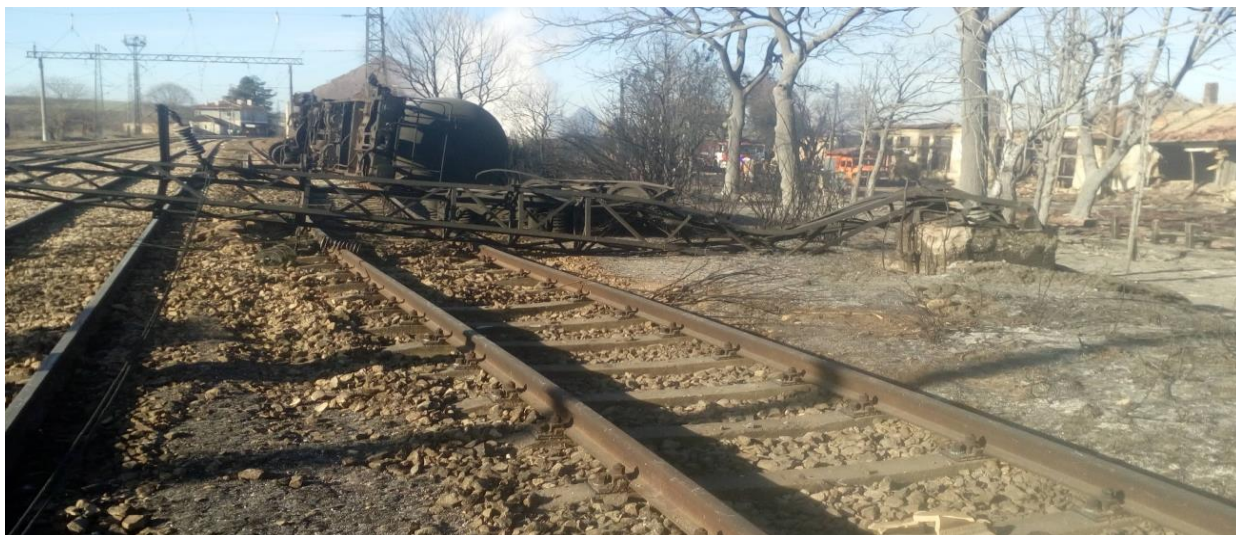
Figure 5

As a result from the derailling of the 6th wagon with one of its carts, the train was torn apart between its 6th and 7th wagons after the railway level crossing. The two locomotives, together with the 6 wagon-cisterns attached to them, continued their trafficking, as the 6th wagon moved with its first cart on the Third platform and the second cart moved on the Fourth platform. After 114 m the 6th wagon with its back side hit a pole of the catenary, broke apart from the 5th

wagon and laid aside on the Fourth platform (Figure 5). The other 5 wagons with the two locomotives continued their trafficking and stopped 340 m after the reception building of the

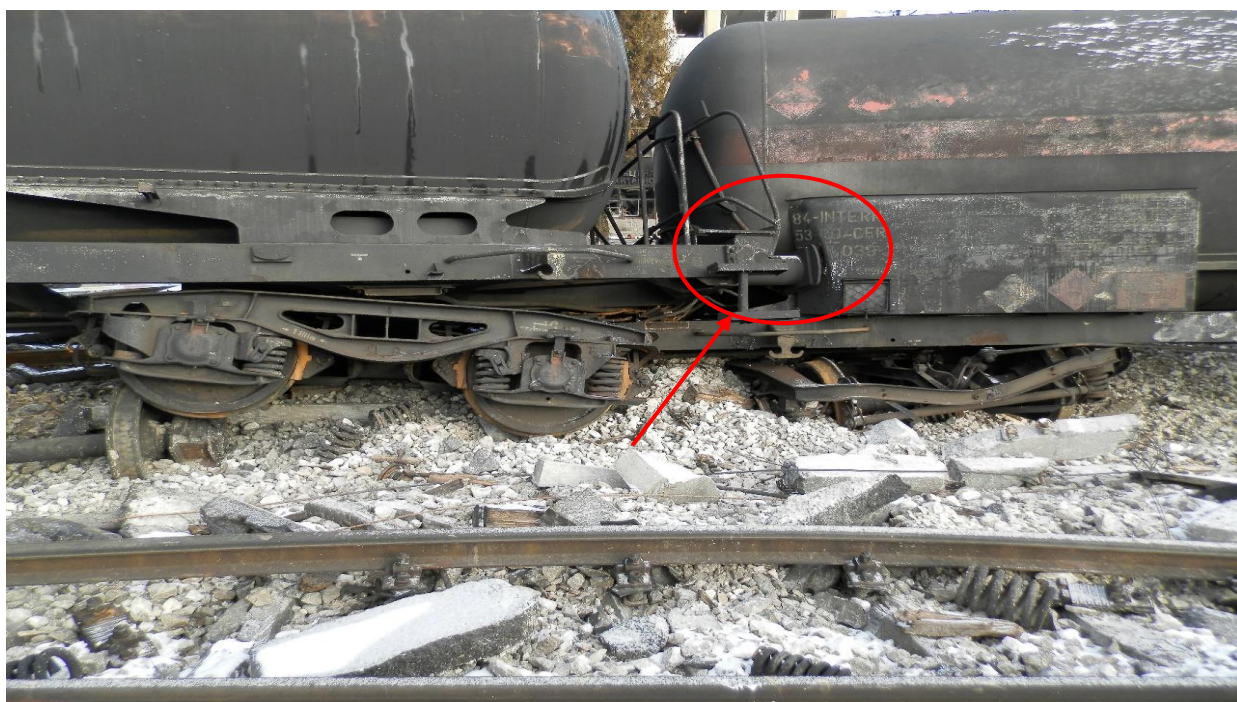
Figure 7

The next wagon-cisterns, from the 7th to the 17th one included, derailed and continued their movement uncontrolled, aside from the railway line. The pulling devices of some of the wagons got free from their catches, others got torn apart, which lead to the occurrence of crashes between the wagons, including in the area of the reservoirs (Figure 7). As a result from such

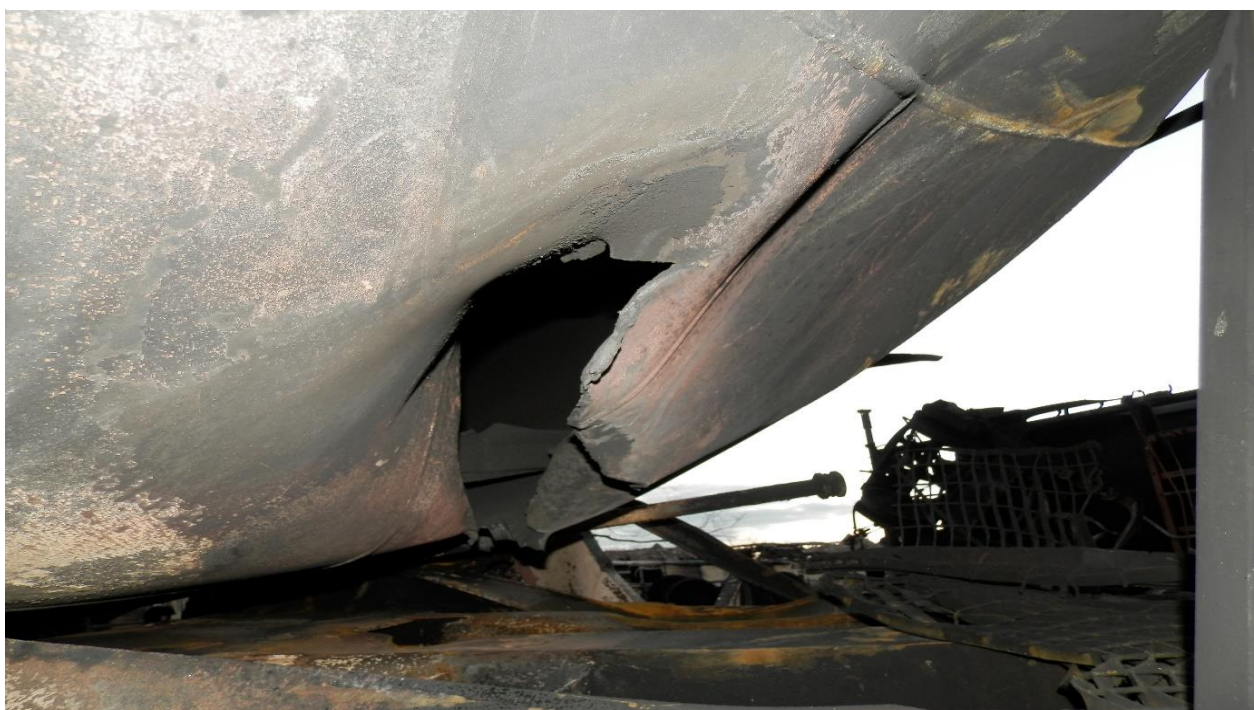
Figure 8

crashes and the uncontrolled movements, the frame of the 10th wagon-cistern got torn apart from the reservoir, bending on the left towards the frame of the 9th wagon-cistern, which climbed over it. Upon catching together of the two cisterns, the taller of the left buffer of the 9th wagon hit and cut the reservoir in its lower part of the 10th cistern Nr. 33 87 791 5652-4. As a result of the rupture, there commenced intense leaking of the freight (propylene), transported in a compressed state (Figure 8).

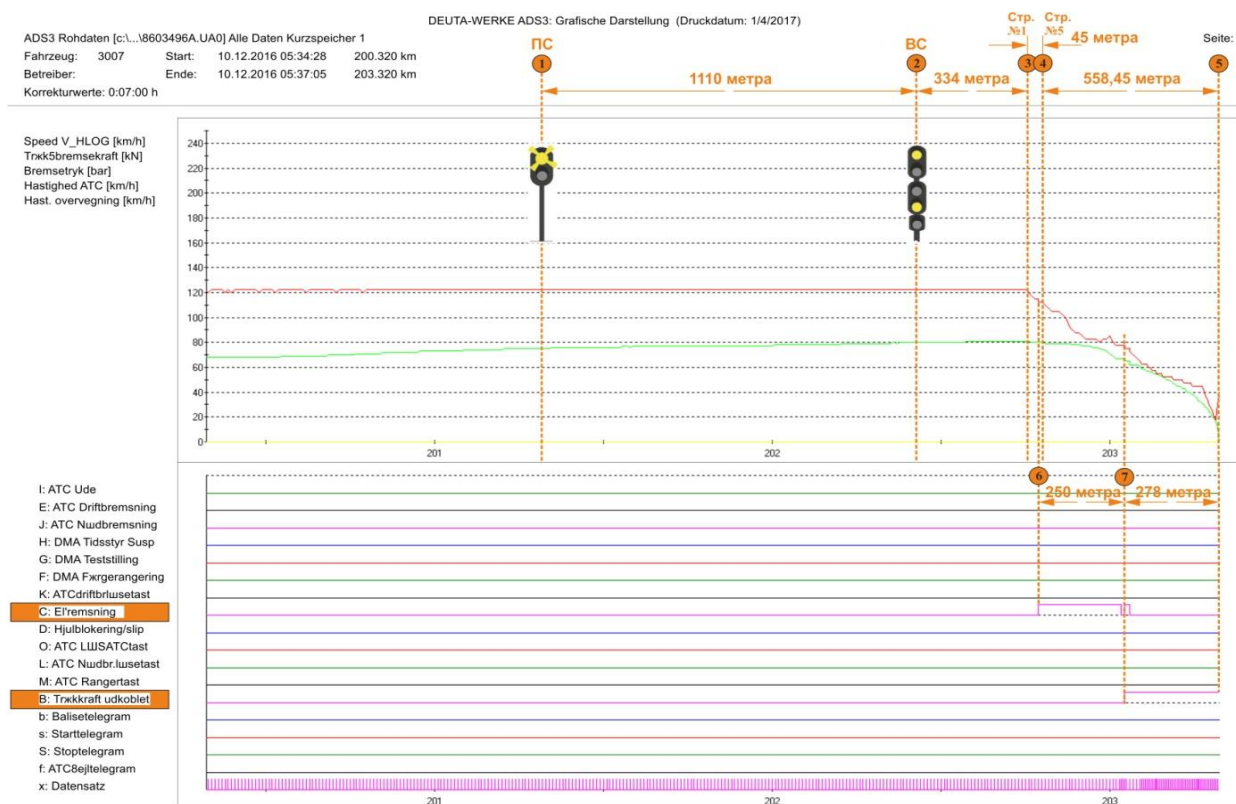
Figure 11

On Figure 11, on the image generated by the original software base markers are superimposed with numbering, designations and distances between them (in brown color). As exhibited by the diagram of speed as a function from the travelled road $V=V(S)$ (depicted in green color), till km 200,500 locomotive Nr. 86003.4 travelled with the permitted speed. After this moment the speed increased in an uncontrolled way and in violation of the trafficking

schedule it reached 81 km/h (marker ③ on Figure 11). At the warning traffic lights (marker ①) the train passed with the speed of 78 km/h, and at the entrance traffic lights (marker ②) – with 80 km/h.

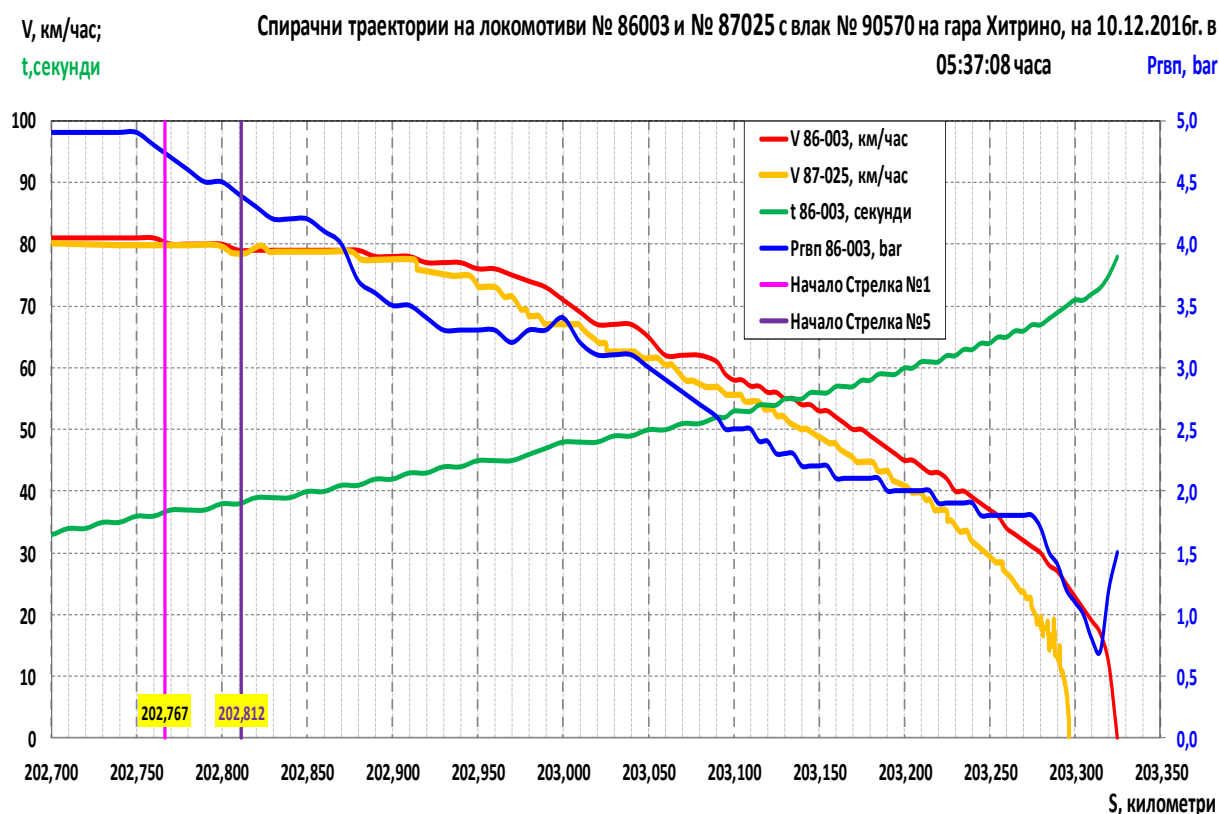
Figure 13

The coincidence of recorded data from the registering electronic systems of the two locomotives from km 202,700 to km 202,900 confirms the conclusion that train Nr. 90570 has passed through point Nr.1 with the speed of 81 km/h, and through point Nr.5 with the speed of 78 km/h.

Breaking trajectories of locomotives Nr. 86003 and Nr. 87025 with train Nr. 90570 at Hitrino station on 10.12.2016 at 05:37:08 h

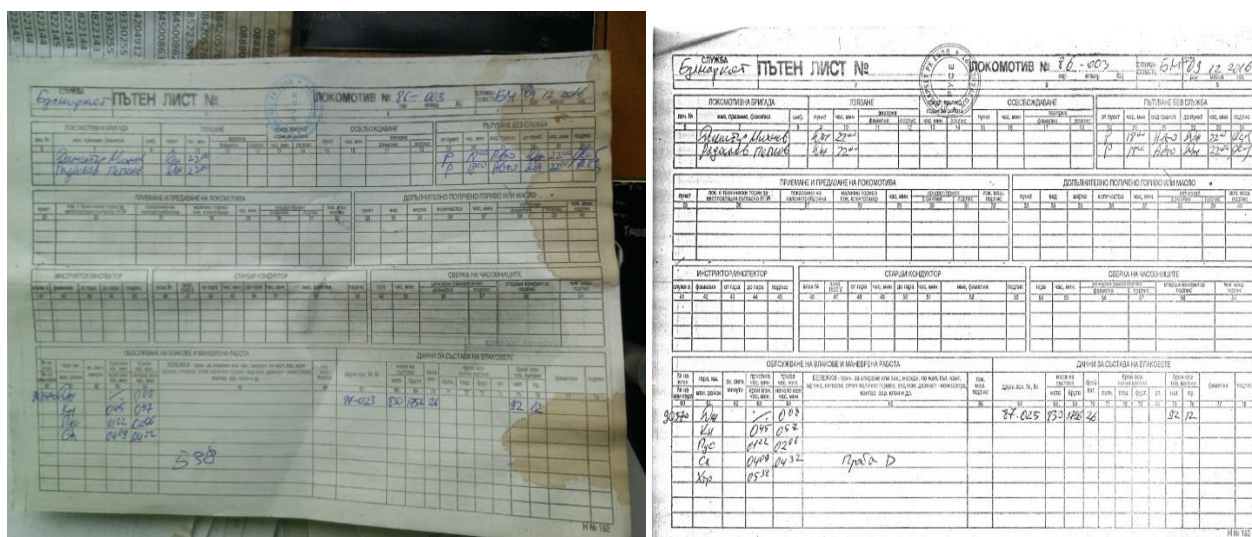
Фиг. 14

Upon their steeping in shift, the locomotive engine drivers who will service train Nr. 90570 appear in person at the office of the company carrier at Ruse-North station, where they are provided with a pass, an automobile for official use, which is driven by them in person to the station where the locomotive, which will be serviced by them, is parked. The pass, which the locomotive engine drivers receive upon their appearance at the office, has no number, verification or seal for capability of the staff members, affixed by the official issuing the pass, and this is a pre-condition for its replacement with another pass, which in reality was established in the process of investigation, namely: in the cabin of locomotive Nr. 86003.4 two passes were

found with different data filled in (Figure 14).

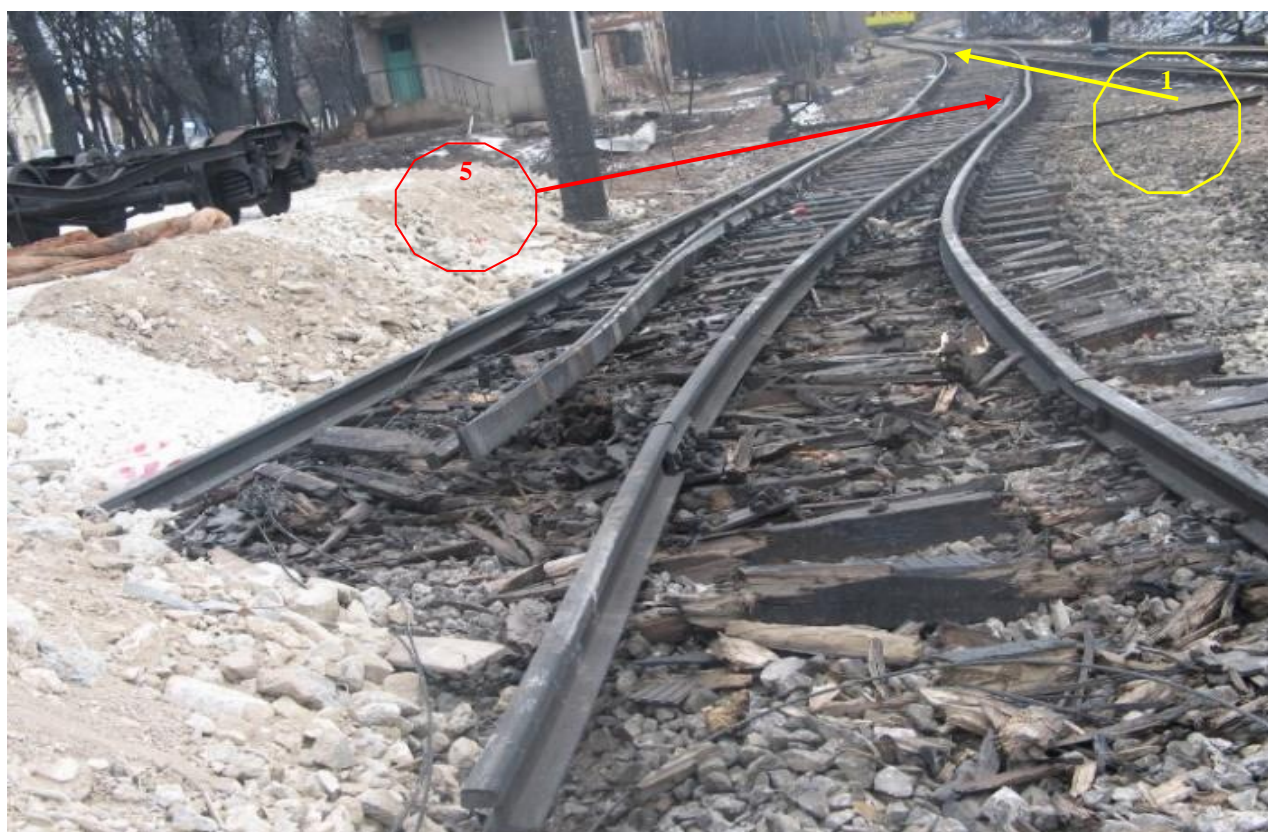
Figure 22

This was not the situation upon passing of the train through point Nr. 5 (Figure 22, the

point designated in red color). Because of the high speed of 78 km/h upon the entrance of the train in the point, the train changed its trajectory of movement depending on the position of the switch rails, and passed from right bent to left bend, as a result of which the horizontal crosswise forces had gained multiple increase. The locked right switch rail, densely affixed to the rail shoulder, and its strong fastening to the sleeper's grid, assisted the switch rail of the point to counteract at the forces generated from the wheels of the two locomotives and of the first five wagons.

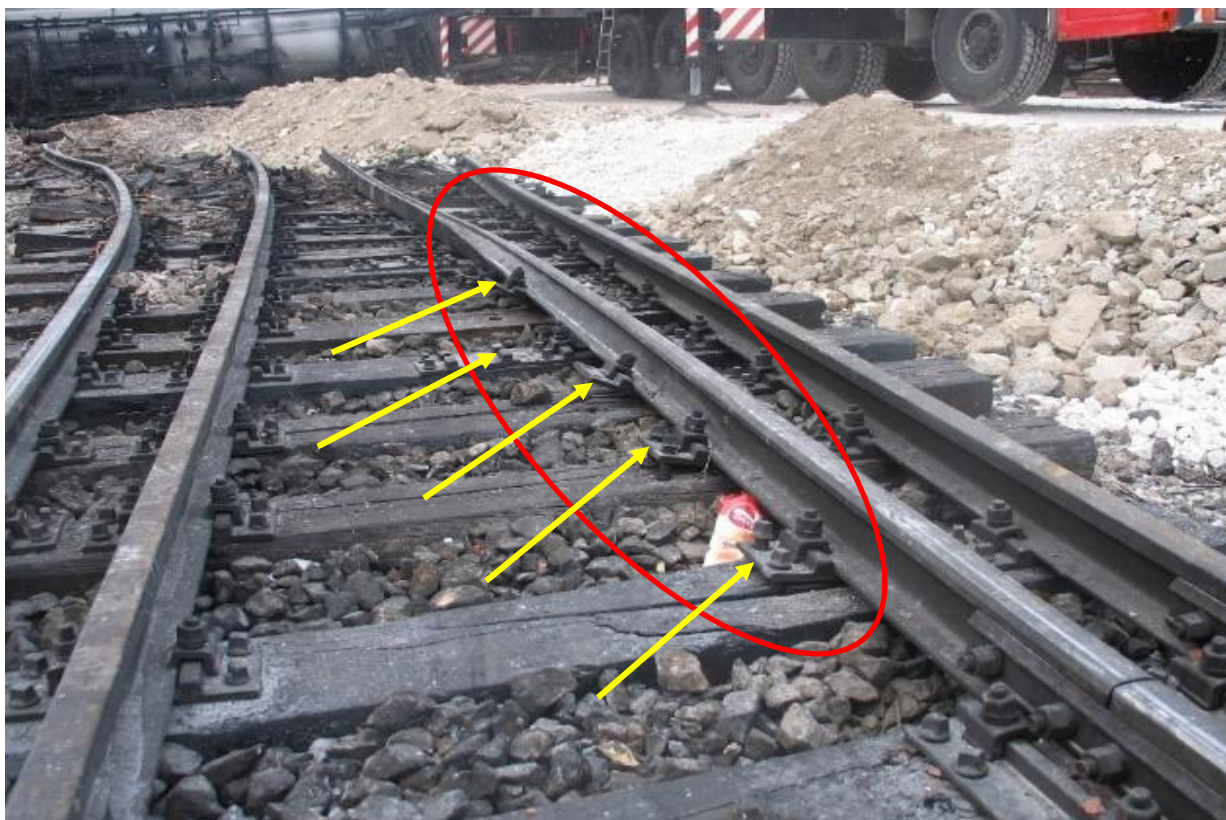
Figure 23

Because of the reliable locking of the right deviation switch rail to the rail shoulder and their joint counteraction against the big dynamic, vertical and horizontal forces, generated by the high speed, the two locomotives and the first five wagons were able to pass unobstructed through the point. This is not the situation with the intermediate right guide rail of point Nr. 5, there the largest shifting and changing of the design radius and the central line of the deviation platform occurred. On such causes, after the joint at the end of the switch rail there started pulling out of

the sleeper's screws, connecting the rib pads to the sleepers on the internal side of the rail. On the first sleeper after the double sleeper, the sleeper screws are pulled out with about 25 mm, and on the 2nd, 3rd and 5th sleepers (Figure 23) the sleeper screws are completely pulled out. On the 4th

sleeper, where there is a strengthened rib pad, the sleeper screws are not pulled out but the heel of the rail is pushed aside from the internal and external fastening sets. All this has contributed for twisting of the intermediate rail of point Nr. 5 along its longitudinal axis on the right. The crosshead of point Nr. 5 is totally destroyed. This occurred after passing of the two locomotives with the first five wagons and after the derailing of the second cart of the 6th wagon. Driven by the centrifugal force, the following eleven wagons jumped over the twisted intermediate rail on the right in the direction of trafficking and started derailing. Consequentially from the inert pressure generated from the remaining non-derailed part of the train, the 6th wagon was lifted and its buffers caught the buffers of the 6th wagon, in this moment the train got torn apart between the 6th and the 7th wagon. The 6th wagon, affixed to the 5th wagon, continued together with the first part of the train to move on the Third platform. The second derailed cart of the 6th wagon managed in the area of the right counter rail and the core of point Nr. 5 to climb on the railway line and continued its movement on the Fourth platform. With the train's first part moving on the Third platform, after 150 m the back side of the 6th wagon hit a pole of the catenary and pushed it down, the pole being located on the right on the Fourth platform. Upon meeting the resistance from the hit, the wagon disconnected its catch to the 5th wagon and after tearing apart the traction device, flew on the right over the Fourth platform and laid aside on the balloon (cylindrical part) of its reservoir. The two locomotives, together with the five wagons, continued to move and stopped a little after the reception building of the station. After the derailing of the 6th wagon and upon an already interrupted railway line, there followed the derailing of other eleven full wagon-cisterns, as the 17th wagon-cistern derailed only with its first cart at point Nr. 5. The second non-derailed cart of the wagon-cistern stopped in the switch rail part of the point. After the 17th wagon, there stopped the remaining non-derailed nine wagon-cisterns from the train's composition.

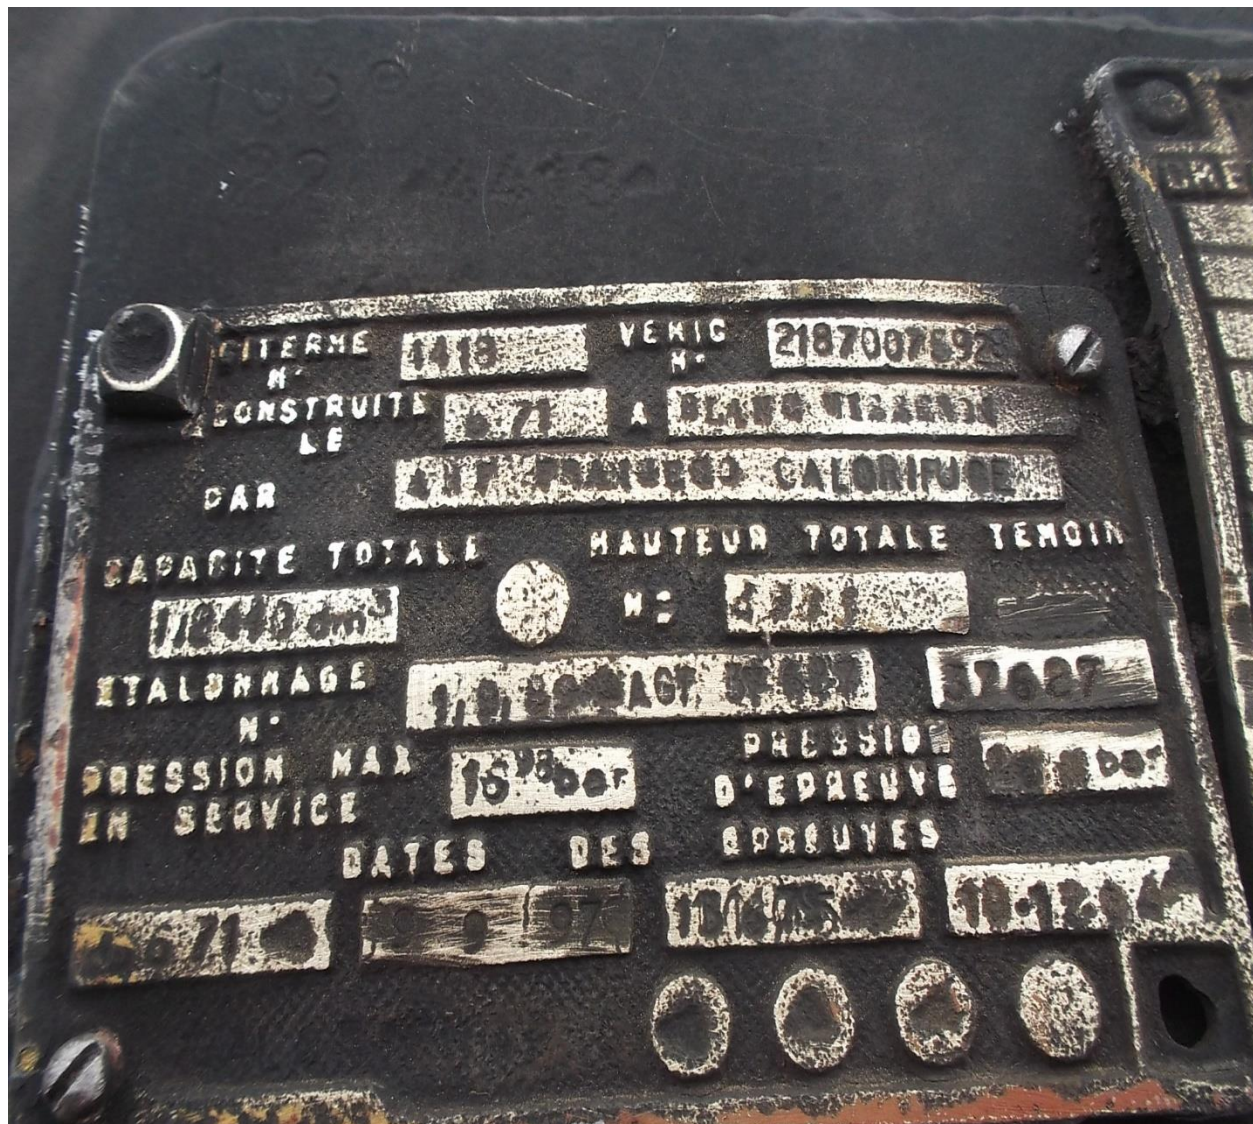
Figure 25

The performance of this test must be reflected not only in the certificate, but on the information plate at the bottom of the reservoir, which anyway was not done (Figure 25).

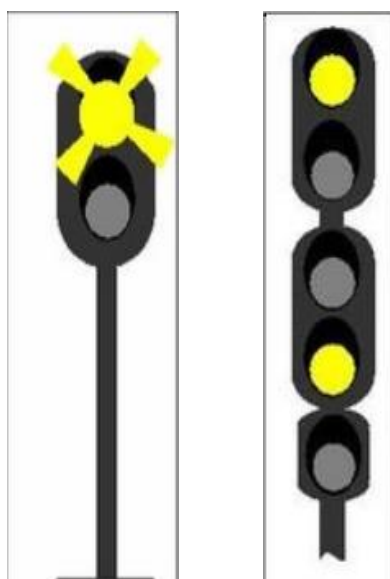
Figure 26

Upon the entrance of the train at Hitrino station, not fulfilled are the permission indications of the warning and the entrance traffic lights, limiting the speed of trafficking up to 40 km/h in accordance with Art. 317, item 3 and Art. 324, par. 2 and par. 3, item 5 of Ordinance Nr. 58 (Figure 26).

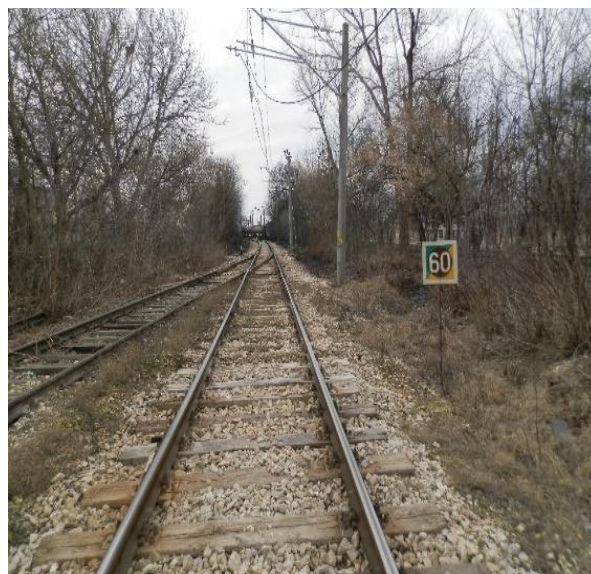
Figure 27

Not fulfilled is also the signal for limiting of the speed up to 60 km/h through the entrance points for entering on the Main platform, necessitated by the type of locking of the points at Hitrino station in accordance with Art. 384, par. 1 and par. 2 of Ordinance Nr. 58
