FINAL REPORT

**investigation of railway accident – fire outburst in electric locomotive Nr. 44134.2, having
serviced fast train Nr. 8693 at Dimitrovgrad station on 12.10.2017**

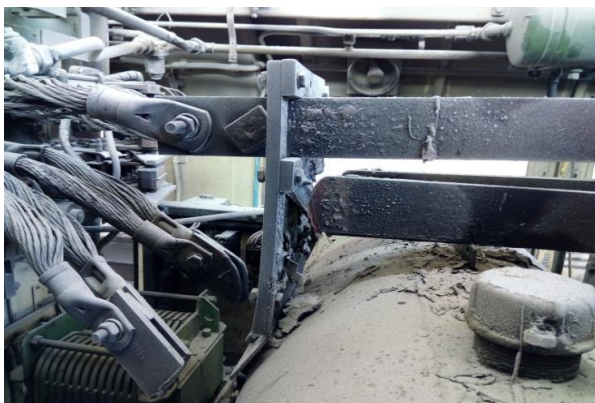
Figure 5

The cause for bursting of fire in locomotive Nr. 44134.2 is a short circuit in the el. conductor buses of the second traction group (Figure 5). The short circuit itself has occurred consequentially from the reduced dielectric strength of the supporting textolite plate, caused by the long-lasting operation under heavy conditions, as well as by the additional burdening factors such as moisture, dust, etc.

4. Elimination of the causes for the occurrence of discharge processes in the textolite insulation plates in view of their ageing, supporting the low voltage bus system of the power transformer - requested is appropriate insulation of the buses in the area of transition through the supporting textolite plates.

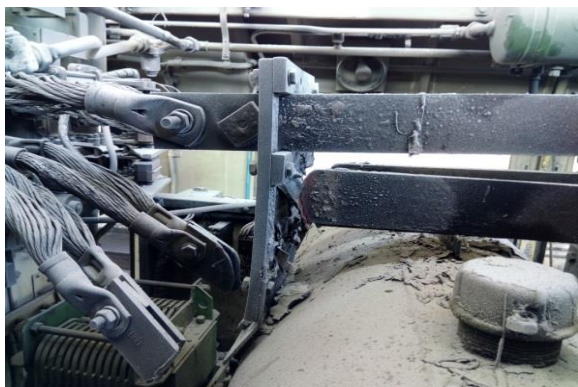
Фиг. 7

After isolating of one traction engine (before departure from Plovdiv station), and later of a second traction engine (before departure from Parvomai station), as a result from the increased resistance force upon train's movement due to the isolation of the traction engines, the el. current in the el. power chain (upon the same voltages) got increased, which also lead to increasing the load of the insulation textolite plate. Because of its reduced dielectric strength, its material was not able to resist and an outbreak between the two el. conductor buses

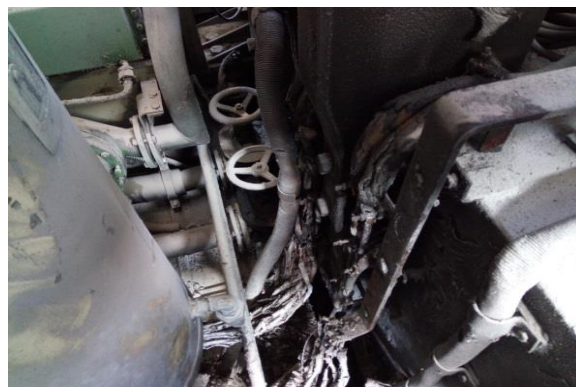
Фиг. 8

occurred, finally leading to the occurrence of a short circuit. Because of the short circuit occurrence, short circuit el. current passed through the buses, which was of very high values, initially causing very strong heating of the buses and activating of the overvoltage protection system of the locomotive. Because of the high temperature the material of the buses (copper) melted (Figure 7) and formed drops over the cables clad underneath, melted and fired their insulation, which lead to their ignition and bursting of fire in the machine room of the locomotive (Figure 8).

The raised temperature from the generated arch during the short circuits and the formed copper melt from the buses facilitated and created conditions for ignition of cabling insulation and bursting of the fire in the locomotive.
