**FINAL REPORT**

from  
**Technical investigation of railway accident –  
fire occurrence during movement in electrical locomotive No 44096.6, which serviced  
fast train No 80290 in Chernograd - Karnobat interstation on 14.09.2016**

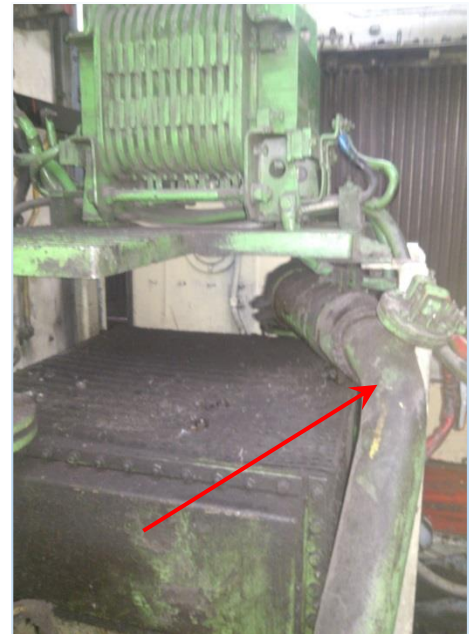
**Fig. 1**

After the performed number of detailed inspections and indepth analysis of the facts and taken to an account the written explanations and statements of the locomotive crew as well as the fast development of the events, the Investigation Commission came to the conclusion that the original cause for the lighting of a fire in locomotive No 44096.6 was a rupture of the rubber joint, which served the oil circulation from the ATP to the transformer located over the radiator for cooling the oil in the transformer (fig. 1).

2. During each small periodical repair (SPR), it shall be performed inspection to the condition and density of the oil cooling contour of the locomotive transformer with focus on the connecting rubber compounds.

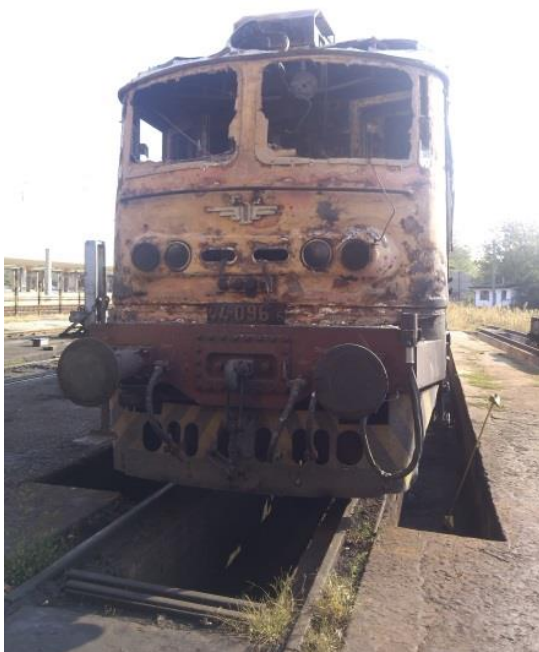
**Fig. 2**

In the course of the investigation, the Commission performed several detailed inspections to the burned locomotive in Plovdiv locomotive depot, it got acquainted in details with the documentation referring the ignition and conducted detailed interrogations to the operational staff involved in the specific case on all the actions undertaken by the locomotive and traffic crews before and during the fire (fig. 2).

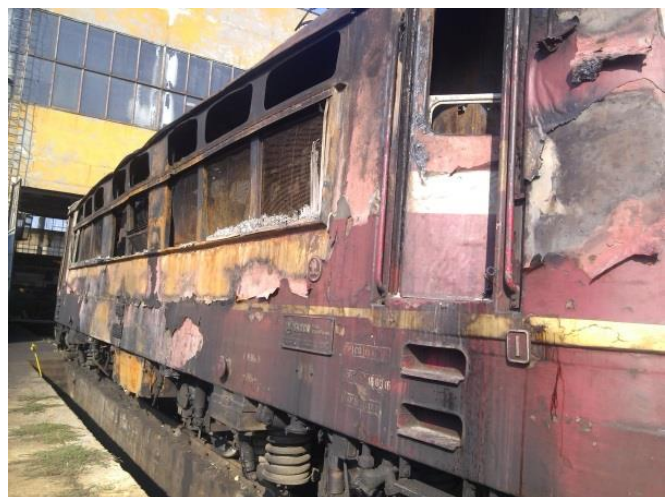
**Fig. 3**

During the inspections was found that the fire destroyed almost all the aggregates and nodes of the locomotive to an extent, from which their recovery was impossible (fig. 3 and 4). The first signs for ignition were the presence of smoke smell from the engine compartment of the locomotive (evident from the explanations of the locomotive crew).

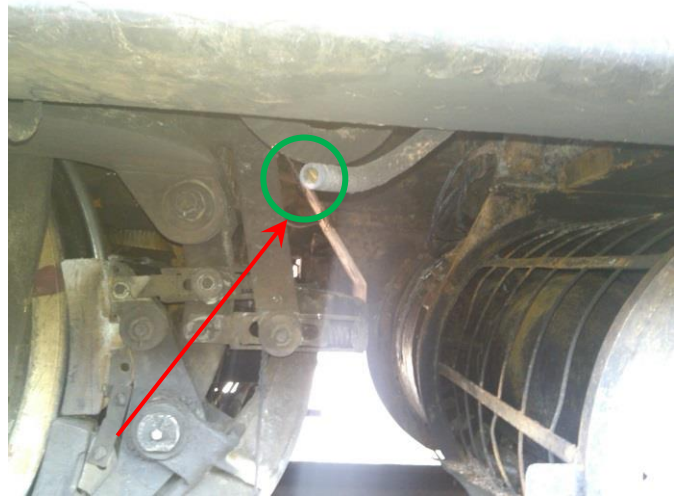
**Fig. 5**

Important moment from the explanations of the locomotive driver was the part in which he explained that during the extinguishing of the locomotive in the area of the fans under the body shell he noticed oil leakage from the drainage pipe on (fig. 5).

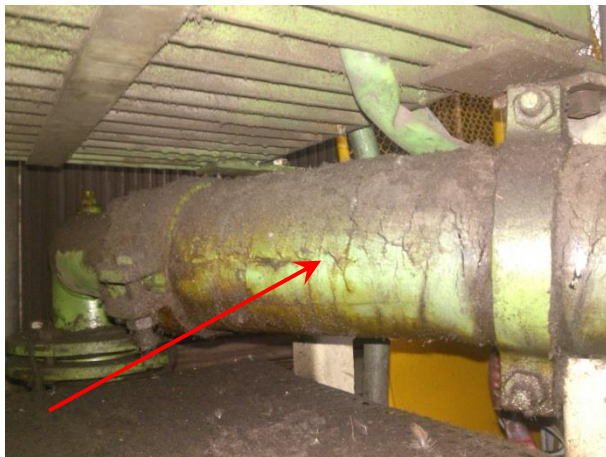
**Fig. 6**

The cracking of the rubber compound is an event with rather insignificant probability and should not happen during the locomotive operation. The Commission, however performed an inspection to some locomotives of the same series and found that there exist also other locomotives on (fig. 6), within which is clearly seen that these rubber compounds are not in good

condition, they are old, cracked and rheumy, which confirms the reviewed version as the most probable for the locomotive ignition.

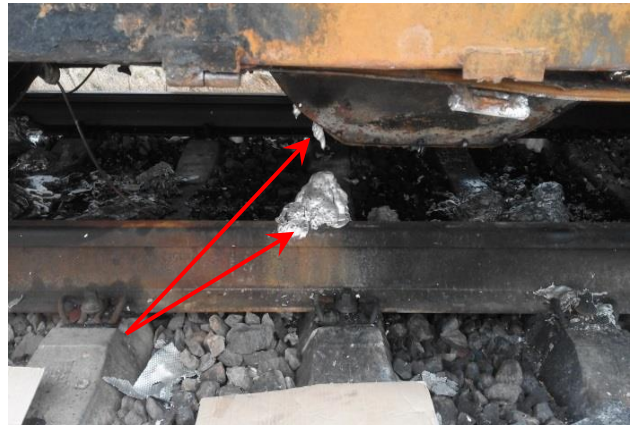
**Fig. 7**

As a result from the oil ignition, the temperature in the engine compartment increased to values (minimum 800°C), which led to melting of the ATP body shell, aggregate located next to the fire ignition – the cooling radiator of first traction group, which body shell was manufactured in allumina. Because the ATP is full with oil, approximately 200 liters during the melting of the bodyshell the oil from it ignited from the high temperature and increased additionally the force of the fire. This hypothesis is confirmed from the allumina melt, found under the locomotive on the two rails on (fig. 7).

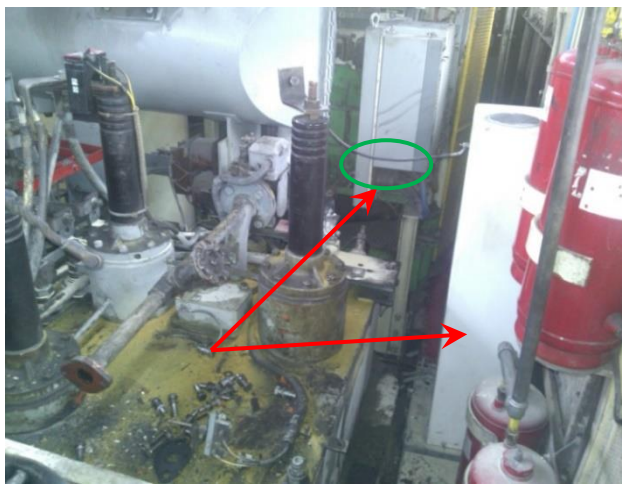
**Fig.8**

The frequent cases of locomotive ignition impose also an analysis of the probability a source of ignition spark to be different node or aggregate, located in the high-voltage camera. In

this line on fig.8 are shown the voltage measuring transformer of the new electronic electrical meters installed within the period 2014 - 2015 (the vertically located on the floor white parallelepiped), the insulator at the entrance of the ATP and the cable connection in-between. It is possible due to strong vibrations occurring during the movement of the locomotive and insufficient length of the cable connections, which connects them, it is possible the cable to be taken out from the cable nozzle. In that case during the movement of the locomotive, the free edge of the cable within touch with metal parts cause voltaic arc, (having in mind the high voltage – 25 kV and earthed body shell parts on the

nearly located aggregates of the locomotive).

1. To be examined the behavior of the voltage transformer of the installed in the electrical locomotives of 44 and 45 series electronic electrometers during movement. To be assessed the risk from occurrence of hazards as a result from irregularities and the connection of the electrometers.
