FINAL REPORT

**Technical investigation of railway accident –
fire occurred during movement of electrical locomotive No 44085.9, which
serviced fast train No 3622 in Sahrane railway station on 16.06.2016**

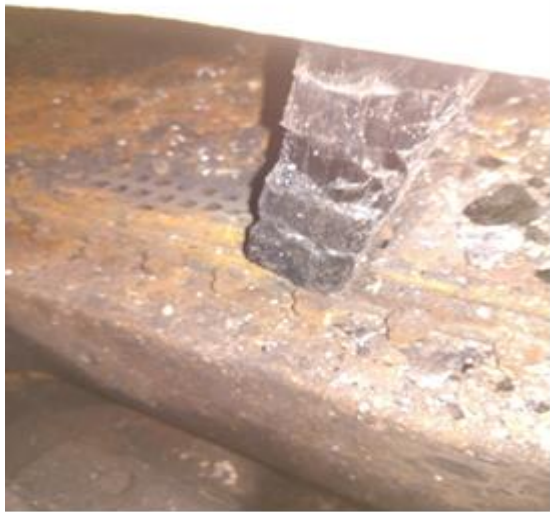
Фиг. 1

The Investigation Commission considers that the cause for the fire of locomotive No 44-085.9 is the presence of a wooden piece under the bearing grid of the smoothing reactor of the auxiliary machines, which is located on the oil cooling radiator of the traction transformer (Fig. 1 and 2). The grid itself was repeatedly welded on the same place due to a fatigue of the material as a result from the presence of vibrations in the grid during operation. **After the consecutive tear of the welding the same was not restored, and instead of that in the repair point was placed a wooden piece from pine, which served as a support of the grid during operation (Fig. 5).**

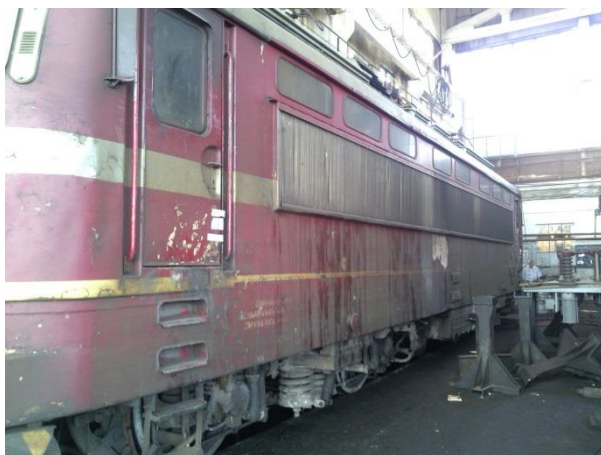
Fig. 3

The accident investigation Commission got acquainted in details with the condition of the locomotive set on fire, with the circumstances preceding the fire as well as with the actions of the train and traffic crew. During the inspection was found that at the beginning the fire occurred in the middle of the engine compartment, and more precisely in the high-voltage chamber (HVC),

then it spread to the roof of the locomotive and burned almost all the equipment mounted on the inner side of the roof, such as cables, insulators, etc., and part of the equipment mounted on the upper side of the roof. The flames affected the underroof equipment, then advanced downwards led by the air-blast caused by the cooling fans and fired a part of the flooring and for this reason occurred a burned spot from the right side of the locomotive body shell in movement direction (Fig. 3 and 4).

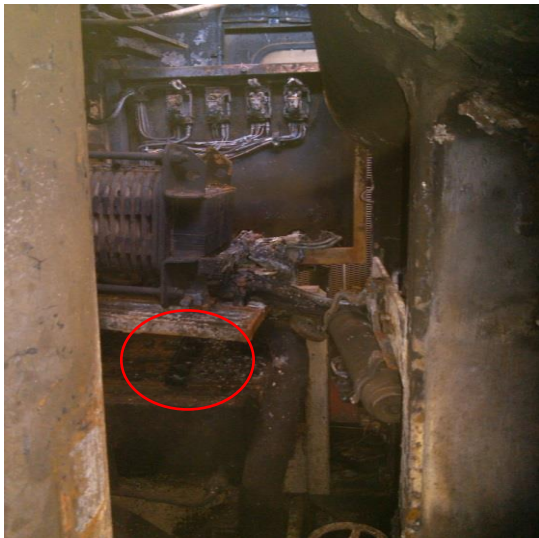
Fig. 5

That initially directed the Commission to search for the cause either in the locomotive power supply from the main air switch (MAS), or in the components for powering the electrical dynamic brake, which are located next to the smoothing reactor of the auxiliary machines (engines) of first group. However, based on the circumstances, that the locomotive run in traction regime, and did not use the mentioned electrical stop, that version was declined. Searching for the fire outbreak, the Commission directed to the group of oil cooling of the traction transformer, because of the trails left by a high temperature fire. Above that group is located the smoothing reactor for auxiliary machines of the locomotive first traction group. **Namely under the grid of that smoothing reactor was found a completely charred wooden piece, but with its form and dimensions kept, placed as a jamb to support the grid in question (fig. 5).**

That circumstance, together with the explanations of the locomotive crew, that during the firing sensed a smell of burning wood, unambiguously confirmed that the primary source of the firing was namely that found wooden piece. The work of the smoothing reactors is accompanied with the emission of significant amount of heat, and their working temperature reaches up to 170°C. For that reason the smoothing reactor of the auxiliary machines is installed on the radiator of the oil cooling heater of the traction transformer, and together with it is cooled by the mounted under the body shell horizontal engine-fan. Over time, the heat was accumulated in the wooden piece (Fig. 2), which led to the specific for the wooden material condition of combustion—*smoulder*, which from its side caused ignition of the wooden piece itself. The emergence of an open fire in the area of the oil radiator to cool the oil in the traction transformer caused the ignition of the oil residues on the radiator itself, the dirt and dust located in the engine compartment, as well as on a later stage, of the insulation of the cables and the rest of the electrical equipment components. Particularly disturbing is the fact, that the fire protection installation of the locomotive did not

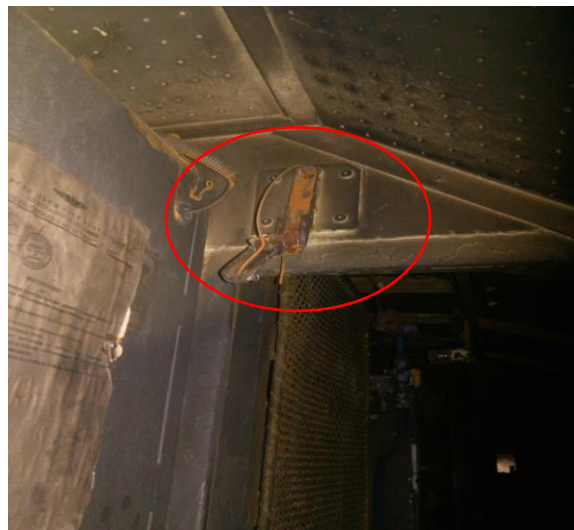
Fig. 6

operate, nevertheless it was activated by the locomotive crew (Fig. 6 and 7), and that caused further expansion of the fire.

1. Immediate check of the fire-extinguishing and fire-alarming installations for their current working order, as well as of the main protections of all the operative locomotives.
2. Strengthening the control over the operating inspections of the locomotives in the main and turnover depots, as well as in the operational service points.
3. Conducting periodic training sessions of locomotive personnel regarding the structure and operation of the fire-fighting installation of locomotives and actions to be undertaken in case of fire.
4. Accomplish modernization of locomotives of 44 and 45 series by means of introducing new fire alarm and fire-extinguishing installations with automatic action and more effective firefighting agent.
5. Remake of the existing fire-fighting installation of the locomotives and adding of extra smoke and flame sensors in danger zones.
