**SPECIALIZED UNIT FOR INVESTIGATIONS OF ACCIDENTS AND INCIDENTS IN
RAILWAY TRANSPORT AT MTITC**

FINAL REPORT

**investigation of a railway accident – derailment of a freight train № 30560 between
stations Gavrailovo - Shivachevo on January 26, 2019**

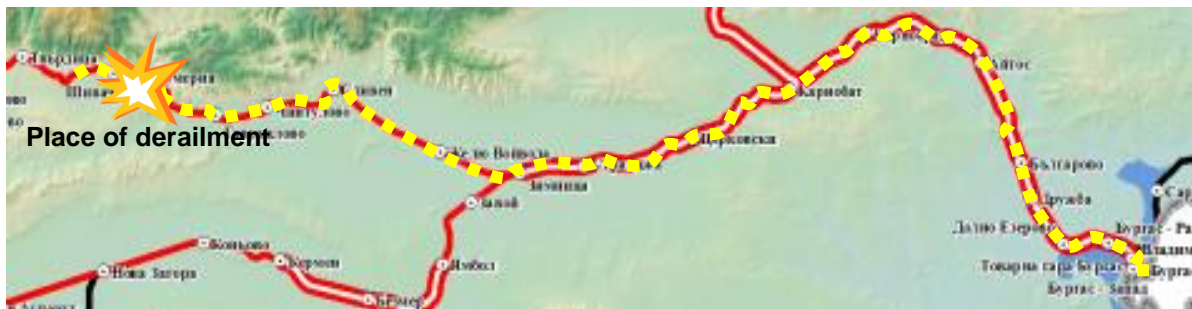
Fig. 2

From Burgas station on January 26, 2019, freight train (FT) № 30560 departs at 14:55 hours along Burgas - Karnobat - Zimnitsa - Tulovo - Pirdop route (Fig.1). The composition of the train is 31 wagons, 124 axles, 841 tons, including the № 86019 non-operating locomotive, serviced by electric locomotive № 86018 and a locomotive brigade of two motormen. The train departs from Burgas station at 14:55 hours along Burgas - Karnobat - Zimnitsa - Tulovo - Pirdop route. During the journey, the train undergoes two changes of the composition: at Karnobat station, an electric out of operation locomotive № 86012 is attached and a diesel in operation locomotive № 56399 is attached at Zimnitsa station together with three empty wagons. The train departs from Zimnitsa station at 16:51 hours and arrives at Gavrailovo station at 17:38 hours. During the movement from Zimnitsa Station to Gavrailovo station, it moves without stopping and the station staff along the route notices nothing unusual. The train has been complied scheduled speed and limitations. The train leaves Gavrail at 18:17 hours for Shivachevo station. After passing the warning signal at Shivachevo station at 18:35 hours, twenty-third wagon № 33 52 080 6 189-5, derails with the first axle of the first bogie at km 268 + 950, to the right in the direction of the movement, at a speed of 75 km / h and at arrow № 1 of

Shivachevo station, derails the second axle. Implementing a non-stop route on the third main track at Shivachevo station, the train passes with the derailed wagon at a speed of 55 km / h and on arrow № 2 derails the next twenty-fourth wagon with the first bogie. After the derailment, the train continues the movement and at 18:40 hours is stopped at km 262 + 720 on the Shivachevo - Tvarditsa railway section from a subsequent disconnection of the voltage in the contact network (fig. 2).

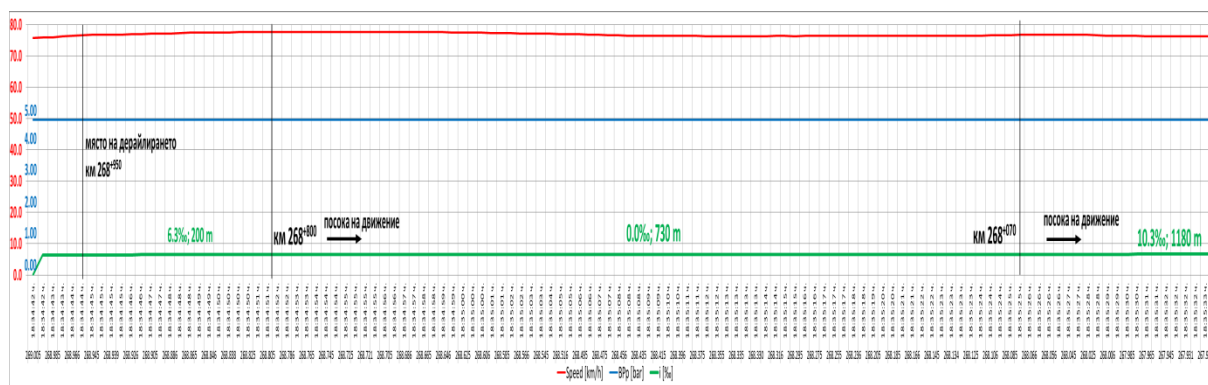
Fig. 2

Train movement analysis starts at km 269 + 005 in the section Gavrailovo - Shivachevo. The train travels at a speed of 75.7 km / h with a slight upward trend, and given the positive slope of the road (6,3 %) it can be concluded that the locomotive is in the pull mode. Although at km 268 + 805 the road is at a level (0 %) the speed continues to fluctuate in a narrow range between 77.7 and 76.7 km / h. In the next interval of km 268 + 070, the slope changes and the road passes into climbing (10,3 %) for 1180 m (Fig. 2).

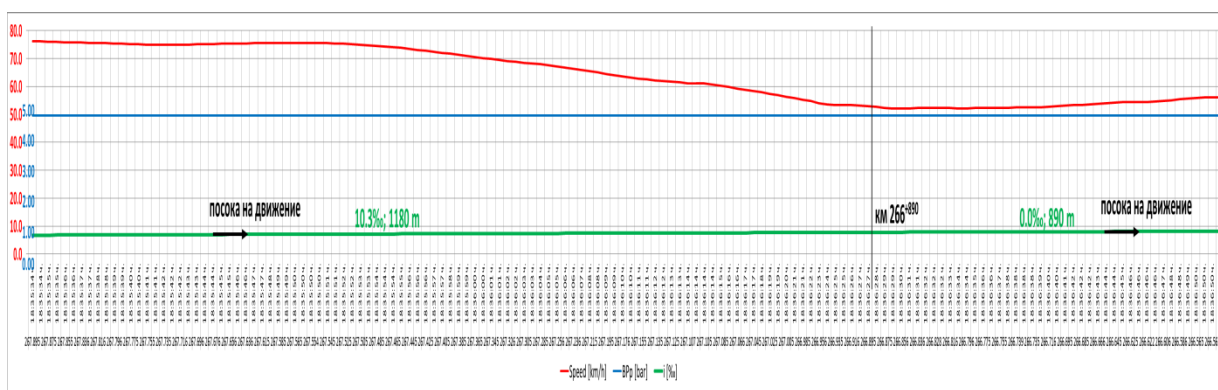
Fig. 3

Initially, the speed continues to maintain values between 77 and 75 km / h till km 267 + 565 at 18:35:50 hours. From that moment on, the speed begins to gradually decrease and at the end of the range of km 266 + 890 at 18:36:28 hours, is 52.7 km / h without the train brake being used; the speed decreases from the natural resistance of the train movement, i.e., the locomotive moves in inertia (fig. 3).

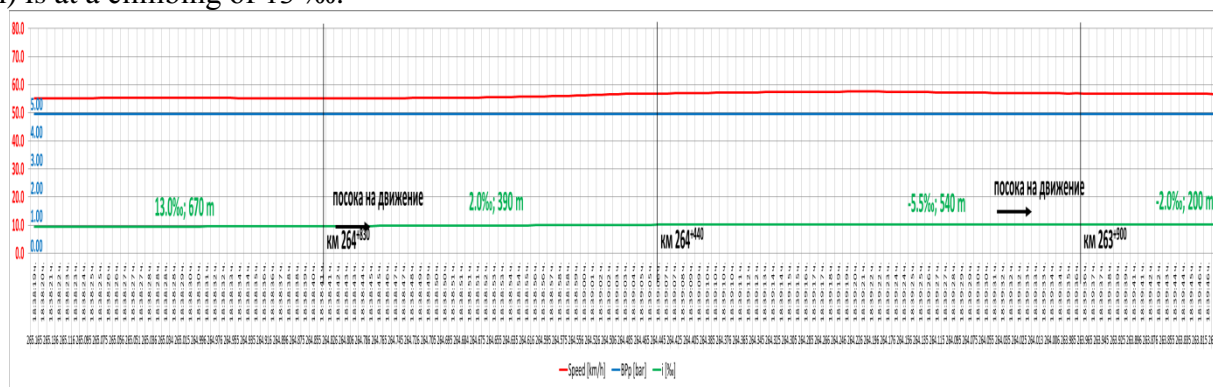
Fig. 5

The next interval is at a level and is 890 m in length from km 266 + 890 to km 266⁺⁰⁰⁰, which includes the passage through Shivachevo Station (km 266 + 545) with useful length of the longest PAK 648 m. The train passes through it, maintaining a speed of between 52.1 and 56.6 km / h. No deceleration of the train speed and activation of the ABC of the train (Fig. 4). In the range of km 266 + 000 to km 265 + 500, which is inclined at an elevation of 8,2 ‰ for 500 m, the train passes along the entrance signaling at Shivachevo station at Tvarditsa side without reaction from the motorman and therefore does not observe variations in the speed between 56.8 and 56.0 km / h and, given the slope, the locomotive is again in the pull mode. This behavior of the train does not change even at the next intervals, the first (from km 265 + 500 to 264 + 830 with a length of 670 m) is at a climbing of 13 ‰.

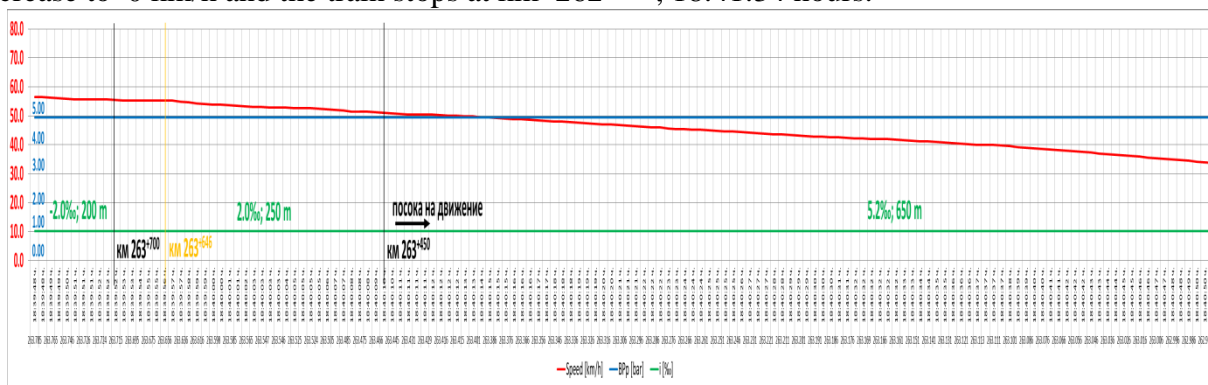
Fig. 6

In the next interval (from km 264 + 830 to km 264 + 440 with a length of 390 m and a slope of 2 ‰) the speed again retains its values between 55.1 and 56.8 km / h, with a slight trend

of increasing. In the range from km 264 + 440 to km 263 + 900 (540 m) the slope is -5.5 %, i.e. in a slight downhill, which again does not affect the change of speed (Fig. 5). In the range from 263 + 900 to km 263 + 700 the speed is decreasing - a trend which is observed in the next interval - from km 263 + 700 to the final stop of the train at km 262 + 720 (Figures 6 and 7). It should be noted that despite the reduction, the curve of the speed is decreasing more slowly to km 263 + 646 at 18:39:57 hours, after which it becomes steeper and over 885 m to km 262 + 761 in 18:41:19 hours in 1 min 22 sec. decreases to 19.7 km / h without using the train brake, i.e. in this interval, the locomotive has turned off his thrust and moved in inertia. The motorman activates the train brake at 18:41:19 hours, when the train is at km 262 + 766, using official retention, dropping 0.957 bar, with the pressure in MACB from 4,943 hp reaches 3.986 bar. These actions lead to speed decrease to 0 km/h and the train stops at km 262⁺⁷²⁰, 18:41:34 hours.

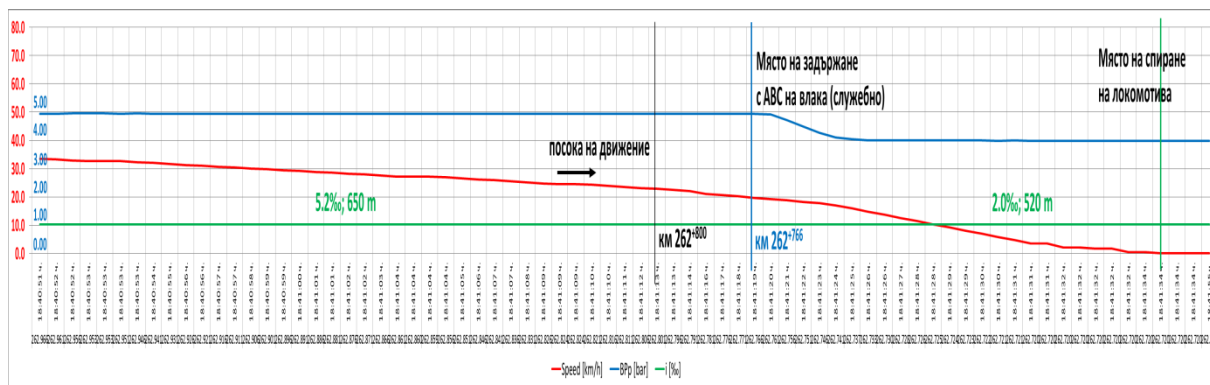
Fig. 7

From the above it follows that the motorman has not respond to the signal from the Shivachevo station (open inverse signal of the inverse entrance signal - Art. 354, para 3), and has reacted to the disconnection of the voltage in the contact network according to Art. 338, para. 1, which happens at 18:39:57 hours on km 263 + 646.

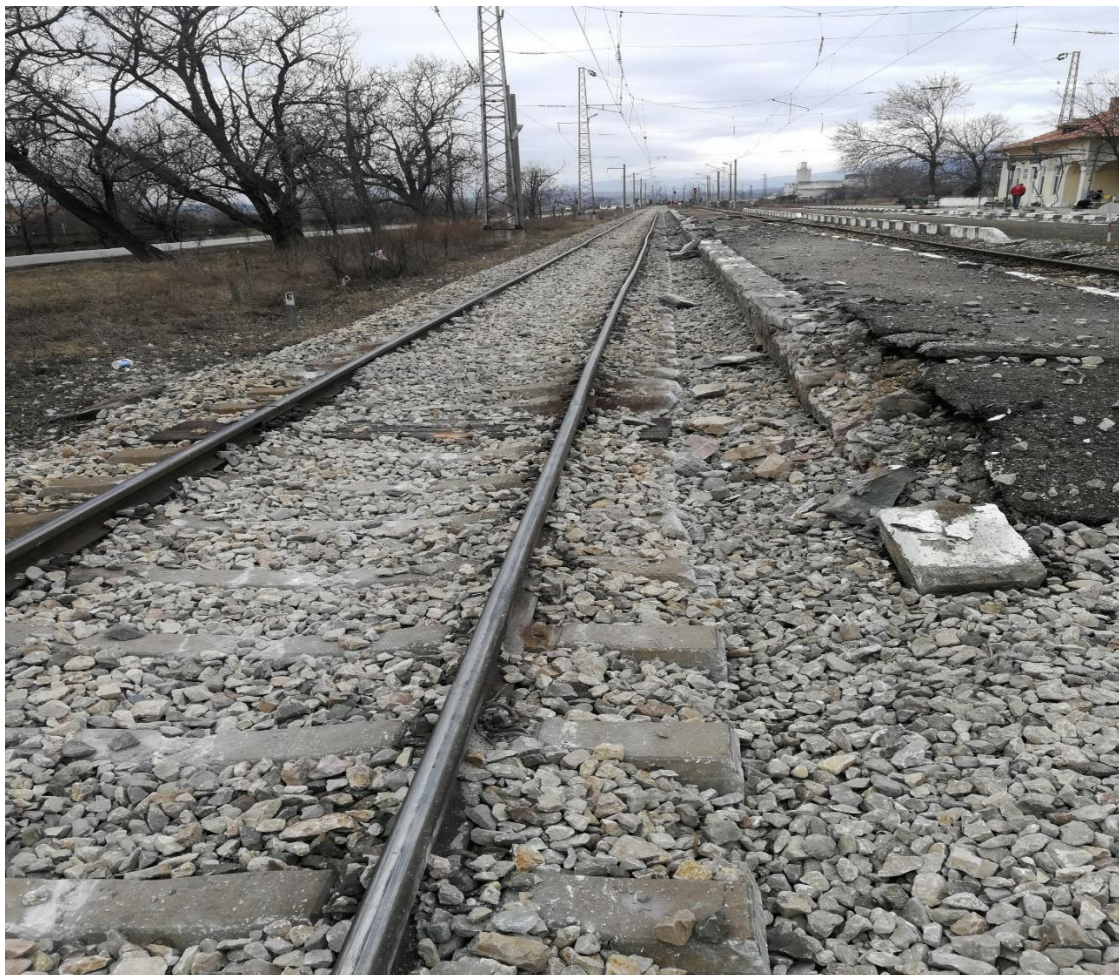
Fig. 8

To determine the causes of the derailment, a visual inspection has been carried out at and around the accident site on the technical condition of the track. The derailment position of the first leading left wheel of the first bogie of 23rd derailed wagon is at km 268 + 950, 8 meters from the beginning of the transverse, right curve, in the direction of the train movement, as slipping to the right of the left rail, there has remained a visible trace of the impact of the wheel on the railbolts of the elastic fastening on the inside of the rail and on the concrete sleepers. At 1.20 m in the direction of the train movement, the right wheel of the wheelaxis skips the head of the right track, leaving visible traces on the railbolts of the traverses on its outside.

The derailment site is in a transverse curve of 30 m length, which is a part of the curve with a radius $R = 2750$ m. The curve is a right one in the direction of the train movement in a slope of 6.3 ‰ downhill. By type, the construction of the railway is with rail joints. The rails are type S 49, reinforced concrete sleepers ST-6 and joints SKL-14. The rail way is well ballasted, with no visible tempered prism with a very good condition of the elastic joints and no absence of a missing one. To the main geometric features of the two rail threads are added the track gauge, longitudinal and transverse level, the position of the rails in plan, and their synchronization (laterally and vertically). It is evident in the minutes for the rail road condition presented by the operational group concerning the different parameters that the rail way around the derailment site complies with the requirements of the technical regulations for the construction and maintenance of the railway track as well as with the normative acts for the railway transport.

2. SE RINC to analyze the results of the measurements on the railway track, carried out by "TINSA" Ltd M-120 Laboratory in the Dubovo-Zimnitsa section, with a deteriorated state in particular sections.

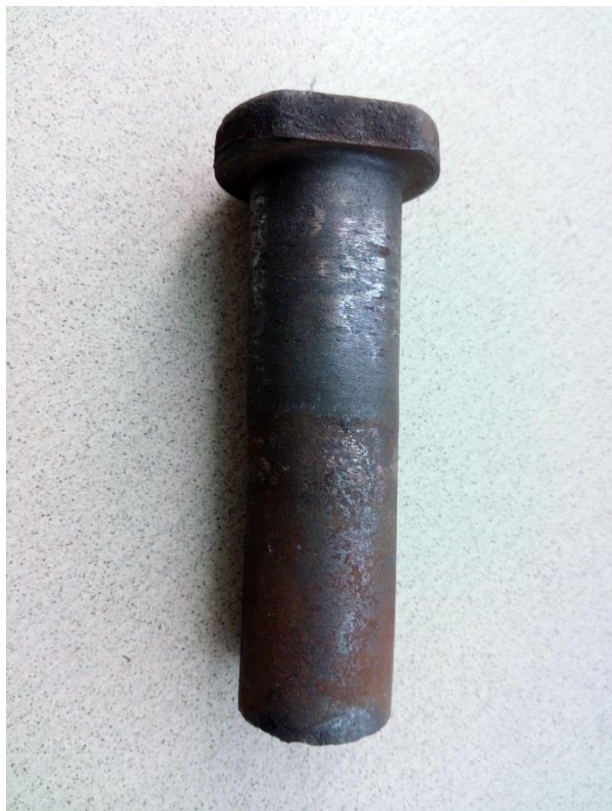
Fig. 10

The Accident Investigation Commission has conducted a thorough inspection of the derailed wagons and has taken note of the provided technical documentation. It is found that the derailed wagons have carried out a mid term repair in 2016 at "Trakcia" AD - Samuil. Damages to bogies, springs, wheel axles, draw gears on wagons №№ 33 52 080 6 189-5 and 33 52 592 8 528-6 are results of the derailment. The reason for the derailment itself can be found in the broken hinged bolt holding the leaf spring of the first wheel axle of wagon № 33 52 080 6 189-5 during movement (Fig. 10)..

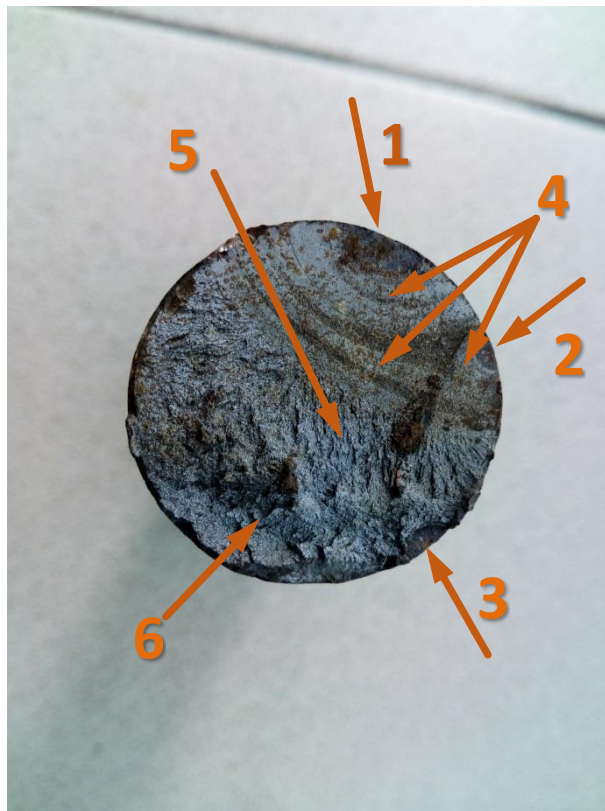
Fig. 11

The Commission has carried out a thorough and in-depth examination of the broken hinged bolt and has found out that the reason for the bolt tear-off was material fatigue due to continuous cyclic loading in the symmetrical operating mode of the element.

The break up obtained at the site of rupture shows several expressive focus points on the initial centers of destruction (pos. 1, 2, 3 in Fig. 11). They are located in one plane and initially have originated as separate sources, but subsequently two of them (pos. 1 and 2) merge and thus increase and accelerate the development of the crack. Pos. 4 shows the area of the crack and its own development with concentrically oriented to the focus lines. Here, the process of merging of both primary centers into one crack is evident too. The accelerated development of the crack with the characteristic lines focused on the center follows (pos. 5). This zone is obtained for several cycles before the final destruction. Finally, the final destruction zone (pos. 6) is observed, characterized by the break up of the material.

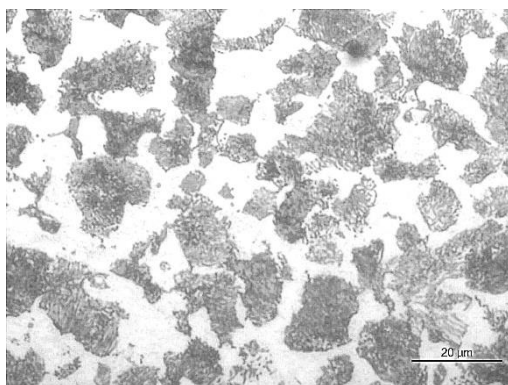
It has found out that the microstructure of the metal is a perlite-ferrite one (Fig. 1). Percent ratio of the amount of perlite to ferrite is% P /% F = 65/35. The morphology of the perlite is a mixture of lamellate (LP) and grainy (GP) perlite in percentage% LP /% GP = 5/95. The dispersity of the lamellate perlite corresponds to a ball of 6 (medium lamellate pearlite with a distance between the plates of 1 μm). The dispersion of the granular pearlite has a ball of 2 (medium-grained grain of 0.4 μm).

Fig. 1 Microstructure of the studied material.

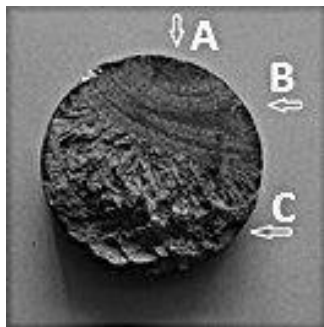
The destruction of the hinge in the accident has occurred perpendicular to its axis. For the purpose of the study, a sample containing the ruined surface is cut out from the object. It is well characterized by a large, bald area with relatively smooth relief and markedly tired furrows (Fig. 2).

Thebald (tough) rupture in this area has begun with two separate sources, indicated on Fig. 2 with A and B. The bald furrows from sources A and B are perpendicular to each other (Figures 3a, 3b). Outside of the large bald zone there is another source indicated in Fig. 2 as C. From this source, only one bald furrow (Fig. 3c) is observed. Between bald furrows the destruction is tough.

Fig. 2 General appearance of the broken surface of the hinge. The sources of bald destruction A, B and C.

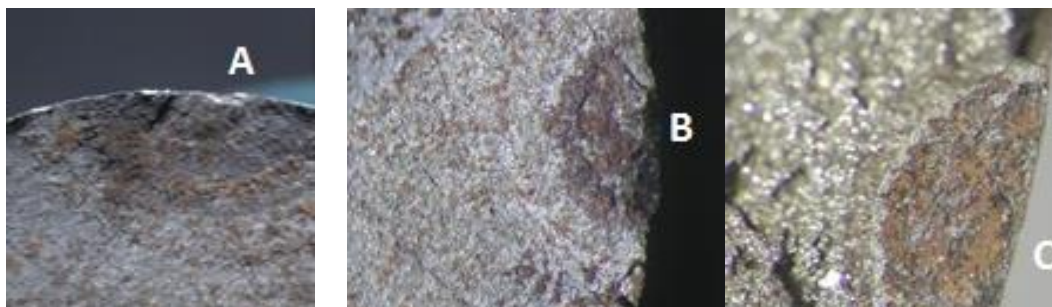
Fig. 3 Sources of bald destruction

As a result of the development of the bald destruction, the wear section decreases, respectively bearing capacity of the hinge too, after which an accelerated spread of the crack begins by a lean mechanism. This leads to a complete rupture of the hinge. Fig. 4 shows the transition between the bald destruction zone and the zone of

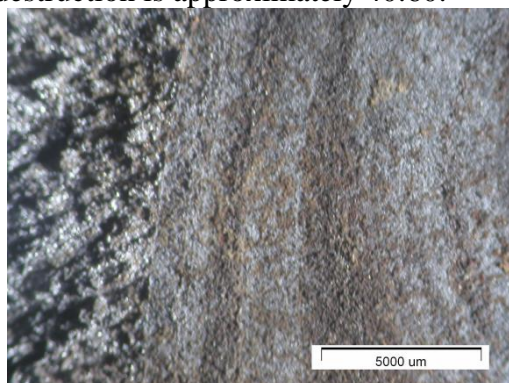
Fig. 4a Moving from a bald destruction zone to a fragile destruction zone in the area of source A

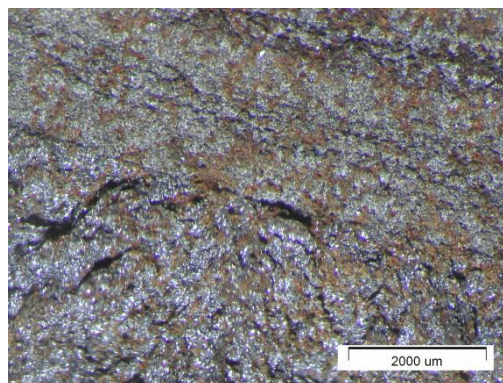
Fig. 4b Moving from a bald destruction zone to a fragile destruction zone in the area of source B

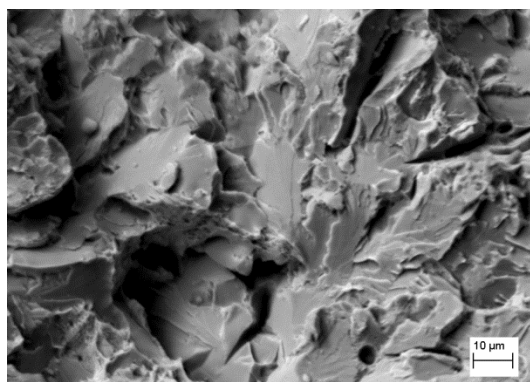
fragile destruction, and in Fig. 5 the area in which the break-up occurs in a fragile mechanism. In the area of the final break-up (the last stage of demolition) an area with elements of tough demolition (fig. 6) is observed. The percentage ratio between the surfaces with bald and accelerated destruction is approximately 40:60.

Fig. 5 Zone of fragile destruction (CEM)

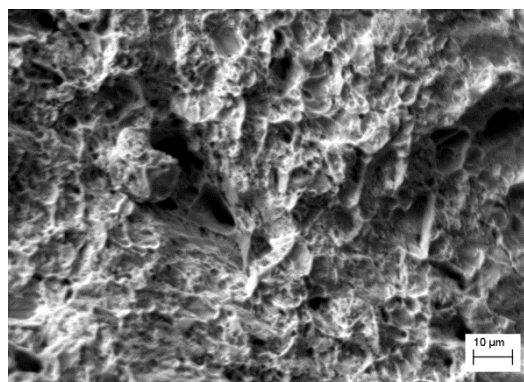
Fig. 6 Zone of final break up (CEM)

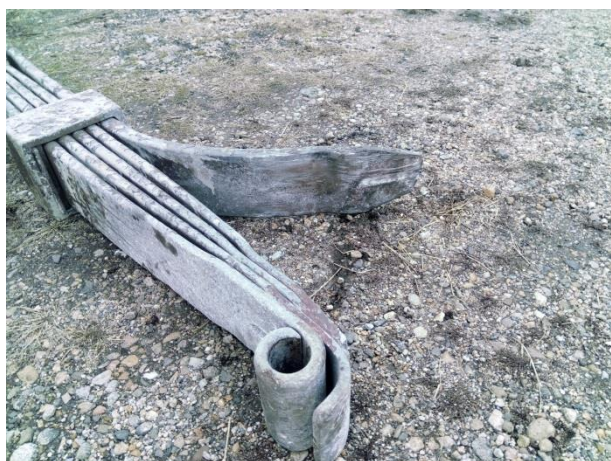
Fig. 8

Direct causes for the derailment of the wagon is the tearing of the front hinged bolt of wagon № 33 52 080 6 189-5 left spring leaf of the first bogie first wheel axis in the train movement direction . Upon this, the left-hand wheel of the first wheel axis in the train movement direction has been released, moves upwards, bounces off the head on the left-hand rail of the track, slides from the inside of the wheel and falls on the sleepers. The released front part of the spring leaf in turn bends into the ballast prism, as the lowermost spring leaf has bent on one side, and on the other side a piece of it has broken off.; (fig. 8 and 9).
