**REPUBLIC OF BULGARIA
MINISTRY OF TRANSPORT,
INFORMATION TECHNOLOGY AND COMMUNICATIONS**

FINAL REPORT

from
technical investigation of railway accident – derailment of freight train No 50505 during
transit passing through Petarch station on 28.08.2016

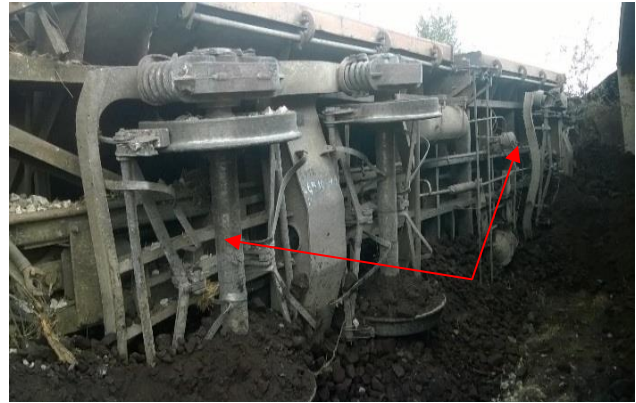
Fig. 1

During the transit passing of the train through the station after switch No 2 at 2 m before the level-crossing flooring (plank board flooring) at km 21⁺²⁵³, which is in the station region derailed the fourth in row wagon No 84 52 665 1054-2, as the two bogies remained to the wagon frame, and from the first bogie were dropped the two wheelsets. The second bogie was without evident failures and deformations (fig. 1).

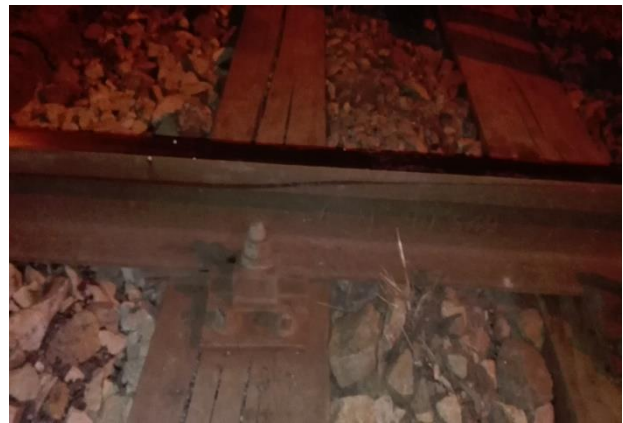
Fig. 2

During the derailment there were no evident traces from jumping of the flange of the left wheel on the rail head, but only trace from the outer non-working part of the rail head (fig. 2). Moving away the wheel to the left and at a distance 1,75 m. from the derailed left wheel slid also the right wheel of the first wheelset of the first bogie. With the movement away to the left, the first derailed wheelset, after 7,20 m followed also an uphill of the left wheel of the second wheelset on the left rail, moving on the rail head approximately 0,8 m fell from the outer/external part of the rail and at approximately 0,7 m slid also the right wheel of the same wheelset. The traces from the derailed wheelsets of the first bogie were clearly defined on the flooring of the

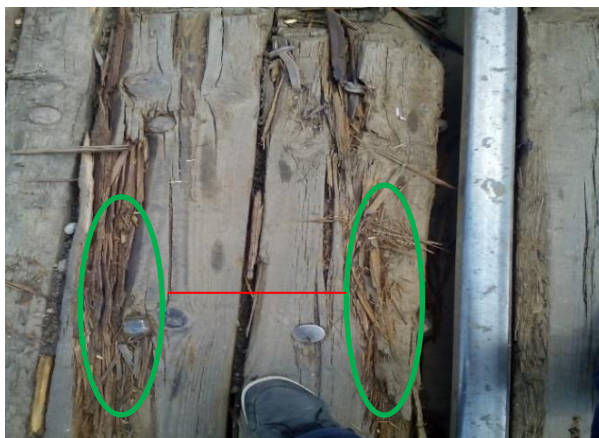
Fig. 3

level-crossing and subsequently slid after it the derailment of another six wagons of the train. As a result from the derailment the train detached between the third and fourth wagon of the composition. The detachment place was (the transition from square to round form) of the

level-crossing, (Fig.3), as two of them were in the gauge and two to the left of the left rail. The train continued its running with the derailed first bogie of the fourth wagon, which moving away out of the ballast prism caused the derailment also of the second bogie of the wagon, after the

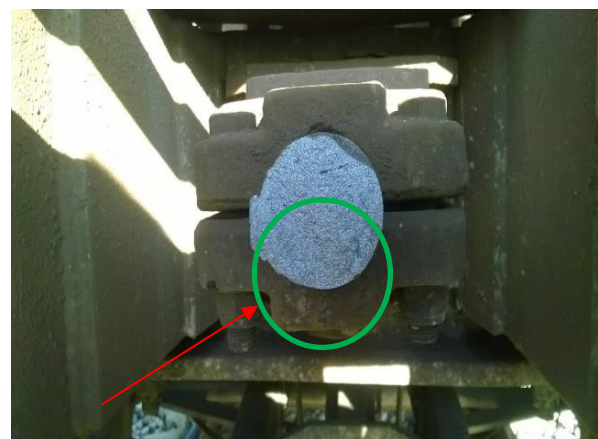
Fig. 4

traction rod of the third wagon to the fourth (Fig. 4). The morphology of the destructed surface was visually inspected by the means of a microscope. From the performed visual observation of the test samples from the traction rod there were not noticed pores or other visual defects with unaided eye. Due to a technological or material defect and as a result from overloading appeared a crack in the traction rod, which because of the atmospheric and working conditions was strongly corroded. The thick and dense layer of corrosion showed that the traction rod was in such a condition for a long time. During the moving away from the track the derailed fourth wagon caused additional external pressures on the traction rod, which overloaded it and the same torn in an avalanche way. During the inspection of the derailed fourth wagon was found that from the first bogie of the second wheelset was detached the clamp of the axle box spring, which held the internal and external springs for the wing of the left axle box (Fig. 5). During the inspection on site, the springs of the left axle box were not found (were missing).

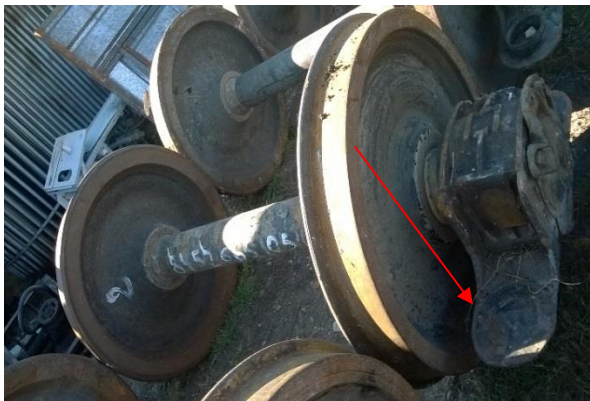
Fig. 5

- on the fourth wagon No 84 52 665 1054-2 was detached the clamp for the axle box spring, which held the outer and inner springs of the left axle box.

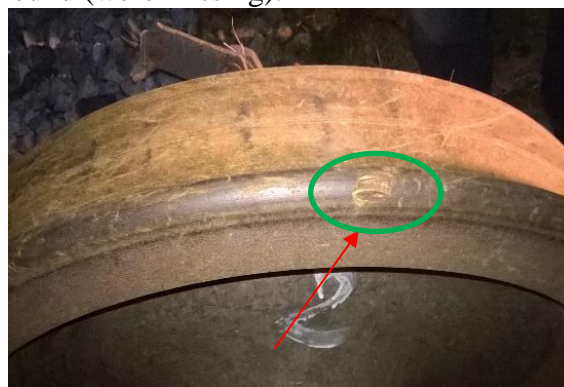
Fig. 6

There were caused serious damages and undercuts on the top/surface of the wheels flanges (Fig. 6) to both wheelsets of the first bogie. During the inspection of the track on the place of derailment was found that there were no missing or loosened fastenings as well as unfit/unusable sleepers. There were no found one-sided or twist subsidence. Based on the performed measurements of track were calculated the transitions before and after the place of derailment.
