AIR, MARITIME AND RAILWAY ACCIDENTS INVESTIGATION NATIONAL BOARD

FINAL REPORT

**Investigation of a serious railway accident - derailment of a freight train № 80561 in the
entrance switches of Nova Zagora station on 15.05.2020**

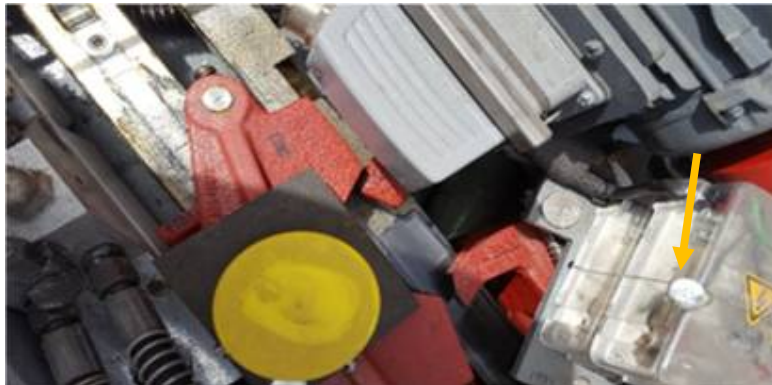
Fig. 41

After opening the EPM cover of switch № 20, it is found that there is no end position control due to a mismatch in the position of the actuator, which is in the extreme plus position, and the switch tongues are turned to the (minus) position. The electronic units are sealed with lead factory seals (Fig. 41).

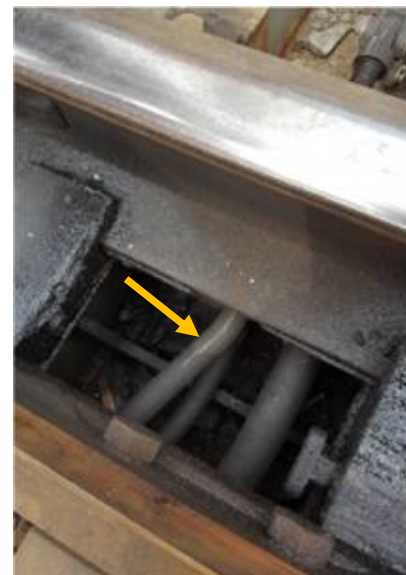
Fig. 43

It was found that there were fresh traces of mechanical friction on the upper side of the short control rod, on the washer, and the nut of the metal hollow sleeper. The length of the trace is approximately the same as is the stroke of the EPM (Fig. 43).

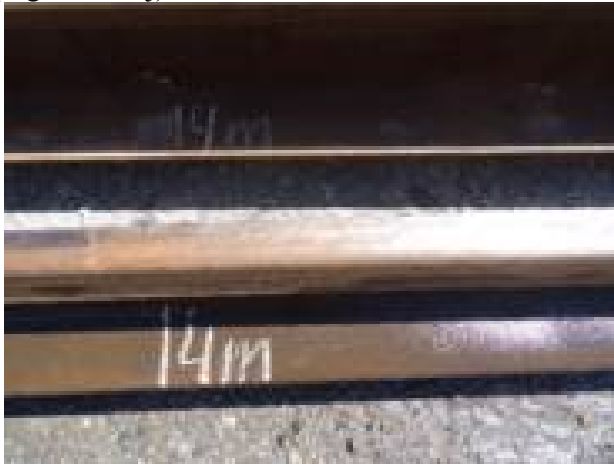
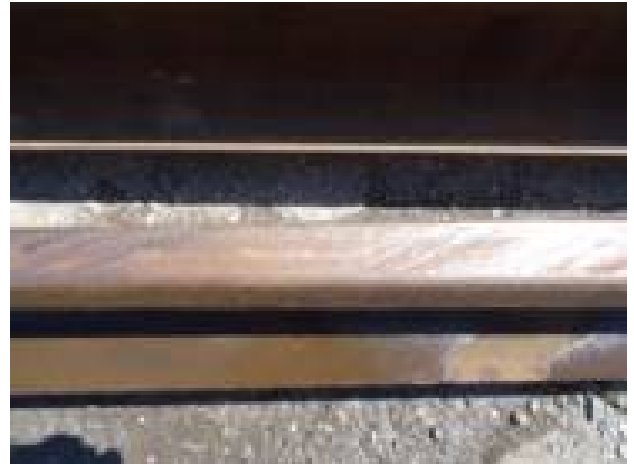
Fig. 50. Surface of the head of the left tongue of switch № 20 between the 4th and 6th meter

Most of the traces of incision were at an angle of 60° relating to the axis of the rail (Fig. 50 a-g), but there were also such that meandered along the studied section of the rail (Fig. 50 d-g). These traces had a metallic sheen (Fig. 50 h), no corrosion products were deposited on them, which shows that they are quite fresh - obtained by moving (dragging) the tongue the day before the examination (Fig. 50 h, i, j).

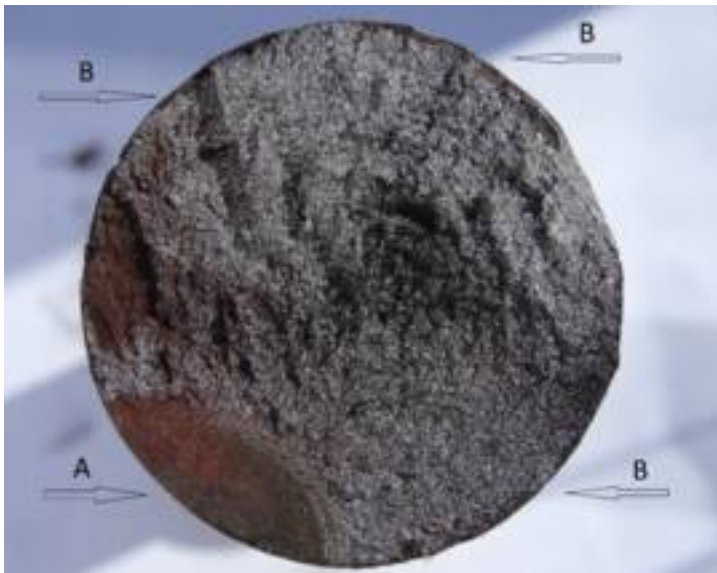
cut from the item. It is well distinguished by a large fatigue zone (A) with a relatively smooth relief (Figs. 54, 55, 56, 57) and with clearly defined fatigue grooves (Figs. 54, 55). Photos show that the spread of the fatigue grooves starts from the outer surface of the sample. Due to the development of fatigue fracture, the bearing section, resp. the bearing capacity of the hinge decreases, after which accelerated propagation of the crack under a fragile mechanism begins, zone B. In the disruption zone the relief becomes more pronounced and elongated hills are observed, oriented in the direction of crack propagation (Fig. 54). This leads to the complete destruction of the hinge. Figure 57 clearly shows the transition between the fatigue zone and the fragile fracture zone. Figure 58 illustrates the morphology of zone B, in which destruction occurs under a fragile mechanism. The percentage ratio between the fatigue fracture surface and the accelerated fracture surface is approximately 15:85. Evidence that the destruction of the hinge has begun gradually under a fatigue mechanism is the relatively smooth surface of the fracture around the initial disruption center, the presence of fatigue grooves and corrosion products on them. The most probable reason for the beginning of the destruction are defects on the surface of the hinge, which play the role of stress concentrators.

Fig. 54 General look of the disrupted hinge's surface

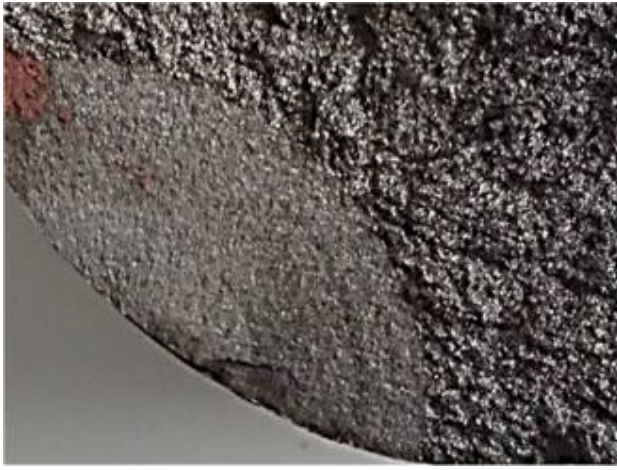
Fig.55. Fatigue grooves in zone A (OM)

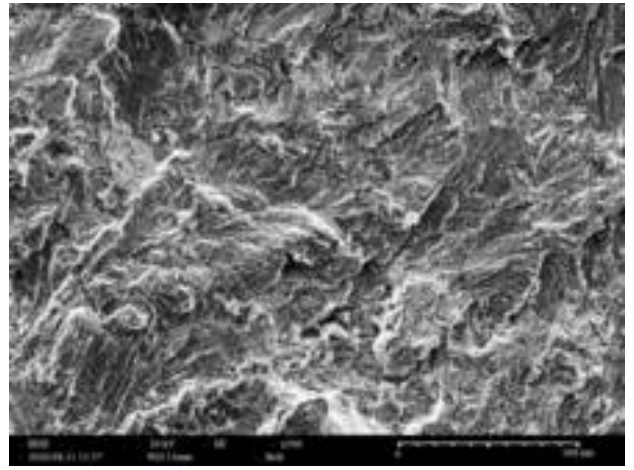
Fig. 56. Fatigue disruption zone A (CEM)

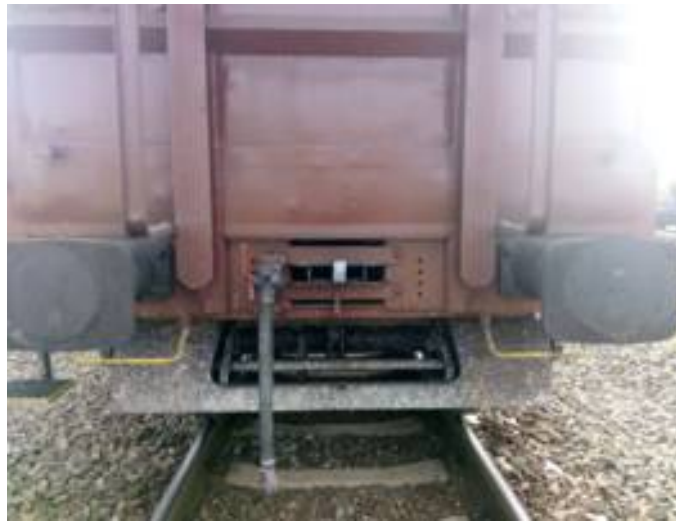
Fig. 59

The locomotive and the first five wagons of the train has passed unobstructed through switch № 20. The Investigation Commission has inspected the first five wagons and found faults only in fourth wagon of the train, № 31520806485-9 - broken traction hook (Fig. 59).

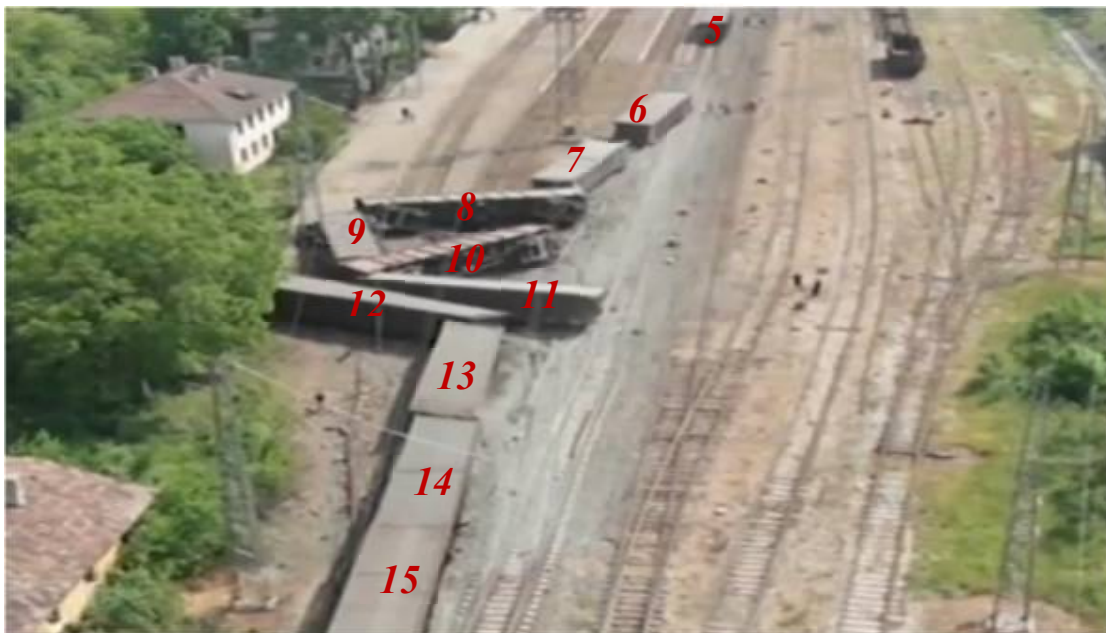
Fig. 60

1. 1. Wagon № 33520806001-2 - sixth of the composition: the first derailed wagon (Fig. 60). Positioned between the third and fourth tracks, derailed with the four wheels, with deformed rear frontal beam and punctured transverse wall of the basket due to the impact of the seventh car, damaged bogies and wheels, loose bolt on the front screw coupling (to the fifth car), broken spring bolt on the rear earring of the first bogie of the first wheel on the left side, according to the direction of movement (Fig. 61). A brief analysis of the condition of the fracture after the disruption of the spring bolt: the structure of the fracture clearly shows the presence of the characteristic fracture zones due to fatigue of the material. A fragile disruption is observed in the base part of the section, characterizing sudden destruction by excessively high sudden loads, many times exceeding the nominal ones for the respective section (Fig. 62, pos. 3).

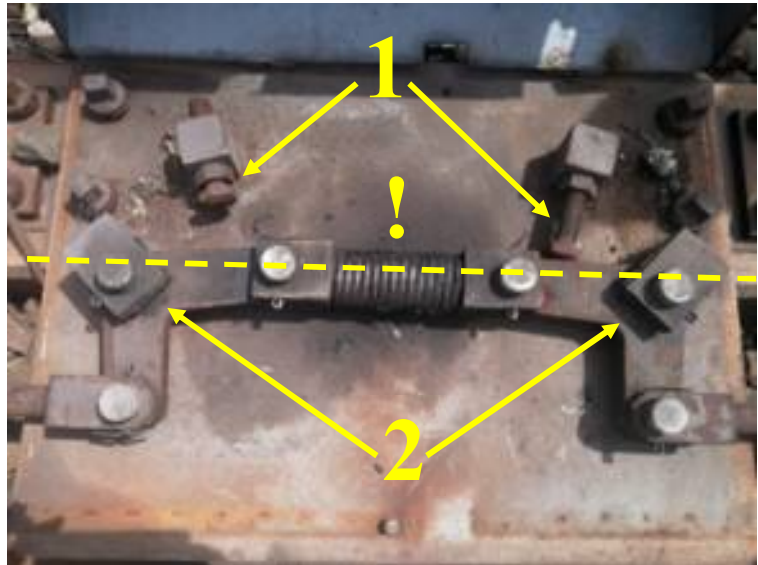
Fig. 67

- The support bolts (fig. 67, pos. 1) of the rocker arms (fig. 67, pos. 2) of the spring rocker arm of switch № 20 are incorrectly calibrated, which leads to non-adherence of the left tongue to the left shoulder rail and the free right tongue remains at a distance of 40 mm from the right shoulder rail while the norm is 65 ± 3 mm. When heavier trains pass, indications for cut switch appear occasionally on the desk at the station (registered in previous cases) (Fig. 68).

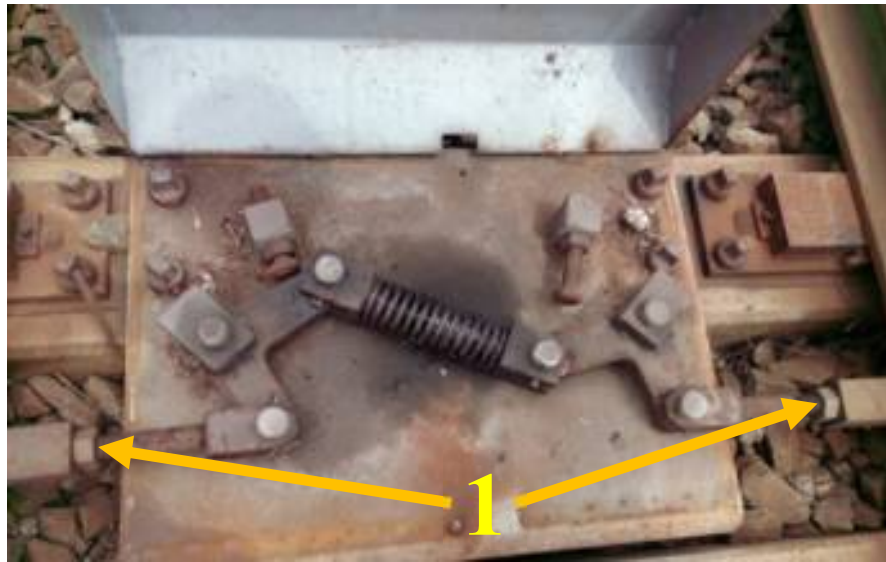
Fig. 69

- The connecting rods of the spring rocker arm are incorrectly calibrated (Fig. 69, item 1).
- During operation, the adhesion of the tongues to the shoulder rails changes and for this purpose, it is necessary to periodically be checked and calibrated. NRIC personnel are not trained to maintain this type of auxiliary reversing and spring apparatus. There are no protocols for training
