**REPUBLIC OF BULGARIA**  
**NATIONAL AIR, MARITIME AND RAILWAY ACCIDENTS**  
**INVESTIGATION BOARD**

**FINAL REPORT**

**Investigation of railway accident – derailment of locomotive № 46041  
from direct freight train № 30602 while entering in Stolnik station on  
15.01.2021**

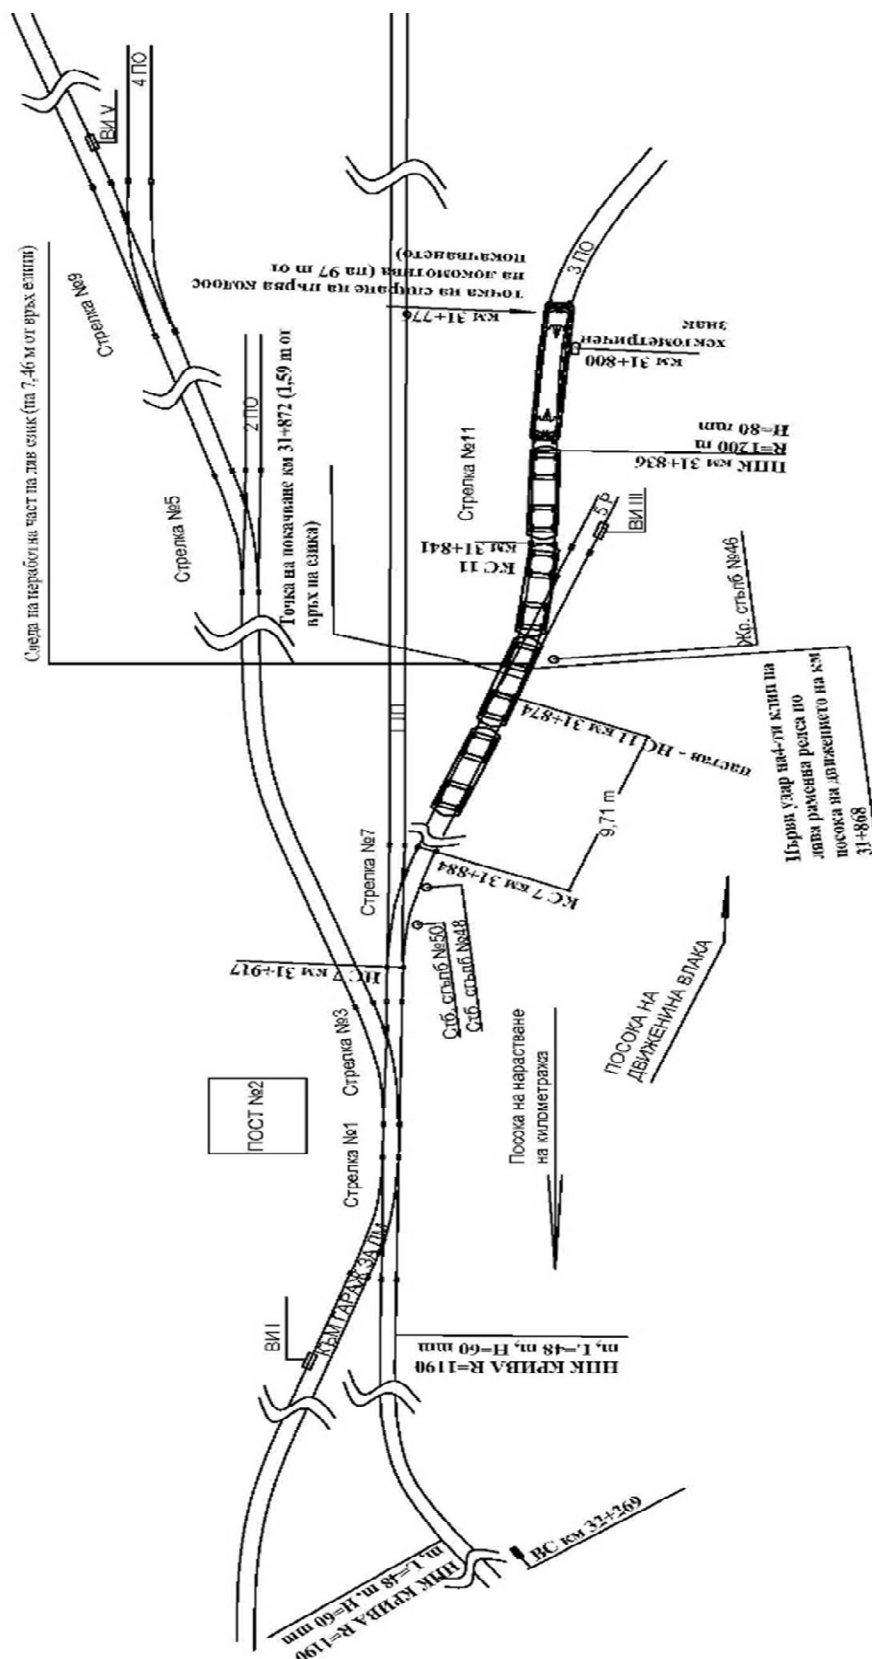
Фиг. 1.3. Схема на дерайлиране на ДТВ № 30602 в гара Столник.

Immediate cause for the accident occurrence (derailment of the first wheelset of locomotive № 46041 in the part of the tongue (blade) of switch № 11 leading to the third acceptance-departure track in Stolnik station) is a malfunction of the right deflection tongue (blade) of switch № 11. The notch in this area of the blade is a consequence of chipping metal from the surface of the blade in its upper thin part at a distance of 330 mm to 730 mm from the tip of the blade. This area of the blade is not subjected to vertical dynamic loading, but is determined by the lateral transverse horizontal force. The wheel flange interacts with the working part of the blade at a point before the point of contact between the wheel and the right stock rail. Due to the inadmissible notching, the wheel rises on the right stock rail and derails (Fig. 1.3).

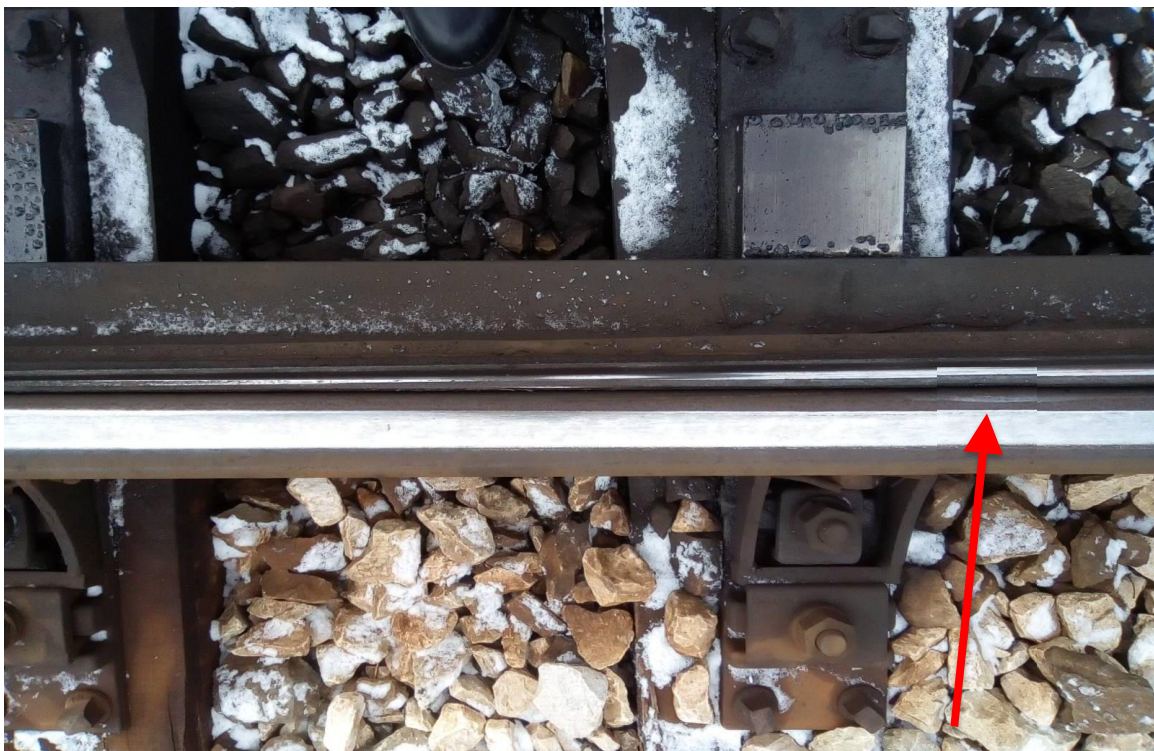
**Fig. 4.6.** First trace of the rise of the first right wheel of the locomotive on the right stock rail.

- **Lateral and vertical wear of the blade of switch № 11**
  - The measurements of the track carried out by the Investigation Commission found that there was vertical wear (notching) of the blade, horizontally with a length of 400 mm and vertically with a maximum depth of 9 mm;

When inspecting the place of rise of the wheelset on the stock rail, it was visually found that from the inner working side surface of the right blade there were notches 330 mm from its tip. That caused a violation of the interaction when entering the right wheel of the first leading wheelset of the locomotive and the right blade of the switch, which led to a rise of the wheel in the notched blade of the switch. (Fig. 4.6).

The notching of the blade is caused by chipped metal in its upper thin part.

The reduced grip between the flanges of the right wheel of the first wheelset, due to the notching of the blade with length of 400 mm at a distance of 330 mm from its tip has caused the flange to rise on the right stock rail. The combination of all these conditions has led to the derailment of the leading wheelset of the locomotive. The sealed blade to the right stock rail in this area did not allow the flange to be inserted between the right stock rail and the right deflection blade adhering to it.

After the derailment on 15.01.2021 on switch № 11, the operation of the damaged blade continued. It was replaced with a new one on 03.02.2021.

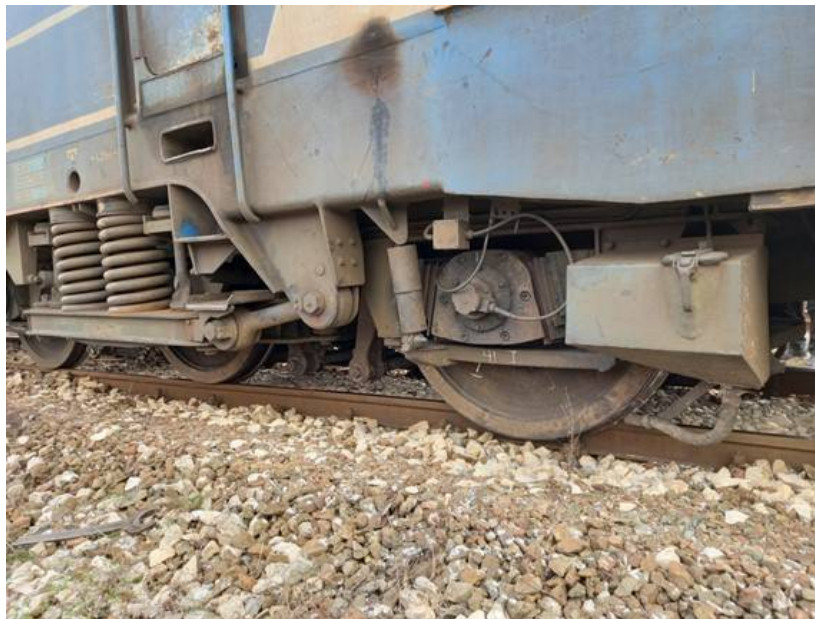
**Fig. 4.17.** The right leading wheel of locomotive № 46041 after the derailment.

At the insistence of the Investigation Commission, repeated measurements were made on 02.02.2021 for establishing the technical condition of switch № 11. The measured notches on the right blade of switch № 11 further complicated the entry of the leading right wheel on the first wheelset of the locomotive, which increased the steering force of the wheel, and led to its rise on the right stock rail and after 9 meters the wheelset derailed to the right in the direction of train movement (Fig. 4.17 and 4.18).

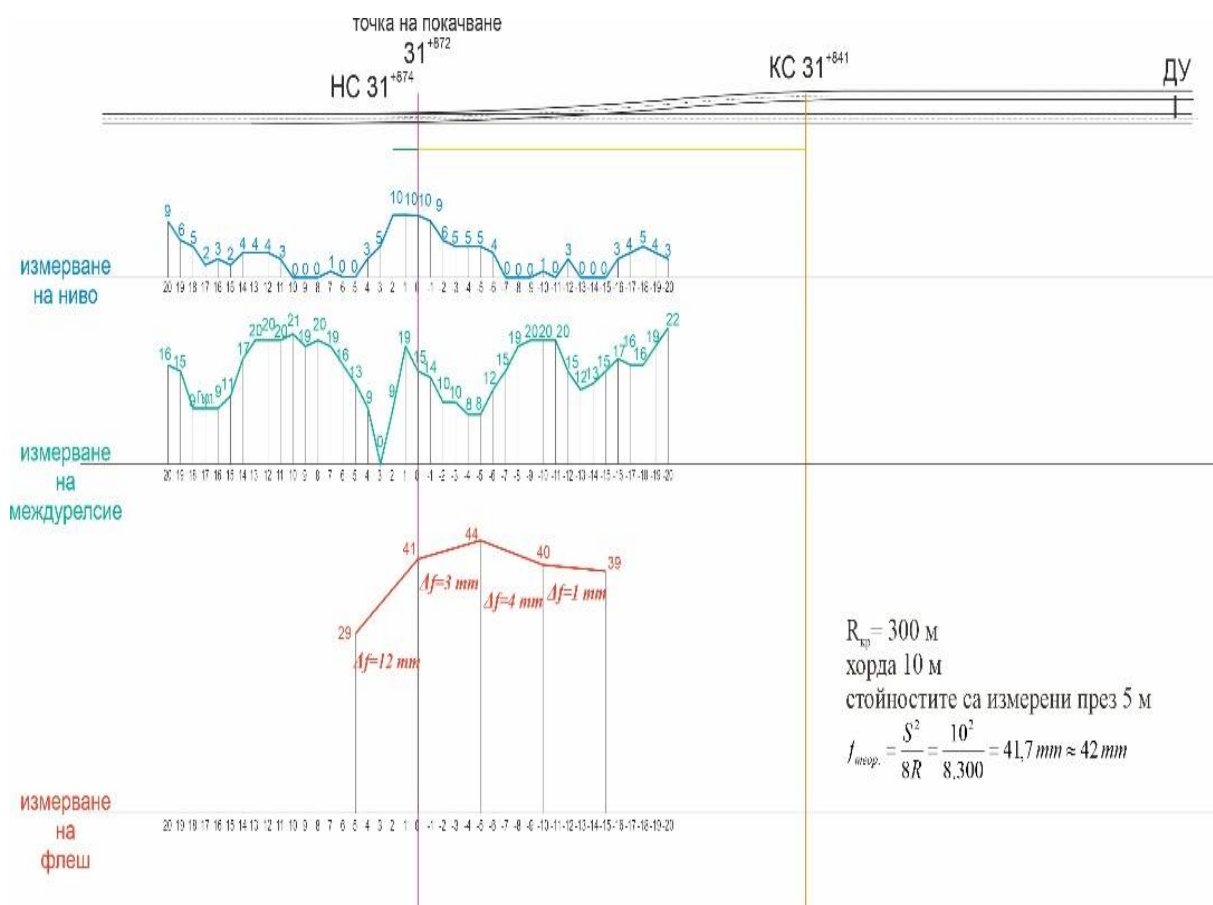
**Fig. 4.21.** Scheme of the measured values of switch № 11

From the inspections made on the right deflection blade of switch № 11 it was found that from its top up to 150 mm horizontal distance from it, there is no contact with its side work surface. There are no traces of blows from the passing wheel on its top. This is an evidence that the blade has been very well sealed to the stock rail, which has no vertical operation. In this position, the blade is well protected in its thinned part from side impacts and vertical dynamic loading from the wheel tires. At a distance of 330 mm from its top to 730 mm with a length of 400 mm with a

permissible 300 mm there is a notch with different depth, and in its middle part reaches 9 mm with a permissible 8 mm. This measurement was performed with a calliper on 02.02.2021. These data appear in violation of Art. 49, item 6 of Ordinance № 58 and of item 7.4 of the Instruction for current maintenance of the rail track and switches. It is clear that when the wheelset of the wheels of the rolling stock move in the straight sections of the rail track, they move in parallel to the rails. However, this is not the case when moving in the curves. In the present case, the leading first wheelset of the first three-axle bogie of the locomotive, after passing the 10 m line between switches № 7 and № 11, enters in the curve for the deviating 3rd track of switch № 11, which is without transition curve and without cant. A centrifugal force appears, as the vehicle tends to continue on its tangent. It forces the flange of the first right wheel to fit snugly against the working side surface of the blade. It is possible that the horizontal transverse force appeared is so large that multiplied by the coefficient of friction, it has overcome the pressure of the wheel. ( $H \times f > Q$ );
