FINAL REPORT

Investigation of significant railway accident – derailment of full tank cars from the composition of direct freight train № 90593 between the stations Vetovo – Senovo on 23.04.2021

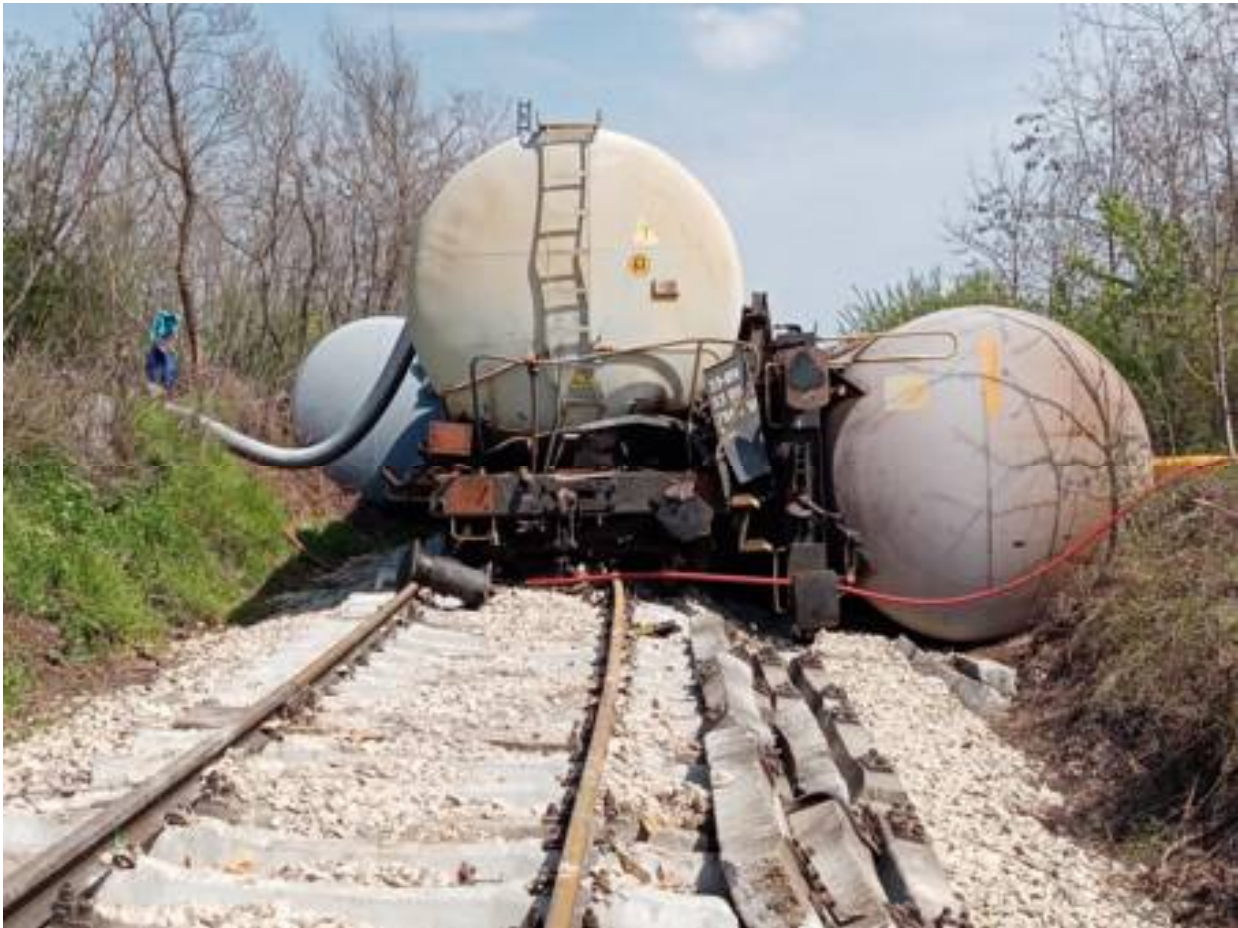
Fig. 1.1.

also submitted information to the national telephone number 112 about an accident with a train carrying liquid fuels (fig. 1.1, 1.2 and 1.3).

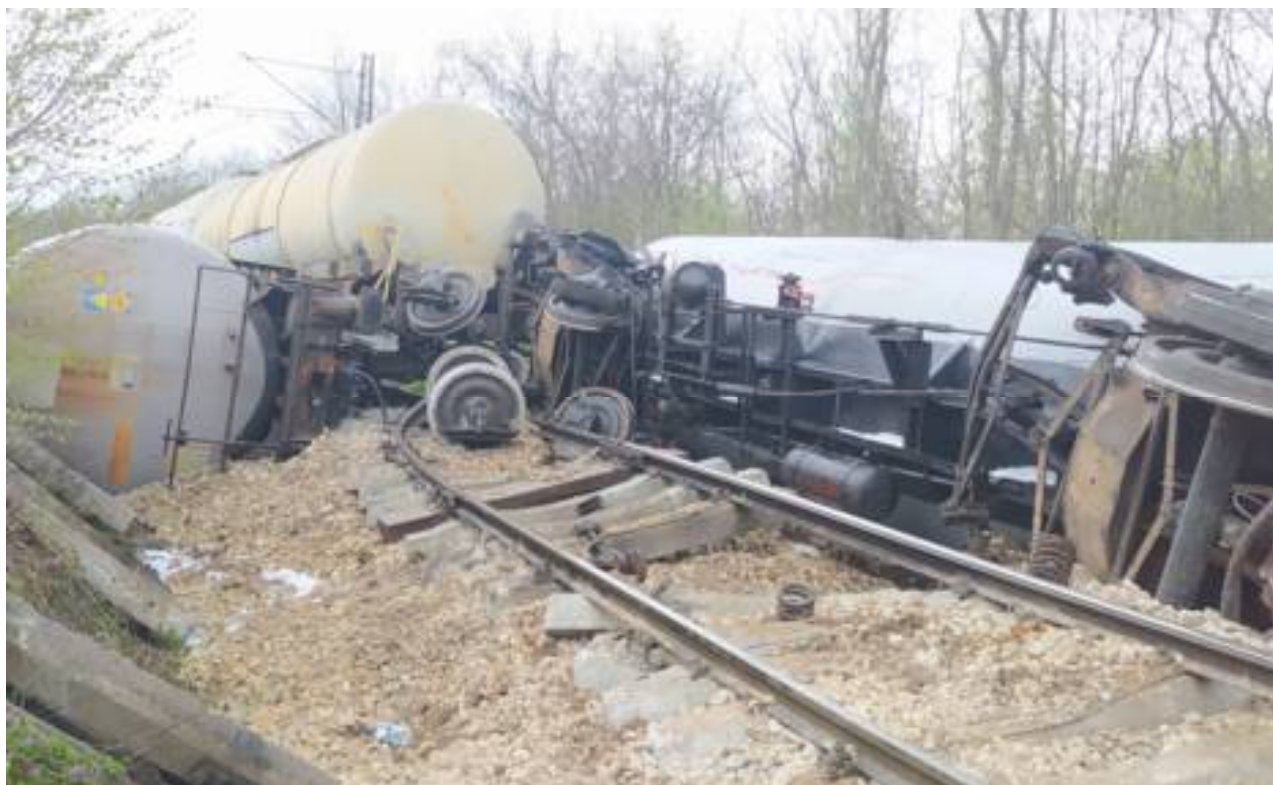
Fig. 1.3.

As a result of the derailment of DFT № 90593, significant damages were caused to the railway infrastructure and on five tank cars.

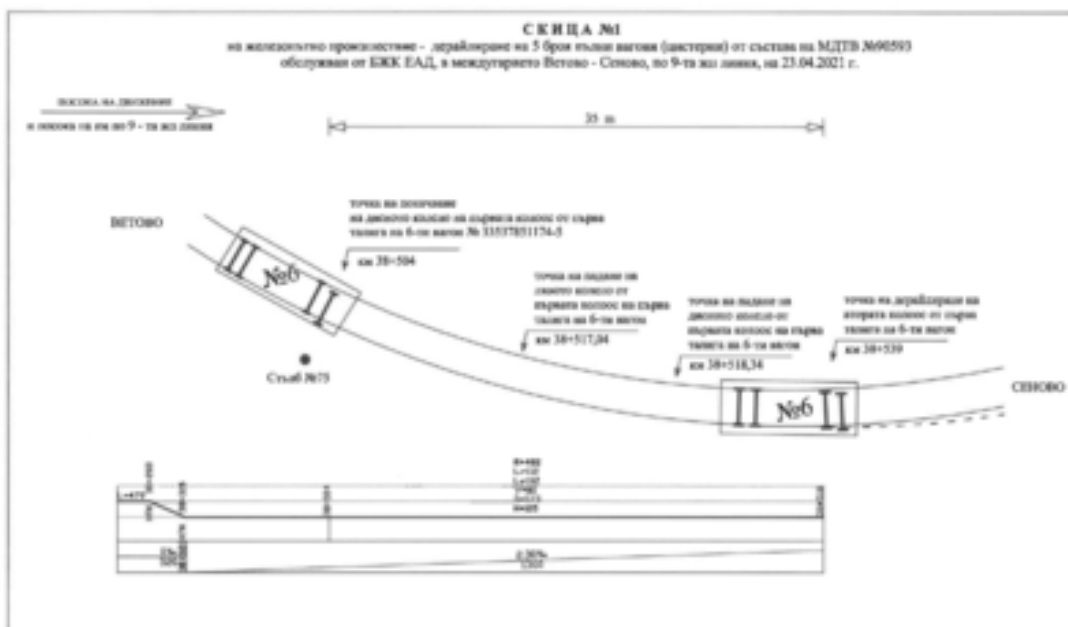
Fig. 1.4. Scheme № 1, start of derailment of sixth wagon № 31525400845-3 in Vetovo – Senovo on 23.04.2021

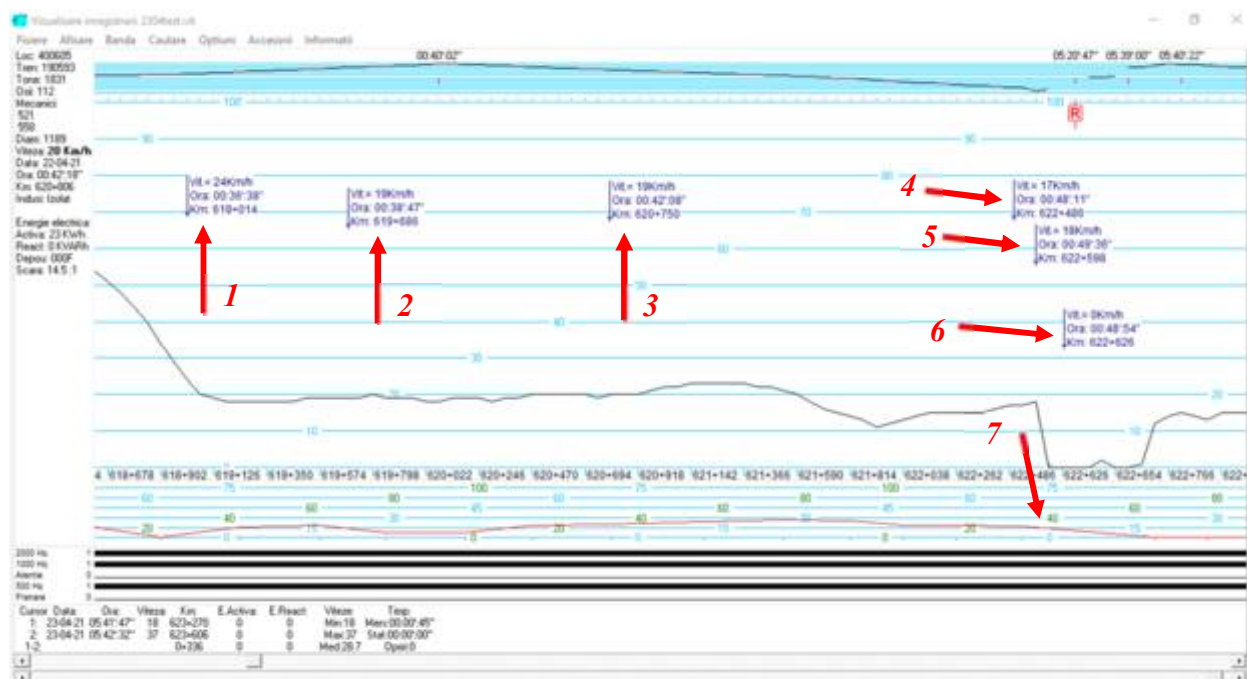
locomotive № 91530400605-8 were located at km 622,626, corresponding to km 41⁺¹⁰³ of the railway line. Thus DFT № 90593 passed 3 612 meters with speed under 25 km/h (fig. 4.4, pos. 6).

Fig. 4.4. Chart of movement of DFT № 90593 through the two fronts of reduction along Vetovo-Senovo interstation

main air duct, however it registered the level of the consumed traction energy, i.e. the loading of the traction engines. The chart shows that at the moment of reducing the speed (Fig. 4.4, pos. 6) the locomotive was in traction mode, which means that its braking system was not applied, therefore the retention of the automatic train brake occurred due to the bifurcation of the train and the pressure dropped in the main air duct (Fig. 4.4, pos. 7).

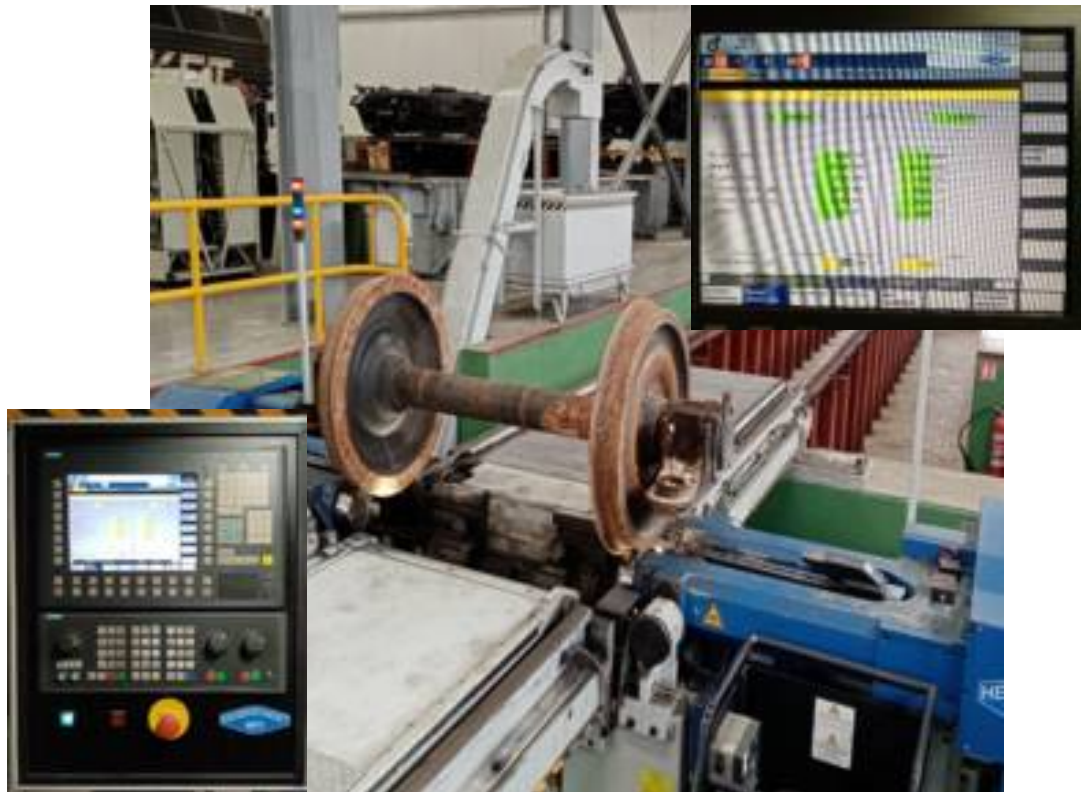
Stakeholders raised reasonable doubts as to the reliability of the measurements of the first wheel-set of the first bogie of wagon № 33537851174-5 with a Riftek / IDK device with a serial № 11213, certified until 10/2021, which is based on a calculation by the length of the chord in the rolling circle.

Fig. 4.7. Photo from the wheel-set measurement on the wheel-set lathe with the control board and the display with the results.

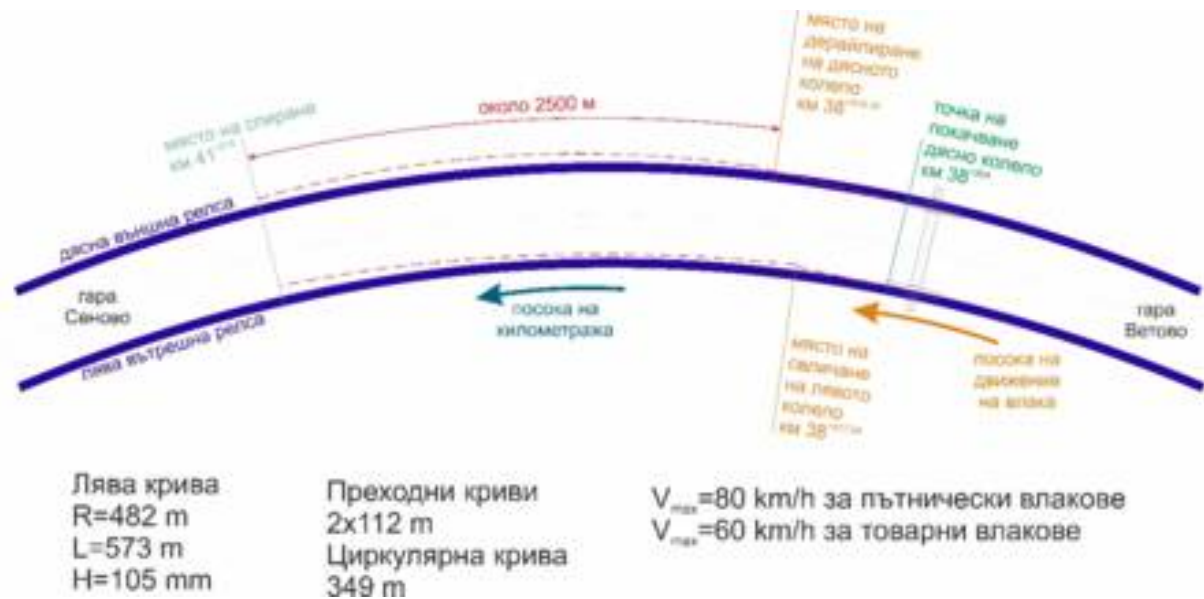
The direct causes of the accident (derailment of the first and subsequently the second wheel-set of the first bogie of the 6th wagon) are unacceptably large superelevation in the left circular curve with a radius of 482 meters due to poor reinforcement of the rail track after the repair. The low speed of the passing freight trains caused an overload of the left inner rail thread, which contributed to the sharp increase of the cant in the curve to inadmissible values. The combination with the driving mode led to a decrease in the adhesion of the right wheel of the first wheel-set of the first bogie of the sixth wagon with the working surface of the right rail in the curve, which led to the wheel rising on the rail and derailing the first and then the second wheel-set.

Fig. 4.14. Scheme of the derailment mechanism

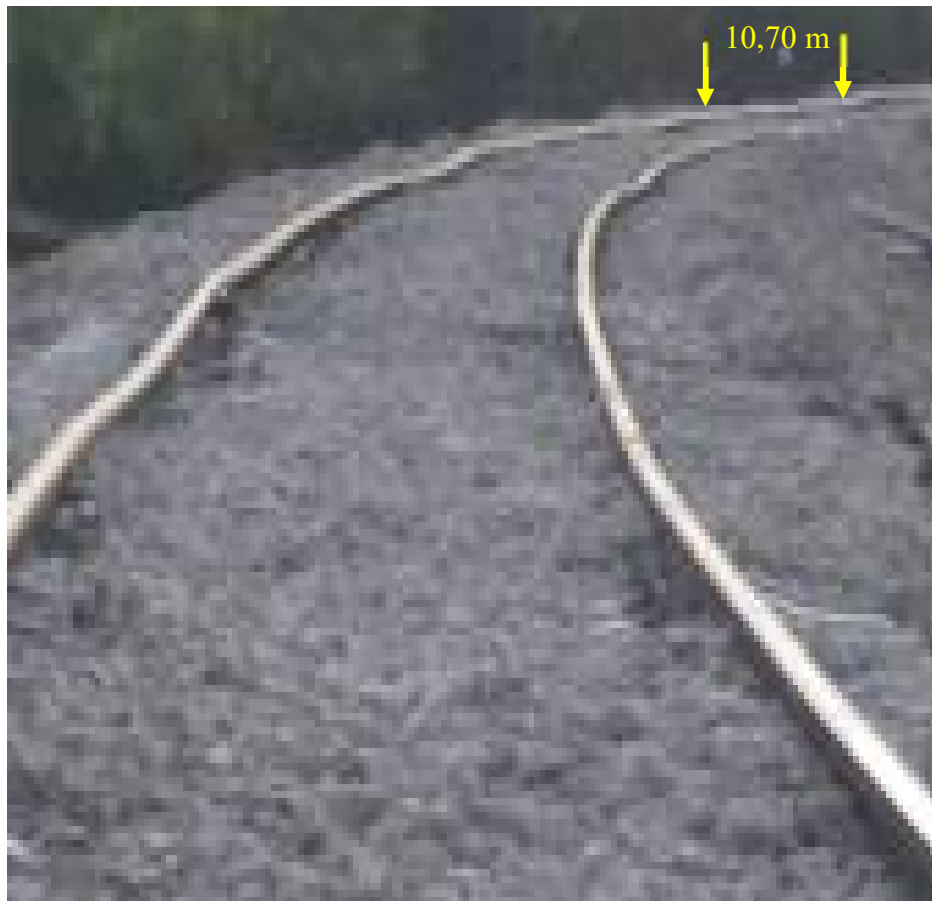
Transverse level of the rail track, measured 20 m before and after the point of ascent of the wheel (Fig. 4.15). The superelevation in the rail track curves depends on the radius of the same and the speed of the trains, and the higher (maximum) speed is taken for the movement. According to the Tables with technical parameters and norms, the maximum speed for the movement of passenger trains in the interstation Vetovo - Senovo is 80 km/h, for freight trains 60 km/h.

Fig. 4.15. Condition of the rail track under level at the place of derailment, measured on the basis 10,70 m of the sixth wagon

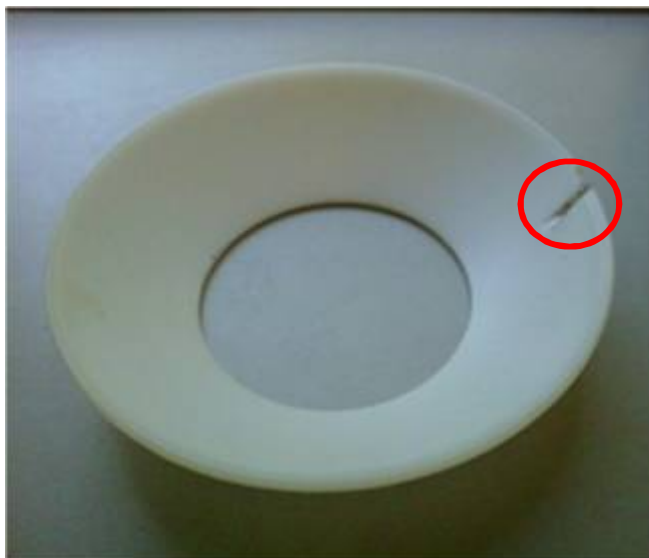
Fig. 4.19. Wag_new

Sample type: New non used insert in white colour, and two strongly deformed, contaminated inserts in rusty-brown colour.

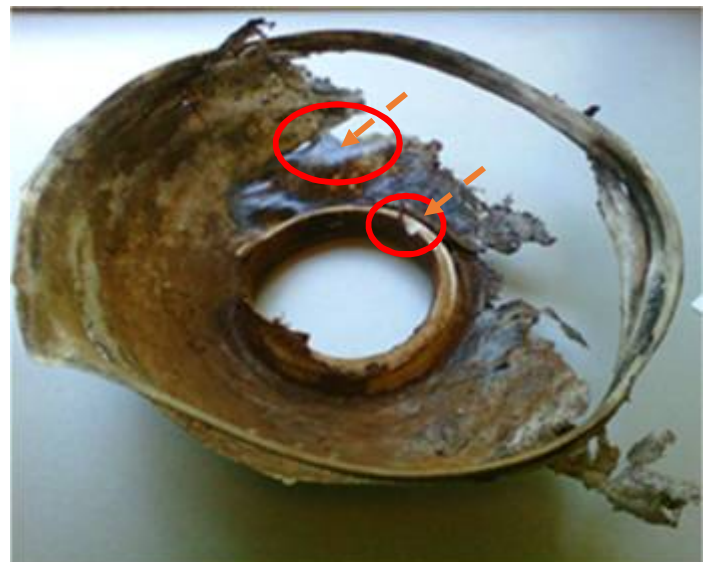
Fig. 4.20. Wag_old (Center / melted)

In conclusion, it can be said that both products are made of polyamide 6. The new and the old model, in its more preserved part, have identical physical and mechanical properties. A significant difference in properties is observed in the partially submerged area, showing that the insert has visibly undergone a large, asymmetric deformation, exceeding the conditions specified by the manufacturer in aggressive operation. In the process of operation with high loads and intensive friction for a short period (within minutes), a high temperature was reached at which the polyamide insert began to melt and deform.

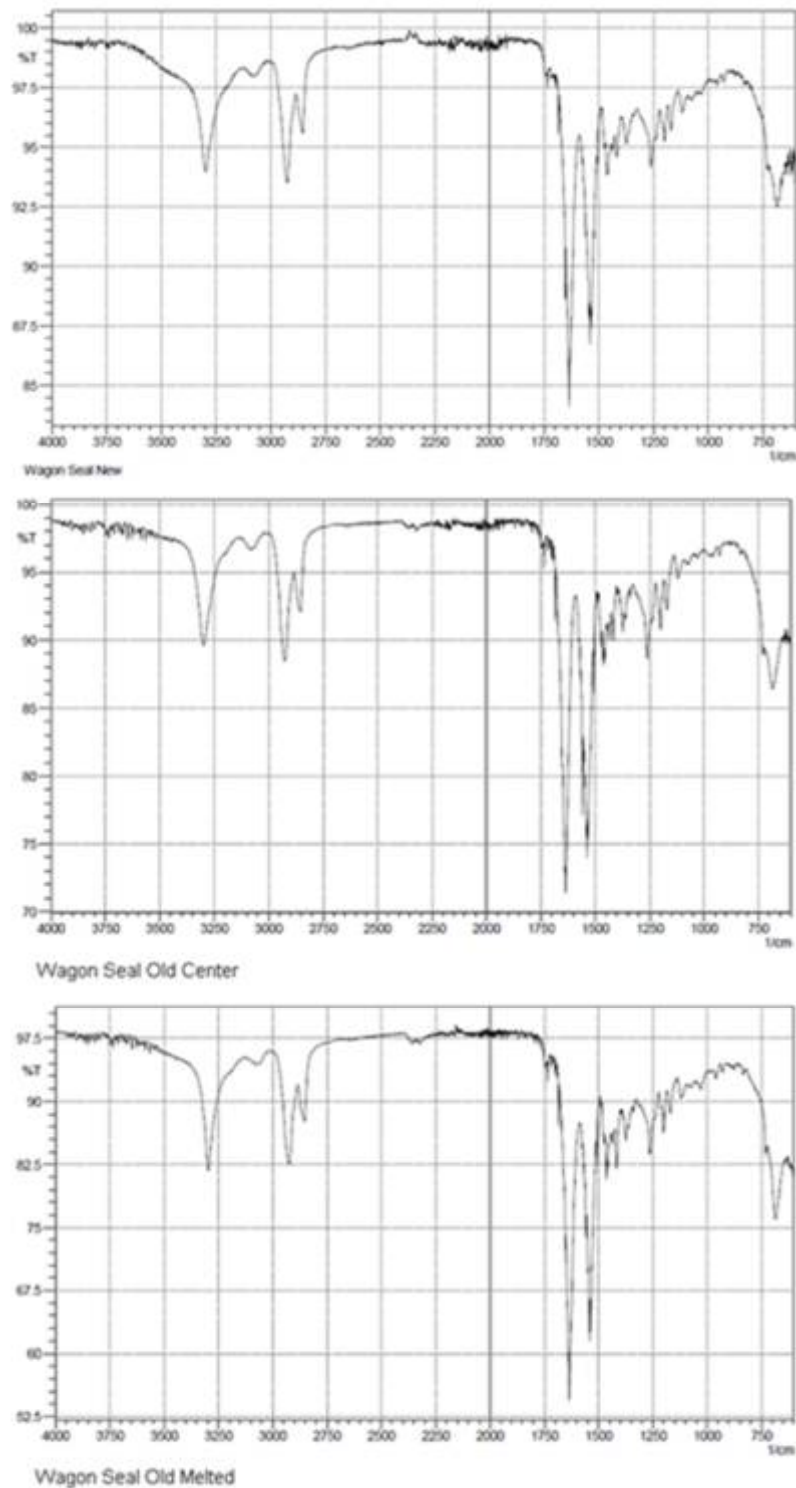
Fig. 4.21. a, b, c

In all three samples, the characteristic absorption polyamide-6 bands were observed at 1520, 1610, 2940 and 3300 cm^{-1} . No significant differences were observed in the spectra of the test samples.

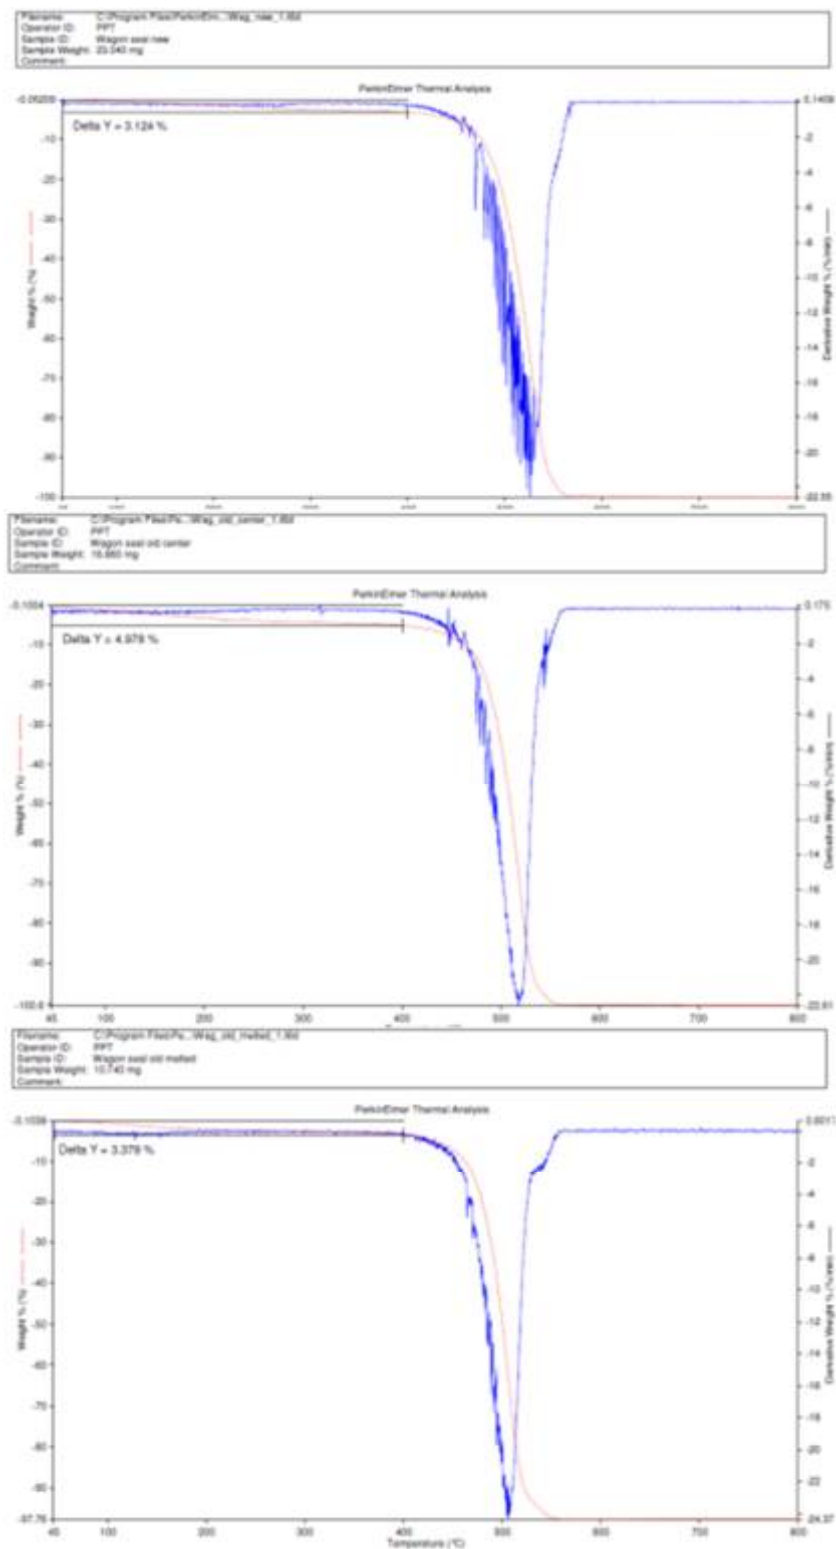
Fig. 4.22. a, b, c

In all three samples, a minimum mass loss of up to 400 °C was observed. The loss of about 3% in the range up to 200 °C in the **Wag_old samples** is due to the absorbed moisture. The polyamide decomposes in the range of 460 ÷ 580 oC, and the maximum rate of destruction is at 509 ÷ 529 oC. The lowest rate of destruction was observed in the submerged **Wag_old sample**. The presence of steel oxides (rust) in the same sample is probably the reason for the residual 2.34% of the mass of the sample.

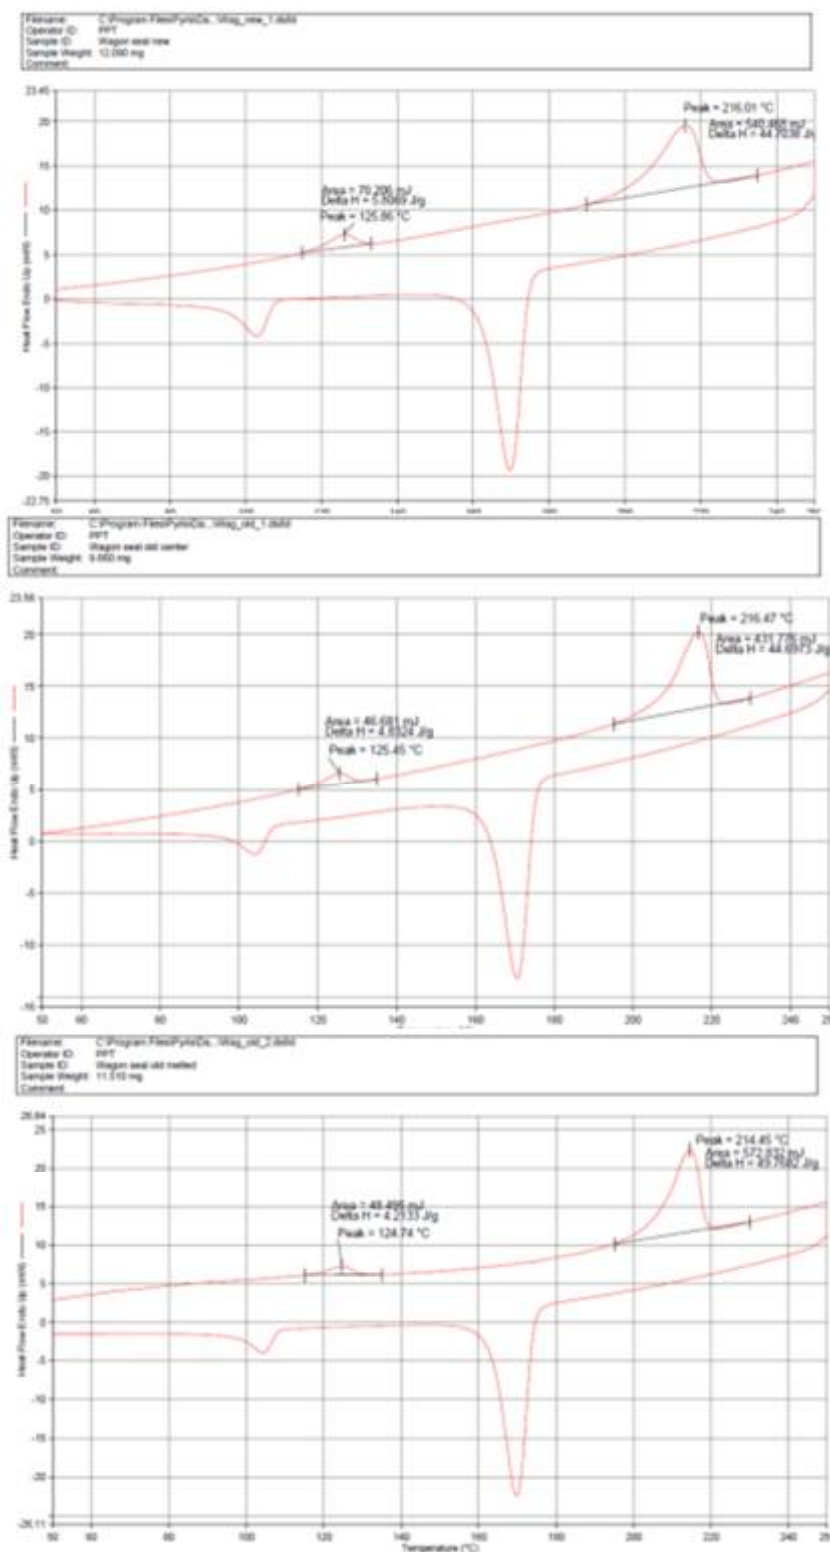
Fig. 4.23. a, b, c

All three samples are partially crystalline, with the crystalline phase melting in the range $192 \div 224$ ° C. The degree of crystallinity of Wag_new and Wag_old center is about 19.5%, and of the sample Wag_old melted is 21.7%. The difference is probably due to partial melting and subsequent recrystallization of the material. The melting peak at 125 ° C is not due to polyamide 6. It is possible to melt an added modifying agent (According to the TENMAT brochure, the product contains a friction-reducing modifying agent).
