R E P U B L I C O F B U L G A R I A
NATIONAL AIR, MARITIME AND RAILWAY ACCIDENTS
INVESTIGATION BOARD

FINAL REPORT

**Investigation of railway accident – derailment of direct freight train
№ 30610 between the stations Shivatchevo – Tvarditsa on 12.03.2021**

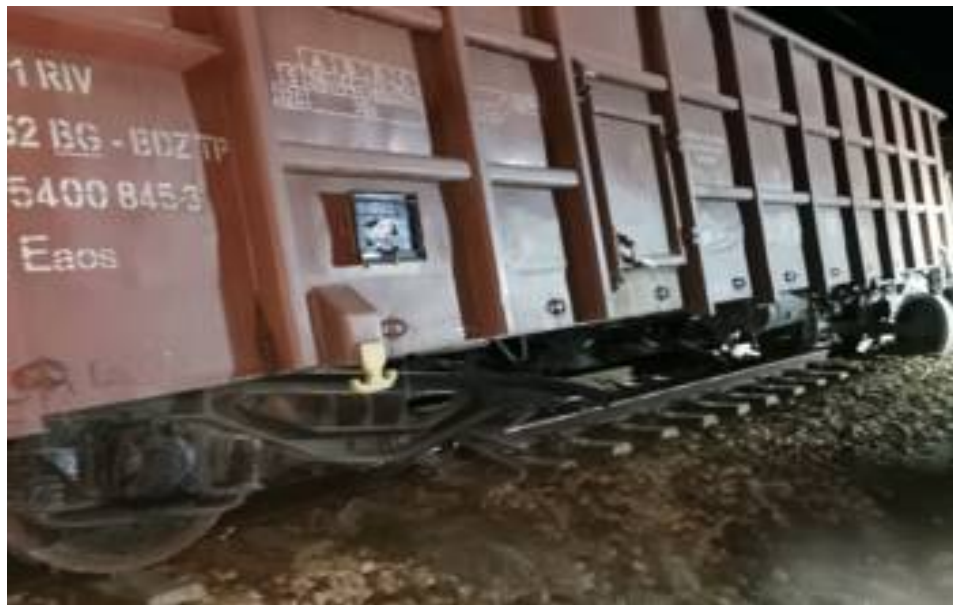
On 12.03.2021 at 16:16 p.m. from Sliven station departs DFT № 30610, consisting of 17 full wagons, 68 axles, 1323 tons, towed by an electric locomotive № 46032 with a locomotive driver and an assistant locomotive driver. The train route is in the direction Sliven - Dabovo - Tulovo - Karlovo - Pirdop. At 16:54 p.m. the train passed Shivachevo station without stopping, the traffic manager on-duty monitored the passage of the train through the station and did not notice any irregularities on the rolling stock. Between the stations Shivachevo and Tvarditsa about km 257⁺¹⁶⁰ the locomotive driver found a decrease in the pressure in the main air duct of the train, turned off the MAD of the locomotive and the train stopped at 17:04 p.m. After the inspection performed by the assistant locomotive driver, it was established that the 16th car in a row from the beginning of the train had derailed with the two wheel-sets of the first bogie (Fig. 1.1).

Fig. 1.1. Derailed the first bogie of wagon № 31525400845-3 along Shivachevo – Tvarditsa interstation

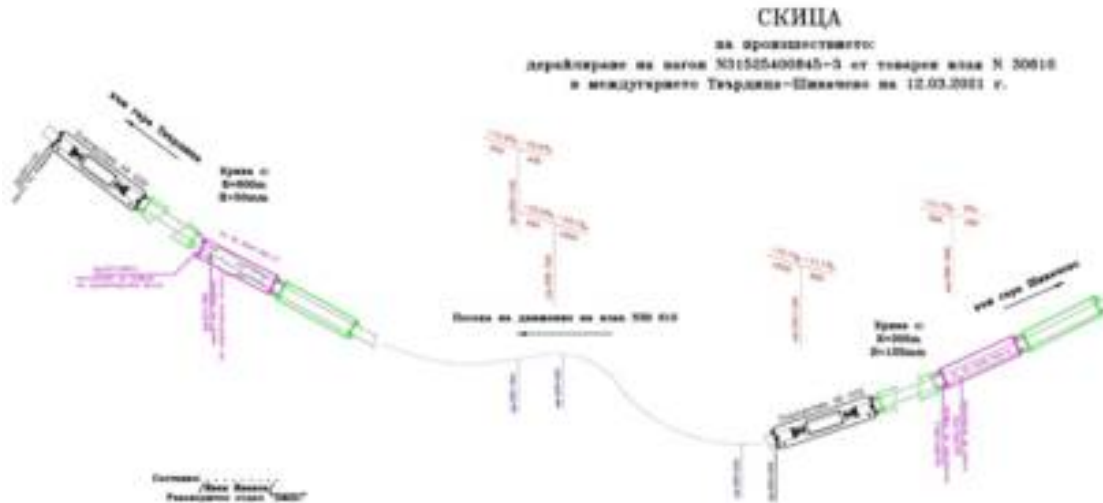
The derailment of the wagon from DFT № 30610 occurred between the stations Shivachevo and Tvarditsa at 17:04 p.m. on km 260⁺³⁰², where first occurred derailment to the left

of the second wheelset, and subsequently of the first wheelset of the first bogie of 16th train wagon (fig. 1.2).

Fig. 1.2. Scheme of the accident – derailment of wagon № 31525400845-3 along Shivatchevo – Tvarditsa interstation on 12.03.2021.

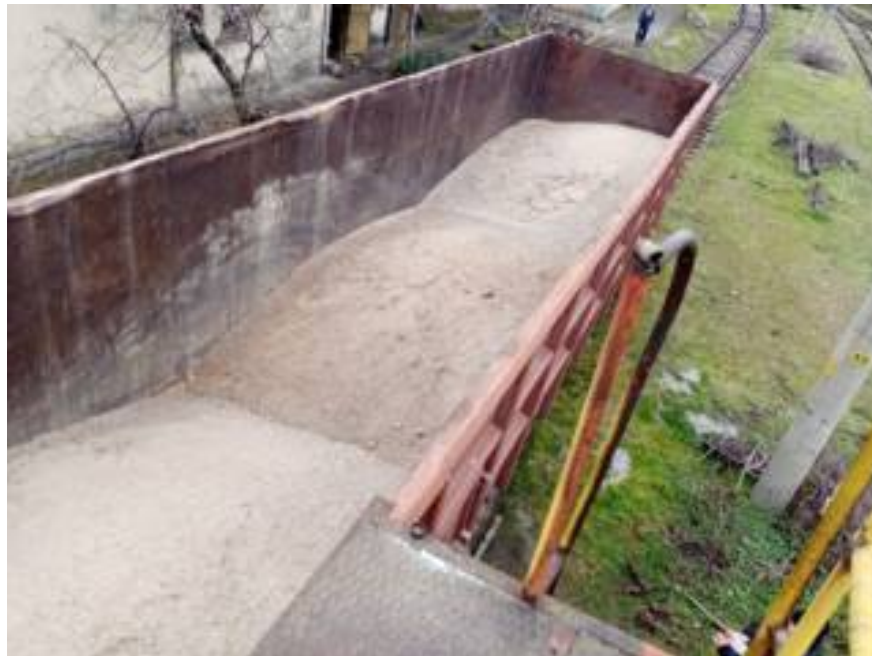
As determining factor for the occurrence of the accident was established irregular (asymmetrical) loading of the derailed wagon with respect to its longitudinal axle (fig. 1.3).

Fig. 1.3. Layout of the load in the wagon № 31525400845-3

The direct cause of the accident occurrence was the uneven distribution of the bulk load in the body shell of the wagon, which led to derailment of the second wheelset of the first bogie of the 16th train wagon, in the following sequence: raising the left wheel of the second wheelset on the left rail, collapse of the right wheel in the track gauge and subsequent collapse of the left wheel on the outer part of the rail.

Recommendation 3 proposes that BDZ-Cargo Ltd. controls the process of loading the wagons when transporting bulk cargo.

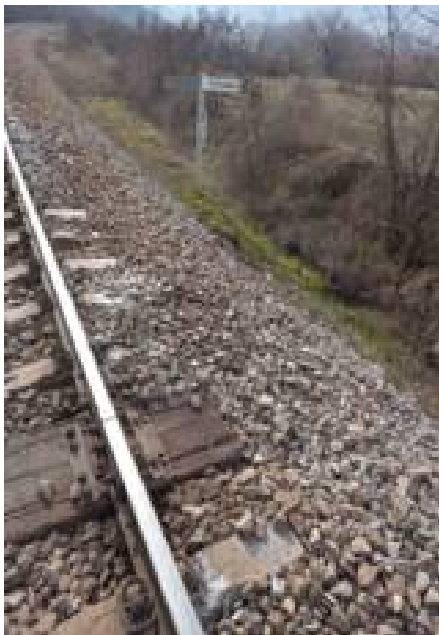
After the detaching and towing the non-derailed wagons from the DFT № 30610, the derailed 16th wagon and non-derailed 17th wagon remain in place. The 16th wagon № 31525400845-3 is placed on the rail track. Upon arrival of the locomotive for towing the two wagons at Tvarditsa station, their self-movement in the direction of Shivatchevo station followed. The profile of the track follows downhill 14 ‰, due to which their speed increased significantly and followed by re-derailment of the 16th wagon № 31525400845-3 at km 271⁺⁰⁵⁰ in the interstation Shivatchevo - Gavrilovo. As a result of the wagon re-derailment, was destroyed rail track for 440 meters (Figs. 2.1 and 2.2).

**Fig. 2.1. Point of
rederailment of 16th wagon**

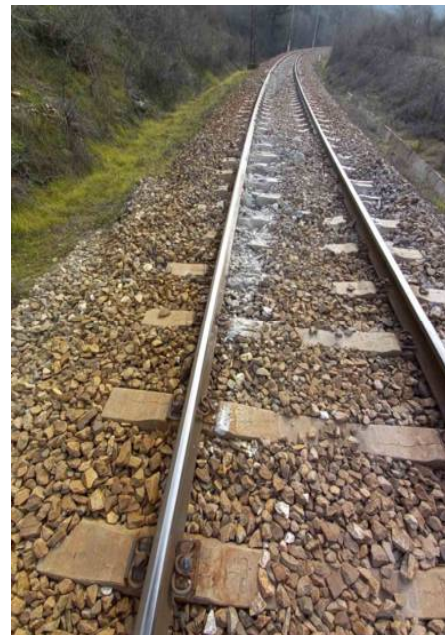
**Fig. 2.2. Rail track condition
after the rederailment of the
16th wagon**

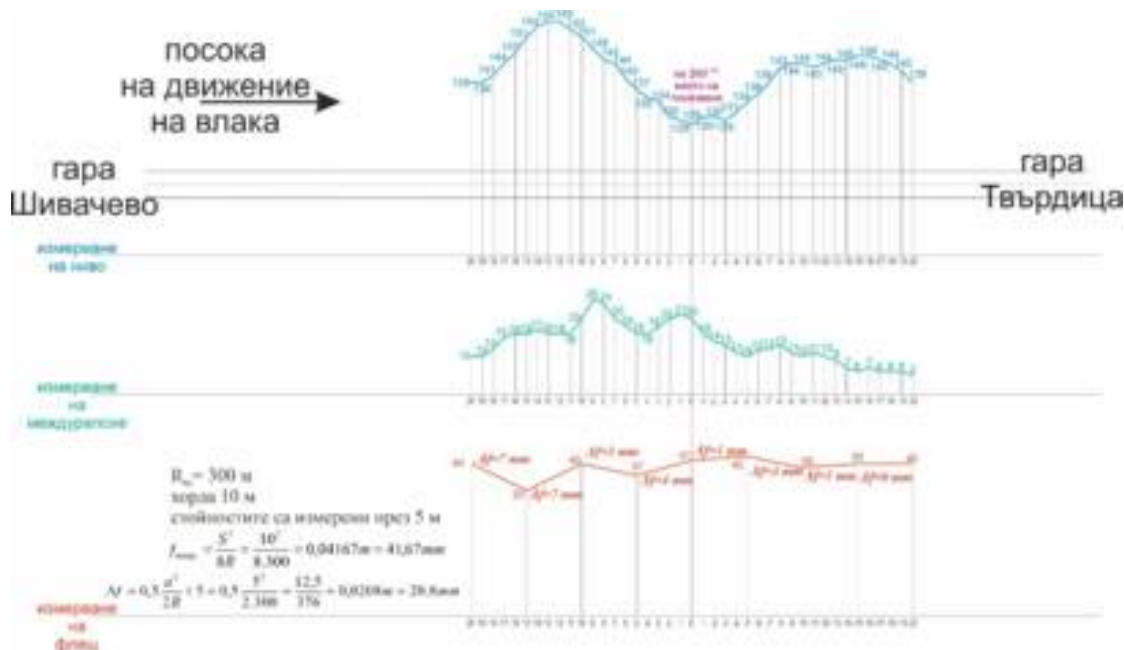
From the measured values of the level in a total of 21 points from +20 to 0, an arithmetic mean cant in the curve of 143 mm is obtained. On this basis, the measured values for the level of the track, reaching up to 155 mm and a minimum value of 128 mm in the zero point with a difference of 27 mm, meet the requirements of ± 15 mm for speeds up to 60 km/h. It is also evident that the inclinations of the transitions are within the permissible norms - greater than 1: 400. The cited cant in the Statement of Findings on the condition of the rail track of 125 mm is the minimum permissible for a curve with a radius of 300 m and a maximum speed of V = 75 km / h. The specified value of 125 mm is for the minimum limit for a curve with a radius of 300 m and for the

Fig. 4.7. Diagrams of the values of separate track parameters along Shivatchevo-Tvarditsa interstation, measured on 12.03.2021.

From the measured values of this parameter, registered in the Statement of Findings for the condition of the rail track, it is evident that the maximum registered track gauge is at point № 9 with a value of 1460 mm and does not violate the requirements described in the “Instructions for construction and maintenance of the rail track and switches superstructure.”, where the maximum permissible track gauge is 1465 mm for first and second class railway lines (Fig. 4.7, Diagram of track measurement under rail gauge).

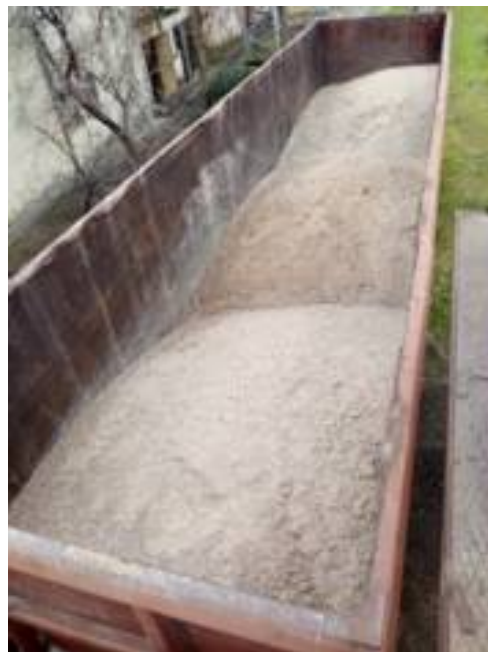
After the inspection, it was found that the load in these wagons was unevenly distributed along the transverse and longitudinal axles of the wagons, as most of it was located in the right longitudinal half of the wagons in the train movement direction (Fig. 5.1).

Fig. 5.1. Distribution of the load in 16th wagon № 31525400845-3

- Recommendation 3 proposes that „BDZ-Cargo“ Ltd. controls the process of loading the wagons when transporting bulk cargo.

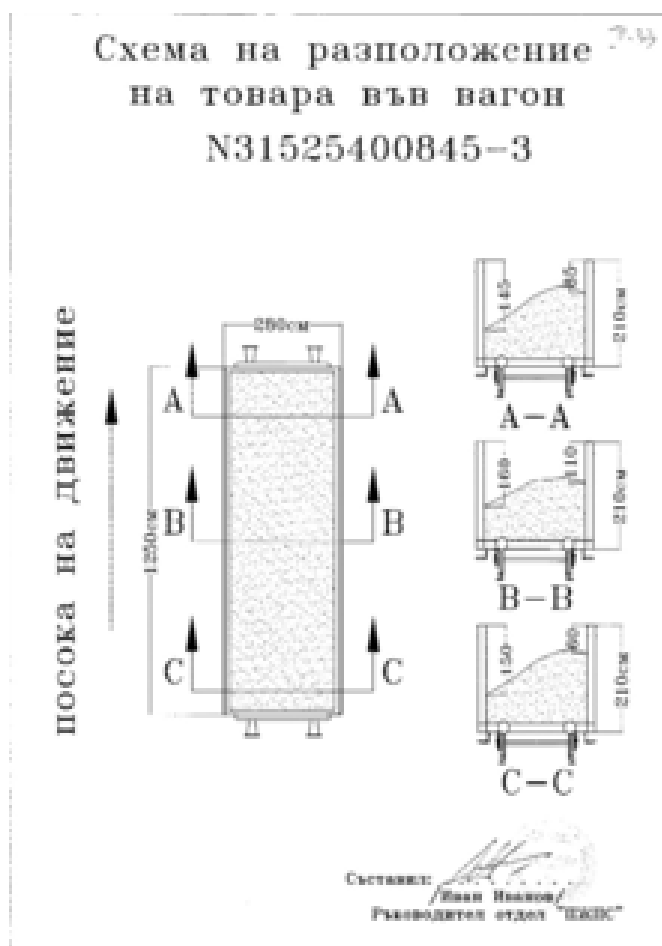
Fig. 5.2. Scheme of load layout in 16th wagon № 31525400845-3

Therefore were found non-compliance with the requirements of Art. 46, para. 3, item 1 of the 2nd and 3rd wheel-sets of the 15th wagon; on the 2nd, 3rd, and 4th wheel-set of the 16th wagon (derailed) and on all the wheels of the 17th wagon.

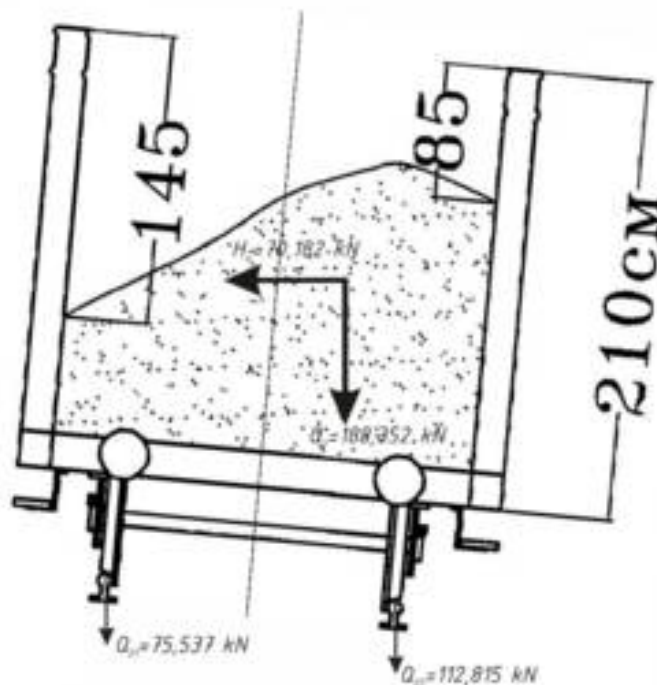
Fig. 5.3. Distribution of the forces acting on the second wheel-set of the first bogie of wagon № 31525400845-3

second wheel-set is located (Fig. 5.3). The center of mass is shifted to the right of the longitudinal axle of the wagon in the direction of train movement, which is logical given the results obtained when measuring the load on the individual wheels (Table 1). The measurements also show that the right wheel is loaded 49% more than the left one.

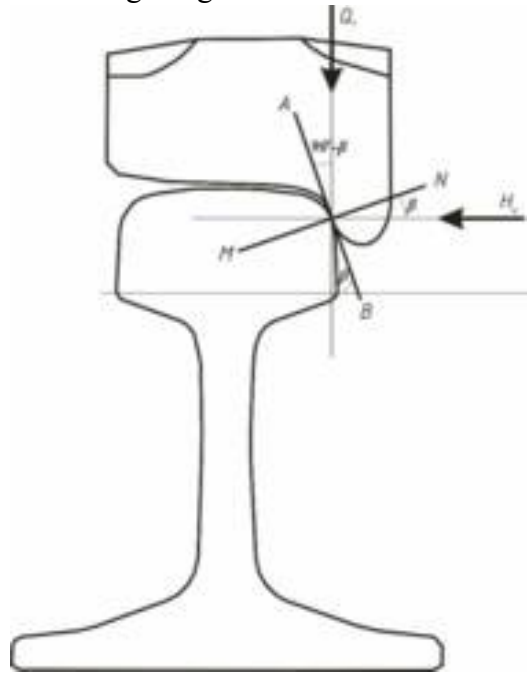
Assuming that $\beta=70^\circ$ and $Q_2=1,49Q_I$, $H_u/Q_I=0,93$ is obtained. For stable movement it is necessary to fulfill the condition $H_u/Q_I \leq 0,8$. Therefore, the horizontal transverse force caused by the centrifugal force in the movement of the train in the curve has a greater influence than the vertical load acting on the wheel, which violates the condition of stable wheel movement and leads to derailment of the respective wheel. These results, combined with the lower value of the level of the rail track (which is within the permissible limits) at the point of ascent (Fig. 5.5: 0.128 m (Fig. 5.5, pos. 1) compared to the first wheel - 0, 13 m (Fig. 5.5, pos. 2) and the third wheel-set - 0.144

Fig. 5.4. Forces, acting in the contact point wheel-rail

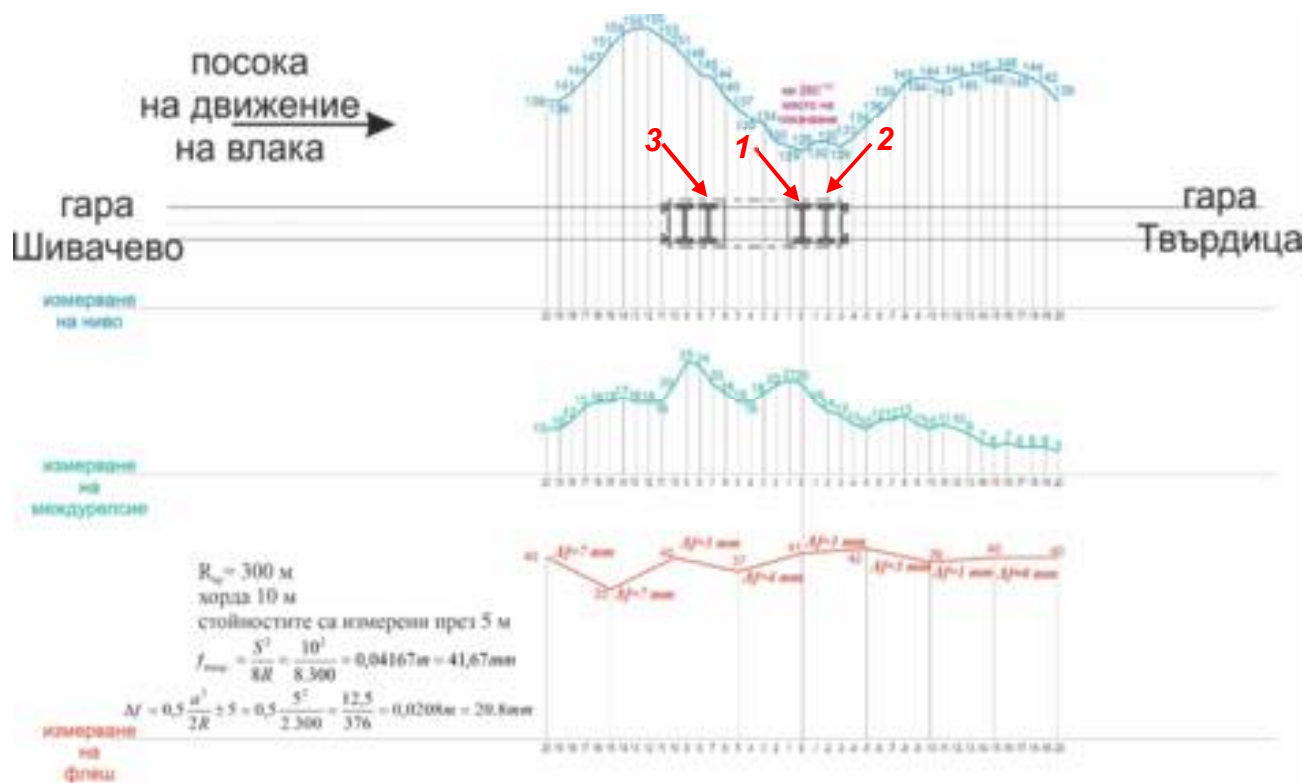
m (Fig. 5.5, pos. 3) have contributed to the rise of the wagon on the rail head at the specified point and its subsequent derailment.

In conclusion, the Investigation Commission considers that the main cause for the derailment of the second wheel-set of wagon № 31525400845-3, 16th in a row in the composition of DFT № 30610 along Shivatchevo – Tvarditsa interstation, is the uneven load of the wagon. This has led to a displacement of its center of mass, as the load was unevenly distributed on the individual wheels (the load on the left in the movement direction was less than the load on the right one). The combination of movement in right curve with a small radius, low speed and deviations in the level of the rail track, has contributed to the rise of the left wheel on the second wheel-set from the first bogie of the wagon on the rail crown of the outer rail and its subsequent

Fig. 5.5. Layout of wagon № 31525400845-3 with respect to the track
derailment.
