REPUBLIC OF BULGARIA
NATIONAL AIR, MARITIME AND RAILWAY ACCIDENTS
INVESTIGATION BOARD

FINAL REPORT

**Investigation of railway accident – fire in a coach of passenger train № 50215 while staying
in Pernik marshalling yard on 04.09.2021**

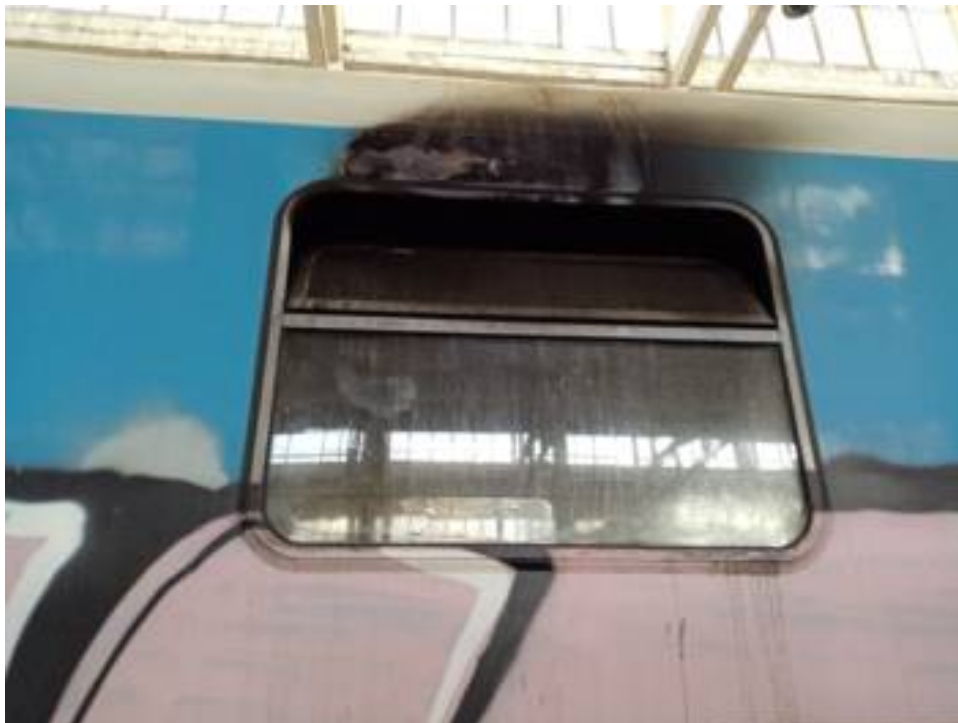
Fig. 1.1. Burnt coach № 51522563019-0 – outside perspective.

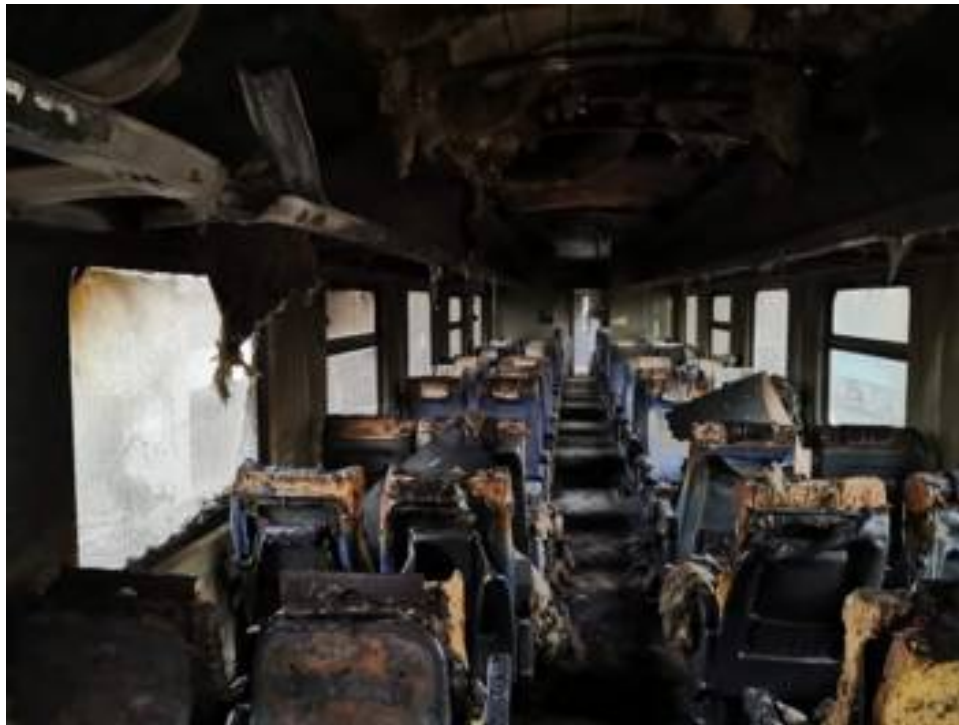
As a result from the fire occurred in PT № 50215 there were no injured passengers and staff, damages were caused to the passenger coach (bigger part of the compartment was burnt) (fig. 1.2).

Fig. 1.2. Fired compartment in coach № 51522563019-0.

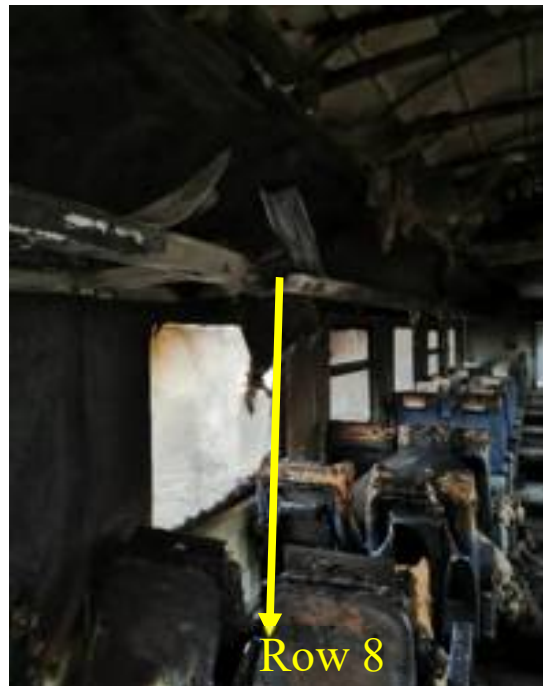
Fig. 1.4.

The determining factor for the accident occurrence is the ignition of part of the electrical equipment of the one-compartment (compartment free) passenger coach No 51522563019-0 in the area of the luggage compartments over the seats from row 8 in ascending direction of the seats number (fig. 1.4).

The most probable direct cause for the occurrence of the accident is forced ignition from an external source in the area of the loudspeaker and the matching transformer of the sound system located in the area for placing passengers' luggage above the seats in the coach.

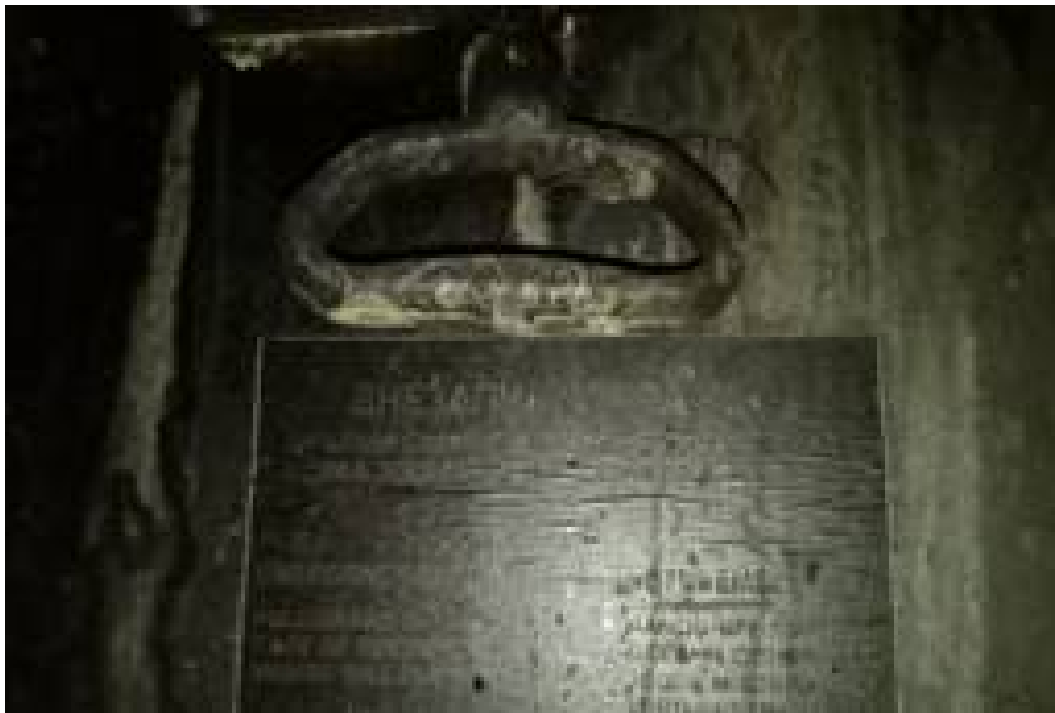
At 23:18 p.m. PT No 50215 was accepted at Pernik station at the 4th main track with a scheduled stop. After a stay of 30 seconds and an authorised indication of the exit semaphore and an order to depart from the traffic manager on-duty, the train departed and stopped after 10-15 metres. The investigation revealed that the emergency brake was activated by a passenger in the fifth coach (Figure 3.10).

**Fig. 3.10. Activated emergency brake in the rear part of the coach
№51522563019-0.**

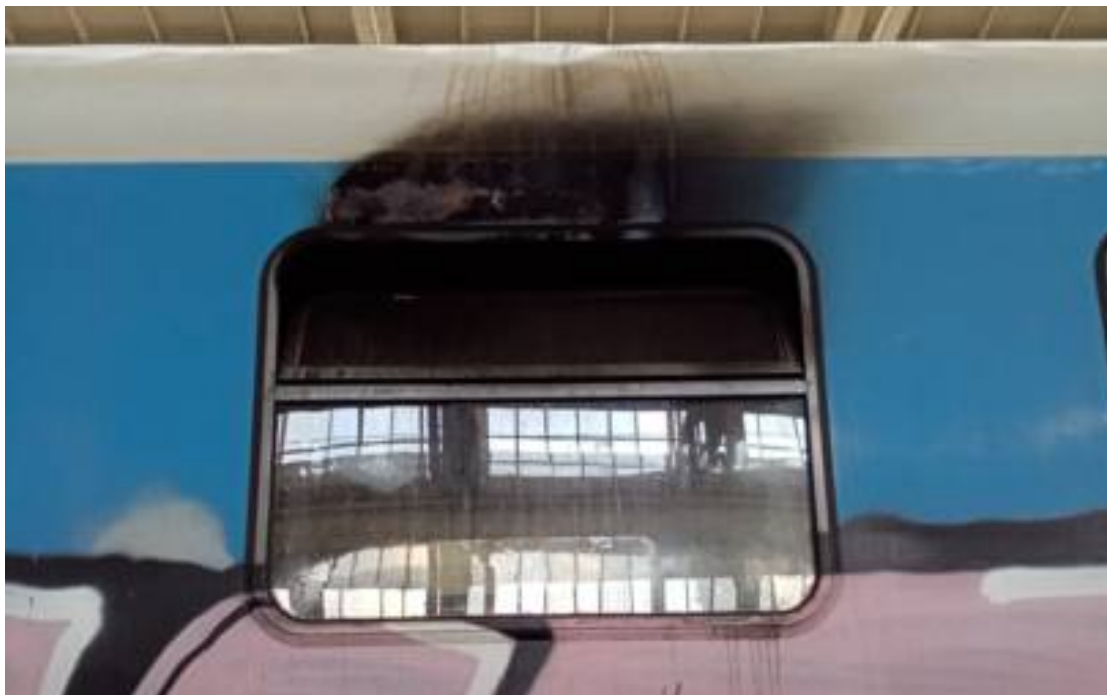
The traffic manager on-duty on the platform saw smoke coming out of the fifth, last coach (Figure 3.11). He went back to the station, picked up a fire extinguisher and headed to the fifth coach. He opened the coach door and there started to come out thick black smoke, he noticed that the coach was burning from the inside and returned. The head of the train and the conductor evacuated the passengers out of the train. The locomotive crew detached the burning coach from the train composition and withdrew the train at a safe distance. The train staff notified the 112 emergency phone on a fire in the passenger train. The voltage in the catenary was switched off at 23:23 p.m. After arriving at 23:40 p.m. of a special vehicle of FSaCP-Pernik, the fire in the coach was extinguished at 00:20 a.m. The voltage at the station was switched on at 00:48 a.m. Test D was carried out on PT No 50215 and it departed at 00:48 a.m. with four coaches to Pernik station, final destination station for the train.

Fig. 3.11. Traces from the ignition of coach № 51522563019-0 from its outer part.

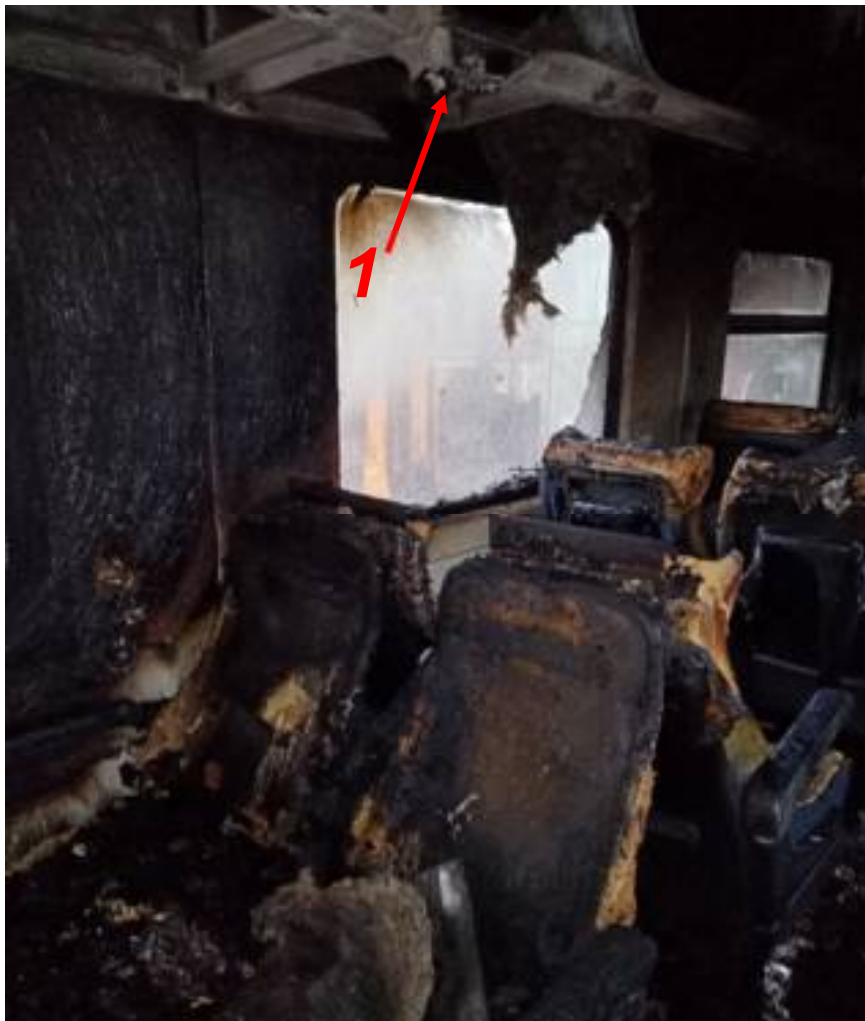
As an initial hypothesis, the possibility of ignition from a flammable liquid was discussed and analysed: alcohol or other similar substance. At first, it seemed reliable enough, but after a more detailed inspection of the ignition site, it was considered unlikely. The reason for this assessment was the presence of an extremely high temperature in the baggage compartment area, concentrated in a limited small area (Figure 4.5, pos. 1). The ignition of the upholstery of the seats in the fire area was obvious, but with such a development of fire it would spread upwards over a much larger area and hardly the temperature of the fire would have reached such values and certainly not in such a small area as to melt and bend the aluminium skeletons of the luggage compartments, burning at the same time all the elements and wires from the electrical equipment of the coach located there.

Fig. 4.5. Location of the most intensive burning in the coach compartment.

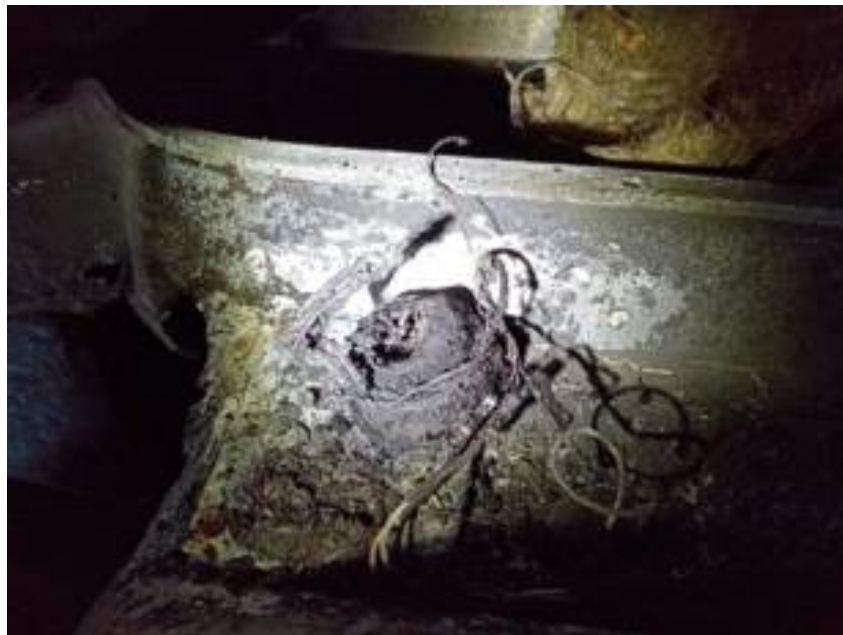
The second hypothesis, examined and analysed in depth by the Investigation Commission, involved failures in the electrical equipment of the coach related to its design and performance. This hypothesis was considered in connection with the extremely high temperature (above 700-800 C) which occurred in the fireplace, resulting in the melting of the aluminium profiles of the baggage compartments, the complete combustion and charring of the insulation of the wires and the structural and colour change of the copper wires themselves (Figure 4.6).

Fig. 4.6. Burnt elements of the electrical equipment of the coach, located in the cavities of the luggage compartment skeleton.

- During the examinations of the burnt elements and wires, no traces of short circuits were found anywhere - the characteristic “melters” and traces of “welding” of the metals due to the presence of large currents that would give rise to high temperatures;

- On the basis of the above considerations, it can be concluded that the **probability** of any failure in the electrical circuits of coach No 51522563019-0 being the cause of the fire in the coach is **minimal**.

The third hypothesis, considered and analysed by the Investigation Commission, allows the fire to be caused by an external source, whether intentionally or inadvertently. In this case, the possibility of starting from an external source (most likely a lighter) imported to the loudspeaker of the sound system shall be considered. It is known that its membrane is made of impregnated paper and the remaining parts, with the coil of the matching transformer also made of combustible materials. All of this, with a very high probability, could be ignited by the imported fire, then further combusted, developing extremely high temperatures, and molten aluminium would immerse on the seat upholstery and trigger their ignition. The fact that the ignition was detected by the traffic manager on-duty at 23:19 p.m., and the authorities of the FSaCP started the extinguishing only after 23:40 p.m. shows that the fire had sufficient time to burn and cause damage to the coach. Ultimately, it can be stated that the hypothesis described is the most likely to cause the fire in coach No 51522563019-0.

- Recommendation 1 proposes that SE NRIC and BDZ PS Ltd. shall acquaint the interested staff with the content of this report.
- Recommendation 2 proposes that BDZ PS Ltd. when renewing or upgrading (capital repair) passenger coaches, shall include in the passenger coaches' specification, technical requirements concerning the equipment and areas associated with fire hazards as the coaches shall be equipped with an early-stage fire detection system (fire alarm system).

- Recommendation 3 proposes BDZ PS Ltd. when renewing or upgrading (capital repair) passenger coaches, shall include in the passenger coaches' specification, technical requirements, by the virtue of which, when a fire is detected, an optical and audible alarm shall be activated in the coach.

- Recommendation 4 proposes BDZ PS Ltd. when renewing or upgrading (capital repair) all series of passenger coaches, shall envisage in the technical specification the installation of video recording cameras at both ends of the coach in order to monitor the actions of the passengers.
