**R E P U B L I C O F B U L G A R I A**  
**NATIONAL AIR, MARITIME AND RAILWAY TRANSPORT**  
**ACCIDENTS INVESTIGATION BOARD (NAMRTAIB)**

**FINAL REPORT**

**investigation of serious railway accident – collision of fast train № 7623 in loaded truck at  
railway level-crossing between the stations Dimovo and Oreshets on 07.06.2022**

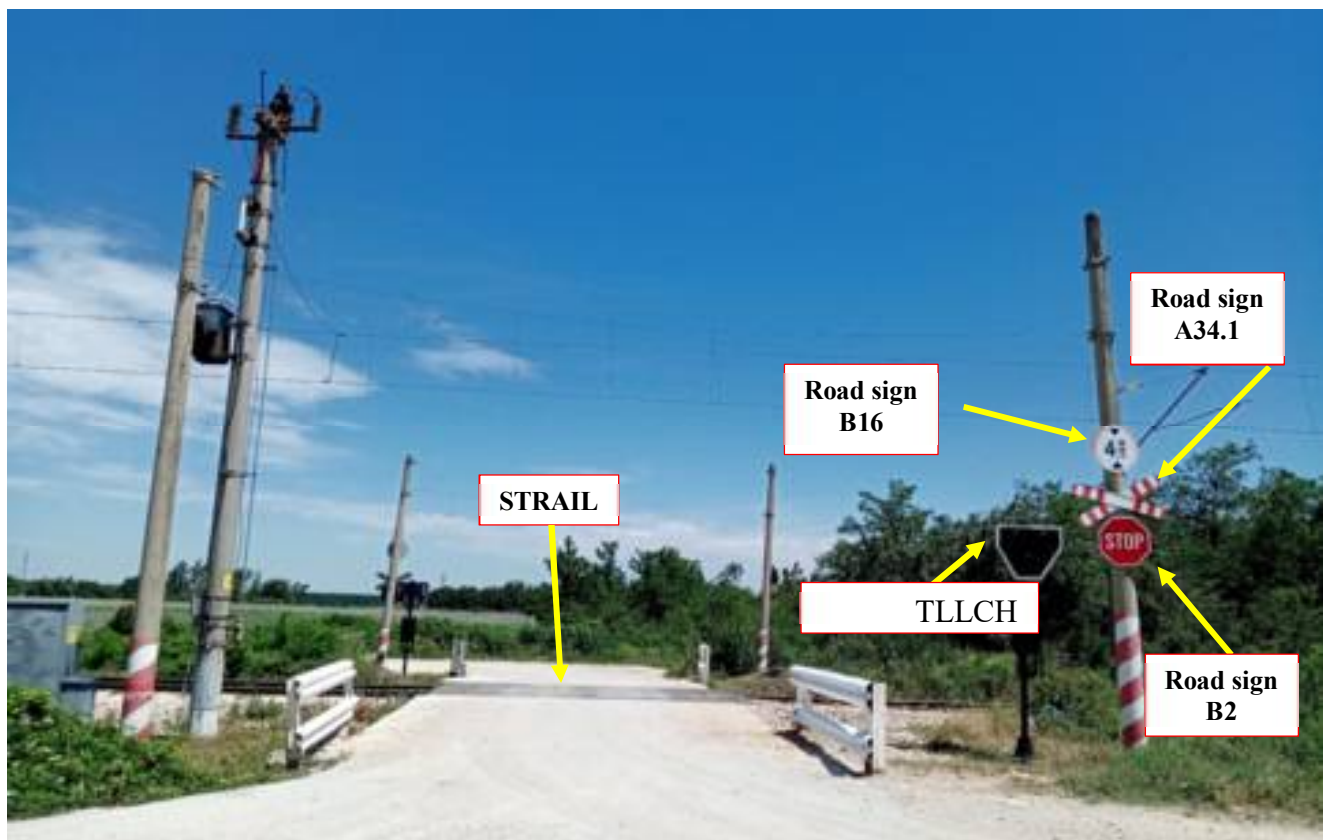
During the movement of the train at the Dimovo - Oreshets interstation, a remote sensor for controlling the ALCD at km 127+123 was activated, which, after being activated, turned on the pre-crossing traffic light, which began to glow with a flashing moon-white light. That indicated to the locomotive driver that the ALCD was activated and operating normally. The train approached the level crossing and with the locomotive whistle gave signal "Attention" (fig. 1.1).

**Fig. 1.1. Railway level crossing with ALCD at km 127+123 between the stations Oreshets and Dimovo.**

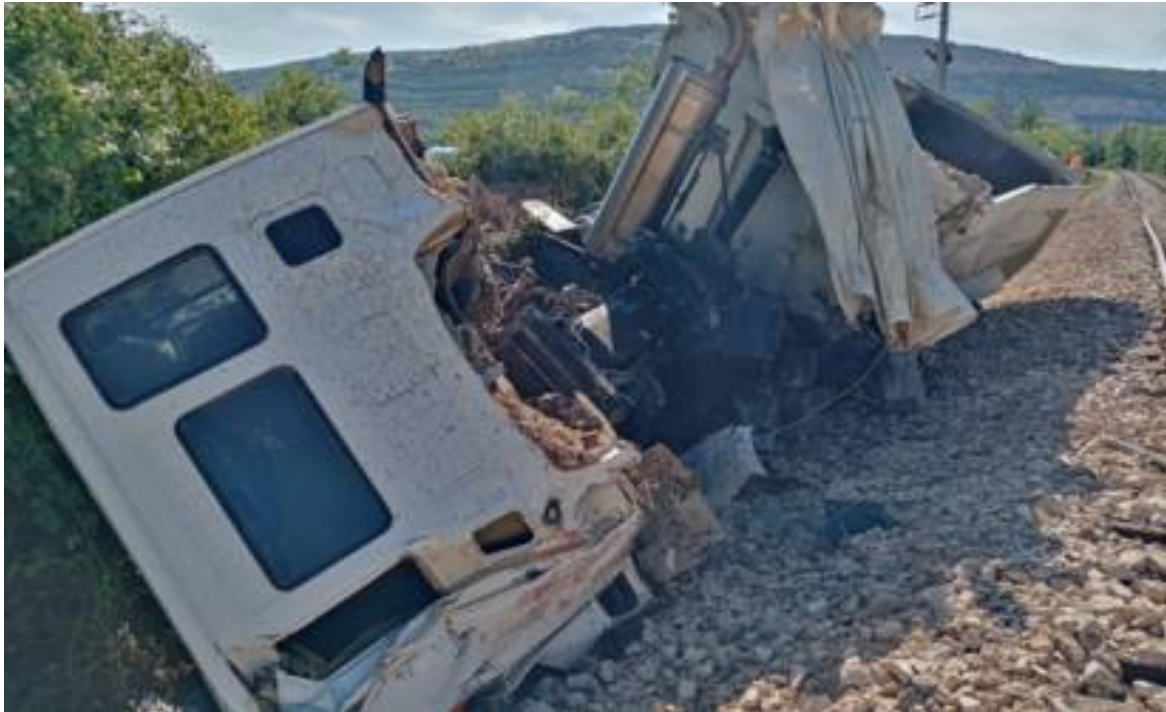
Because of the collision, the driver of the truck died and fell from the cab of the vehicle, and the heavy goods vehicle was thrown from the locomotive to the right in the direction of the movement of the train into the ditch 20 meters after the level crossing with a destroyed cab (fig. 1.2).

**Fig. 1.2. The heavy-goods vehicle after the collision with the locomotive of FT № 7623.**

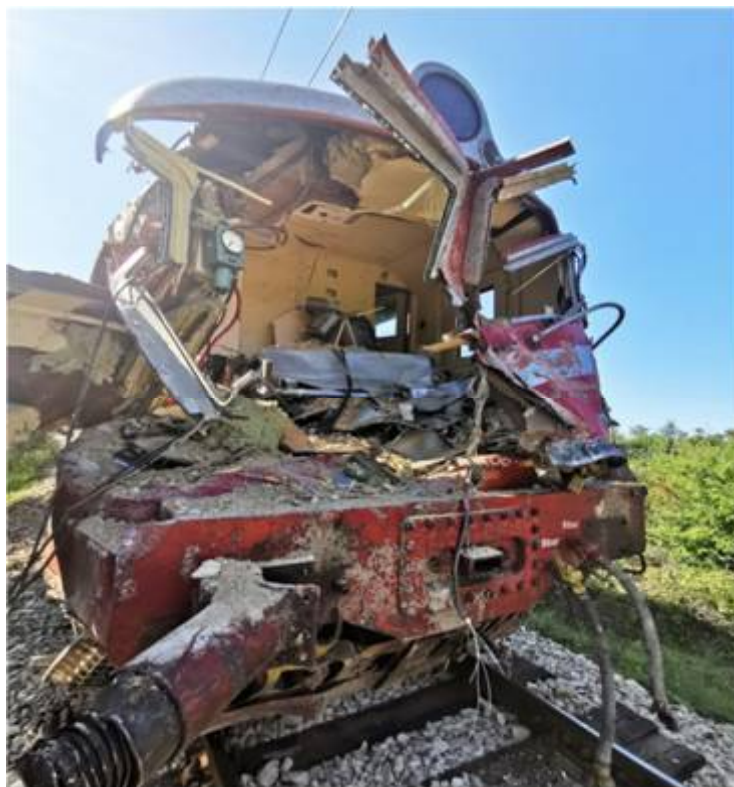
**Fig. 1.3. Locomotive № 91520044158-1 after the collision with the heavy-goods vehicle.**

Because of the subsequent collision, the cabin of the locomotive was severely deformed and the two locomotive drivers died (Fig. 1.3). Three passengers from the train were slightly injured. Two were given medical aid at the Vidin General Hospital and were released; the third passenger was given medical aid on the spot and was also released. The injured passengers were traveling in the first passenger coach next to the locomotive with number 51522563027-3 (fig. 1.4), which derailed with both wheel-sets of the first bogie and one wheel-set on the second bogie (third wheel-set).

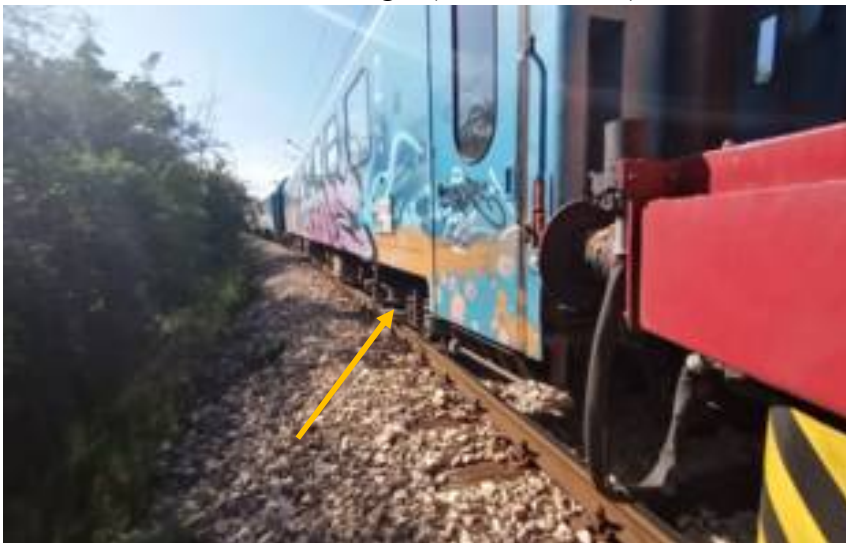
**Fig. 1.4. The derailed first coach from the composition of FT № 7623 with № 51522563027-3**

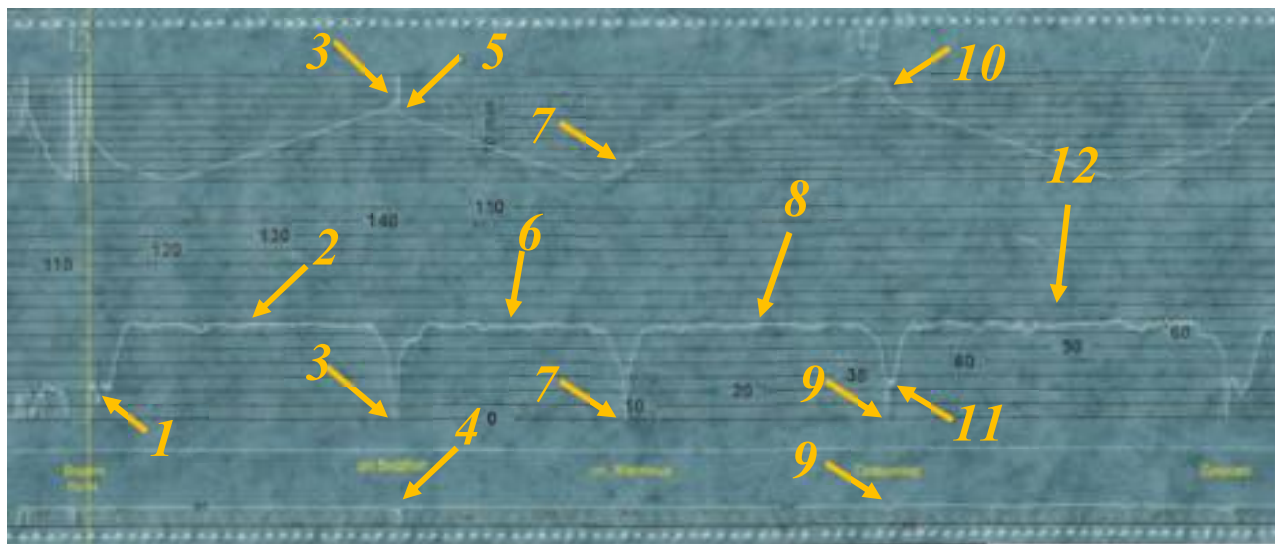
**Fig. 4.5.**

At 12:37 p.m., the train arrived at MY Vidbol station (fig. 4.5, item 3). It was observed that the driver initially performed a partial duty hold, reducing the main air pressure to 3.75 bar, until a speed of 30 km/h was reached, and then increased the main air pressure to 4.0 bar, performing a partial release of the automatic brake, and immediately after that, he performed an emergency stop (fig. 4.5, pos. 4). The train stayed at MY Vidbol for 5.5 minutes and departed at 12:43 p.m. (fig. 4.5, item 5).

At the Zheglita halt, the train arrived at 12:51 p.m., stayed for 1 minute and departed at 12:52 p.m. (fig. 4.5, item 7). Between the Žeglitsa halt and the Sratsimir station, the train again observed the speed of movement, maintaining a speed between 64 and 70 km/h (Fig. 4.5, item 8).

At Sratsimir station, the train stopped, and the locomotive driver made an official hold by reducing the pressure in the main air duct to 4.0 bar (Fig. 4.5, item 9). After a stop of 1 minute at 13:02 p.m. (Fig. 4.5, item 10), the train departed from Sratsimir station, accelerated to a speed of 25 km/h, then travelled about 200 meters at a speed between 23 and 26 km/h ( fig. 4.5, pos. 11) and accelerated again to 66 km/h, passing the interstation from Sratsimir station to Dimovo station at a speed between 60 and 70 km/h, a greater part of which was in braking mode of movement (fig. 4.5, item 12).

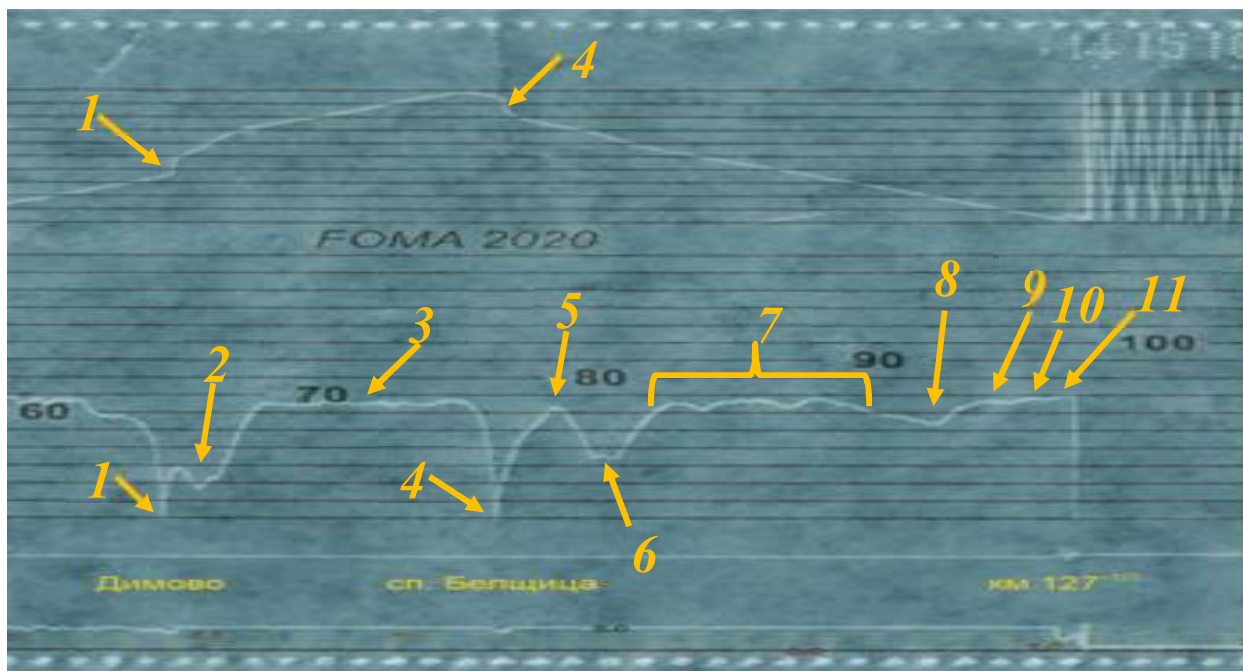
**Fig. 4.6.**

FT No. 7623 arrived at Dimovo station at 13:13 p.m. and after a stay of 1 minute and 20 seconds departed at 13:15 p.m. (fig. 4.6, item 1). It accelerated to 30 km/h, traveling 200 meters, then the speed decreased to 17 km/h without using the automatic train brake, i.e. from the natural resistance to the movement of the train, which can be explained by the fact that immediately after the Dimovo station, an uphill with a value of 15 ‰ began (fig. 4.6, item 2). In that way, the train travelled 300 meters, then accelerated and after another 900 meters, it reached a speed of 65 km/h, and at that speed was travelled along the section to the Belshitsa halt (Fig. 4.6, item 3).

The train arrived at the Belštitsa halt at 13:21 p.m. and after a 1-minute stop, it set off (Fig. 4.6, item 4), accelerating to 65 km/h after 850 meters (Fig. 4.6, item 5). This was followed by a decrease in speed to 34 km/h for 300 meters in about 1 minute with a peak to 36 km/h (Fig. 4.6, pos. 6). Further, the train accelerated to 65 km/h and continued its movement, the speed was varying in the range from 60 to 68 km/h, thereby traveling 3.5 km (Fig. 4.6, item 7). About 2000 meters before the railway level crossing at km 127+123 (the place of the accident), the speed decreased to 54 km/h (Fig. 4.6, item 8), after which it accelerated to 67 km/h for 800 meters (Fig. 4.6, item 9) and then followed a new acceleration in stages: once to 69 (fig. 4.6, item 10) and a second time to 70 km/h (fig. 4.6, item 11).

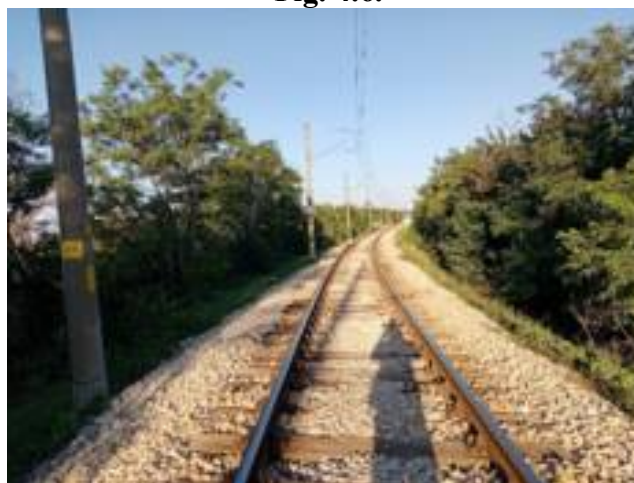
**Fig. 4.7.**

Coming out of the right curve (in the direction of travel), the locomotive driver, whose workplace is to the right of the command cabin, saw the crossing only when he was about 150 meters ahead of it (Fig. 4.7).

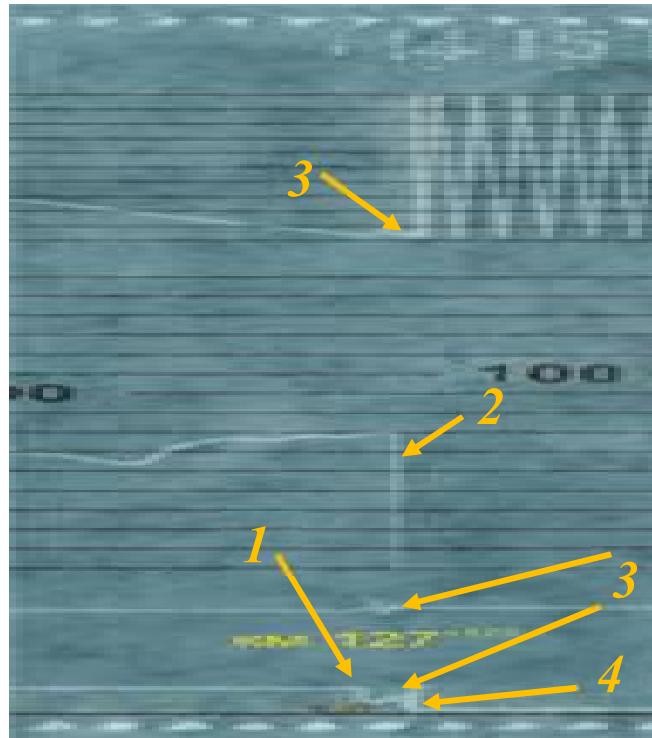
**Fig. 4.8.**

About 150 meters before the collision (i.e. from the time of visibility to the crossing) the locomotive driver applied the automatic train brake, reducing the pressure in the main air duct from 5.0 to 3.85 bar (Fig. 4.8, item). Since it took a certain amount of time to apply the brake (in that case about 10 seconds), at a speed of 70 km/h from the moment the brake was applied to the moment of collision, 9 seconds have passed (the time during which the train travelled the specified distance), i.e. the train brake was in the process of increasing the braking force, but there was no real braking effect at that moment. For that reason, no speed reduction was reflected on the speedometer bar. The speed recorder drew a vertical line and from 70 km/h dropped directly to 0 km/h (Fig. 4.8, pos. 2).

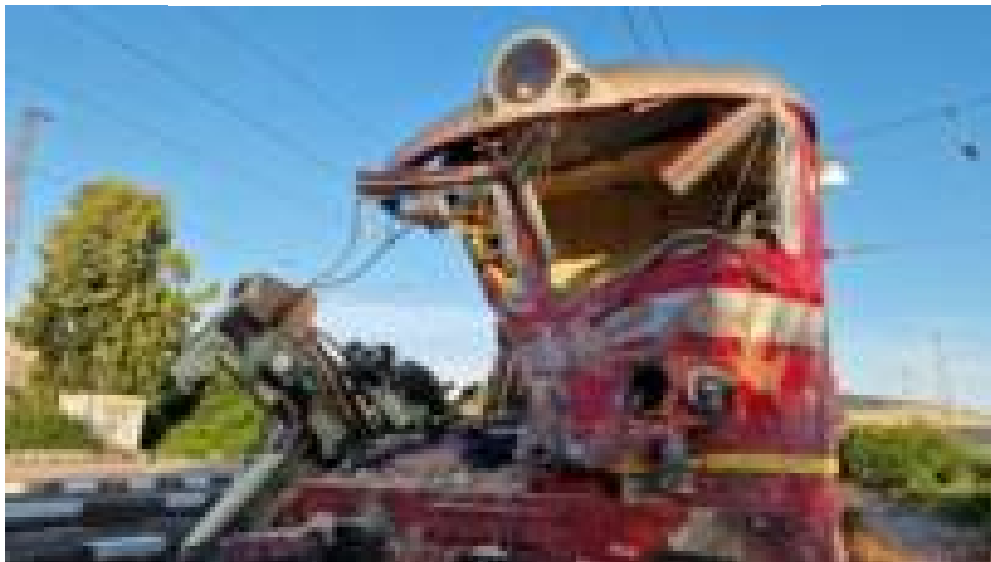
**Fig. 4.9.**

That was explained by the fact that at the time of the collision of the locomotive with the passing truck, the collision hit the right part of the cabin (Fig. 4.9) where the speedometer was located, causing the speed measurement power cable to break, which caused the speed recording circuit to break and the recorder instantly dropped to its zero position (Figs. 4.10 and 4.11)

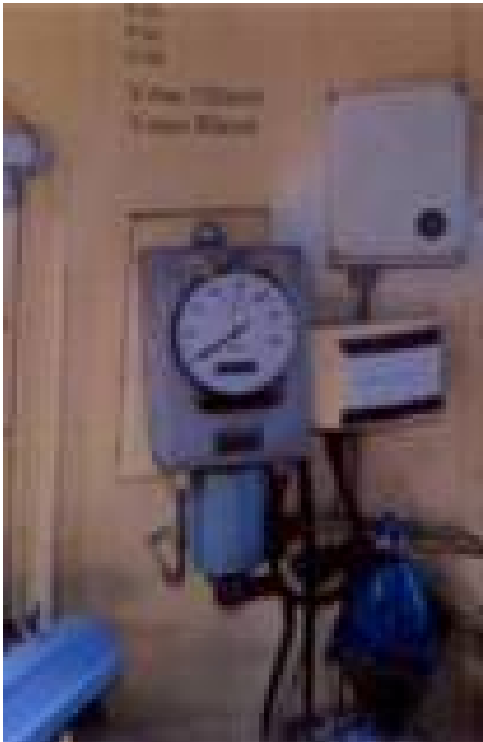
**Fig. 4.12.**

speedometer RT 9, located in the first command cabin, which was rearward in the direction of movement of the locomotive (Fig. 4.12) unaffected.

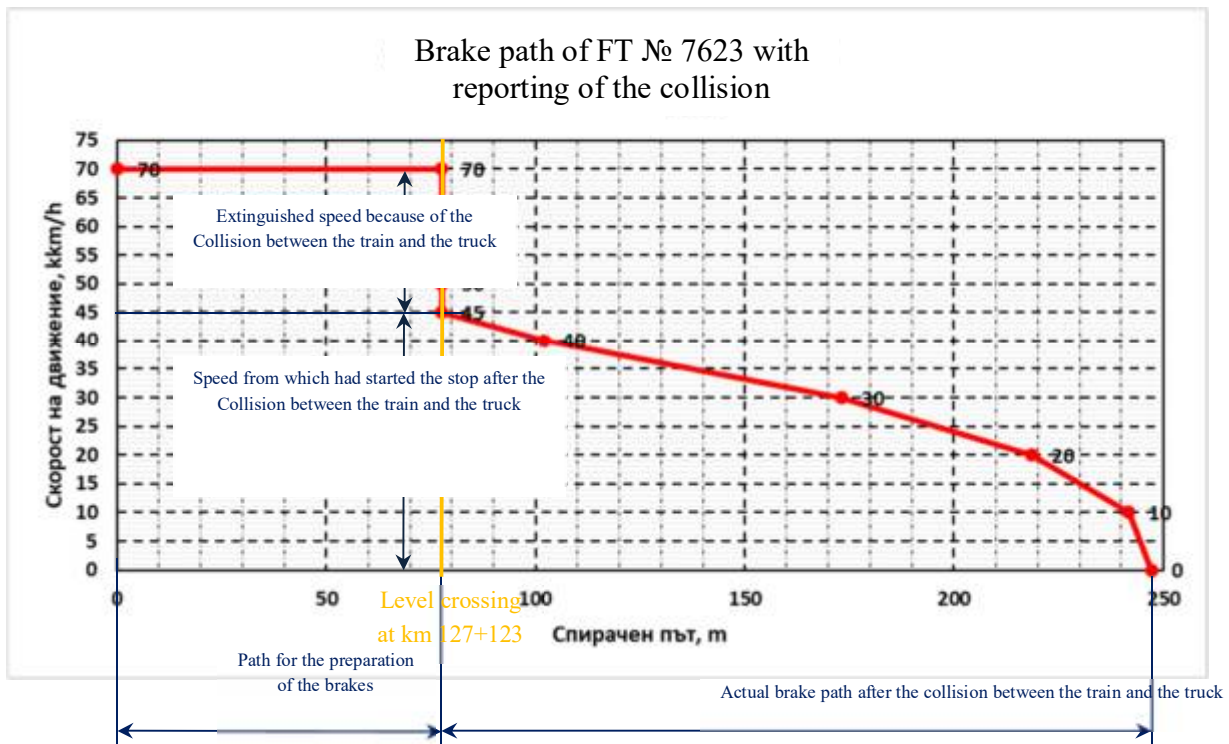
Fig. 4.15.

After a detailed and thorough analysis of the movement of the train in the last meters of its movement, it was found that the braking distance of the train should have continued as described in fig. 4.14 curve and that it stopped 608 meters after the moment of arrest with the automatic train brake, at km 126+587. In fact, the train's braking distance was shortened by the collision with the truck, which resulted in a significant dissipation of the train's kinetic energy, followed by a sharp deceleration, and it stopped at km 126+953 (where the front buffers of the locomotive were after the suspension), i.e. 366 meters shorter braking distance was realized.

Fig. 4.15 shows the graph of the change in the braking distance of FT No. 7623, taking into account the collision with the freight vehicle and the actual change in the speed of the train
