FINAL REPORT

**investigation of railway accident – derailment of wagons from DFT № 30592 between the stations
Yana and Kremikovtsi on 26.07.2022**

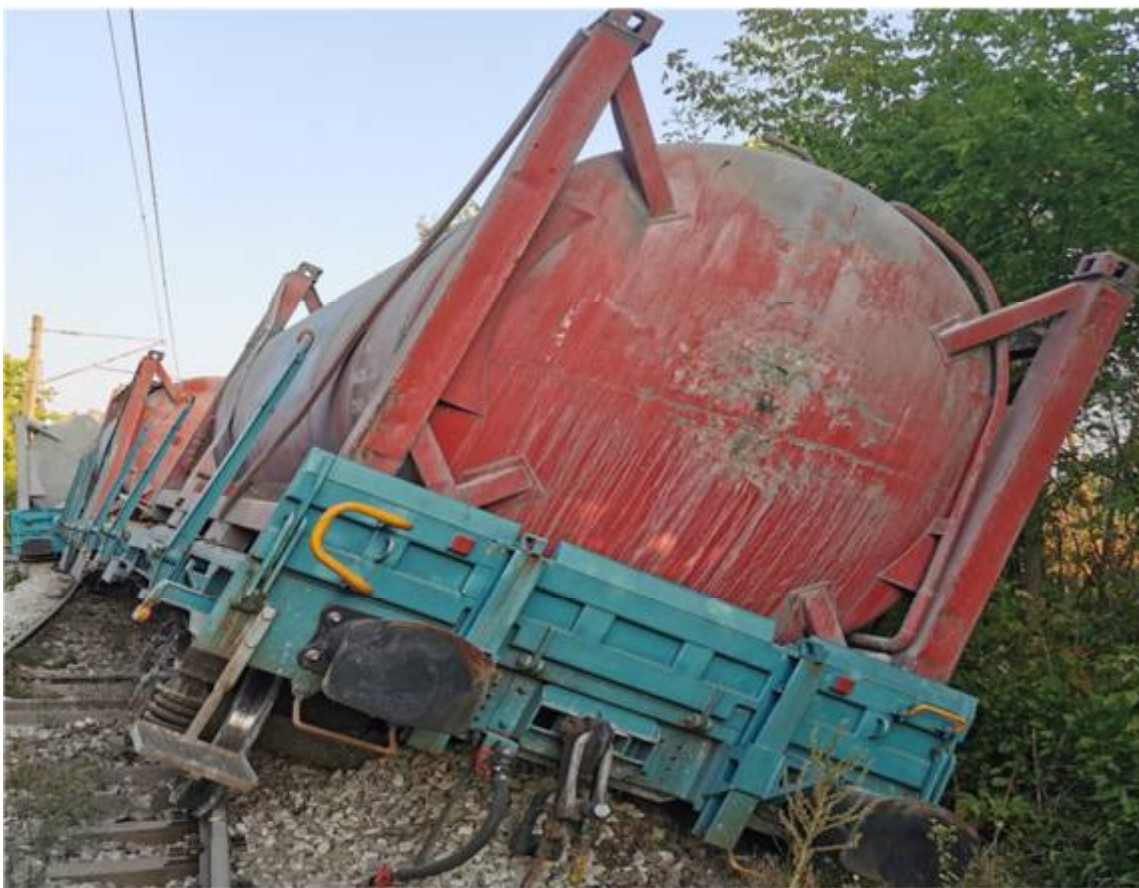
Fig. 1.1. Five wagons derailed of DFT № 30592.

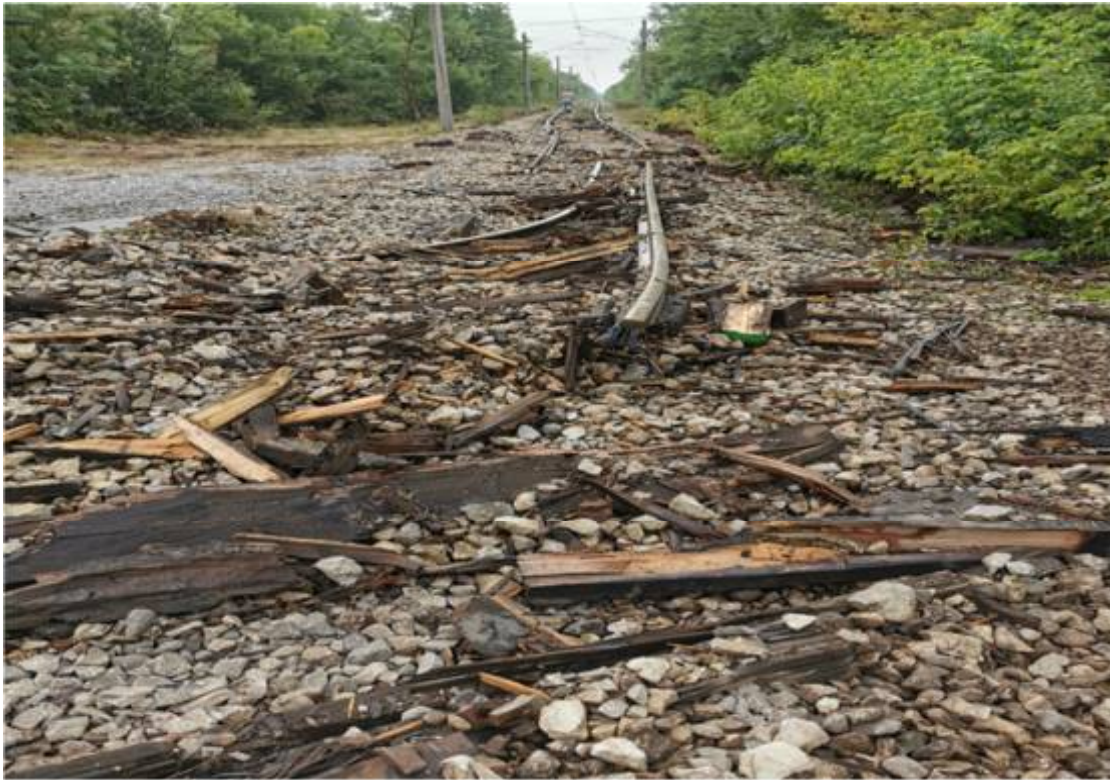
The wagons of the train are flat, loaded with container/tanks full of cement. Because of the derailment, about 100 m of the rail track were destroyed (fig. 1.2), the derailed wagons were also damaged (fig. 1.3).

Fig. 1.2. Damages caused to the rail track because of the derailed train.

- Recommendation 4, suggests that SE NRIC plan and carry out repairs of the rail track in the interstation Kremikovtsi - Yana, guaranteeing the traffic safety.

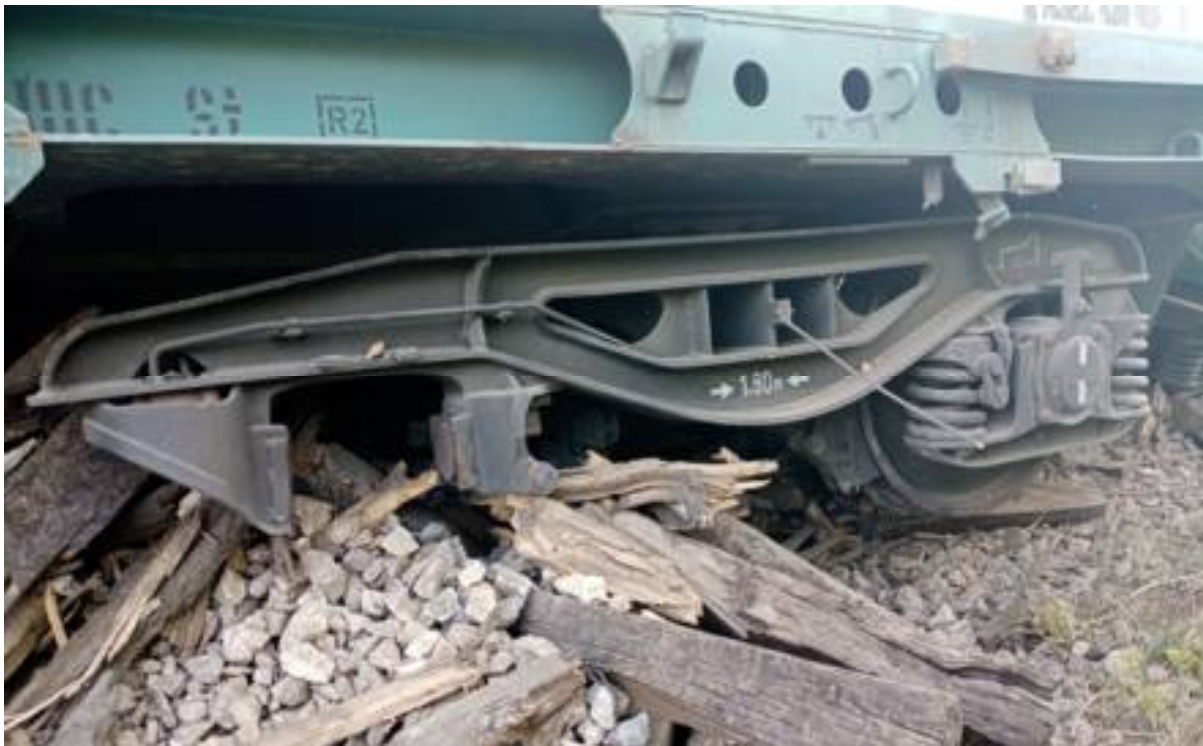
Fig. 1.3. Damages caused to the wagons as a result from the derailment.

2. On 31.08.2022, the Investigation Commission inspected two of the most severely damaged wagons from the derailment at "RVP Sofia" Ltd. and found cracks and broken welds on bearing elements of the frame of wagons Nos. 31753816645-3 and 31754540057 -2, respectively the 17th and 16th of the train composition.

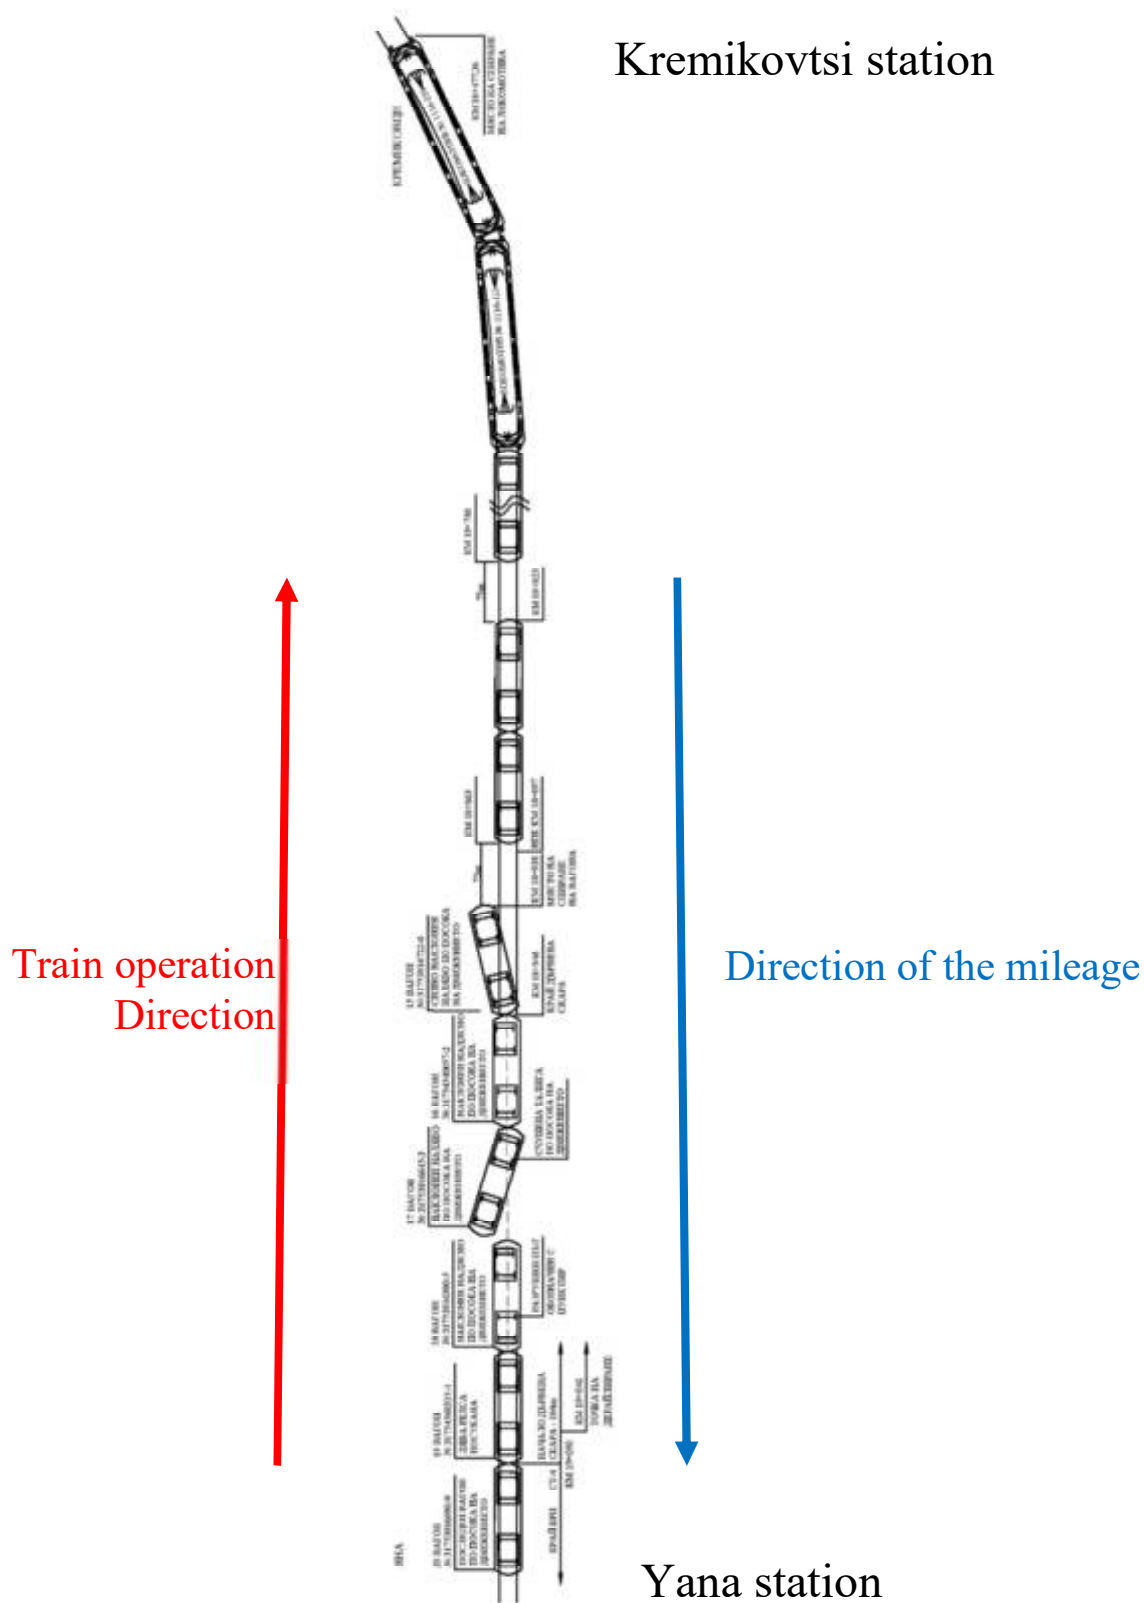
Fig. 1.4. Scheme of the derailment of DFT № 30592 in Yana-Kremikovtsi interstation at km км 19+041, drawn by SE NRIC.

The event occurred on a straight-line section between Yana and Kremikovtsi stations at km 19+041 at 17:01 p.m. on 26.07.2022 (Fig. 1.4).

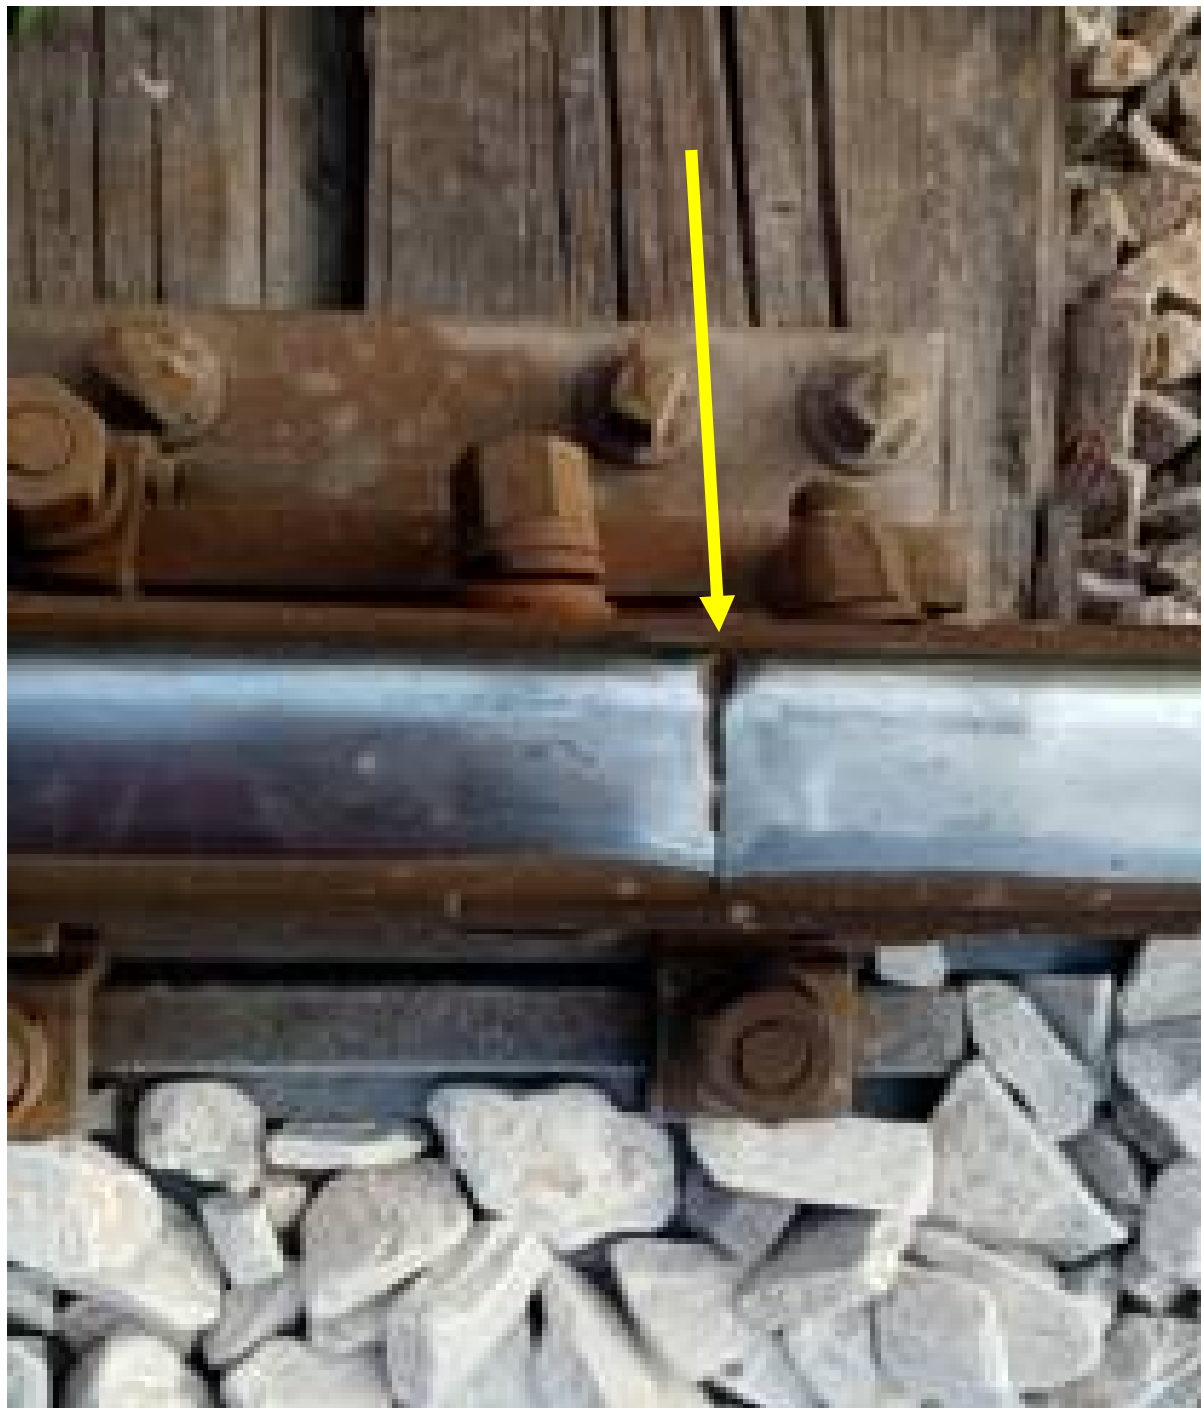
In the derailment area, it was found that the thermal gaps of the jointed track on a wooden gird were closed (Fig. 3.8)

Fig. 3.8. Condition of the joints: the heat gaps are “closed”

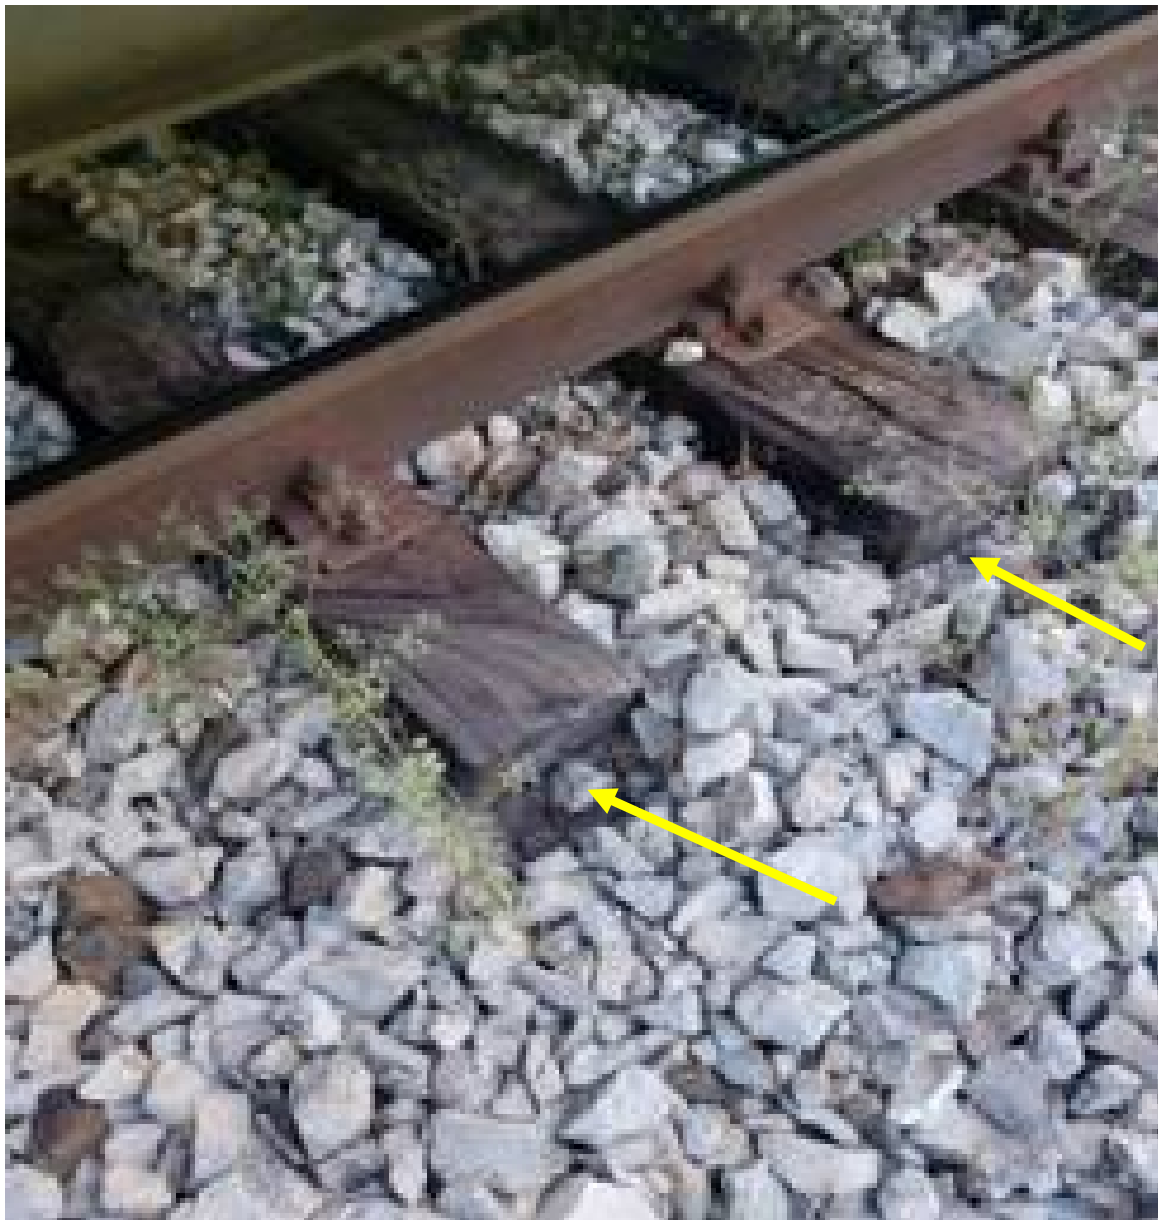
Fig. 3.8a. A displacement in the transition from continuously welded track to jointed track on wooden sleepers is evident in the non-destroyed part of the jointed track on wooden sleepers.

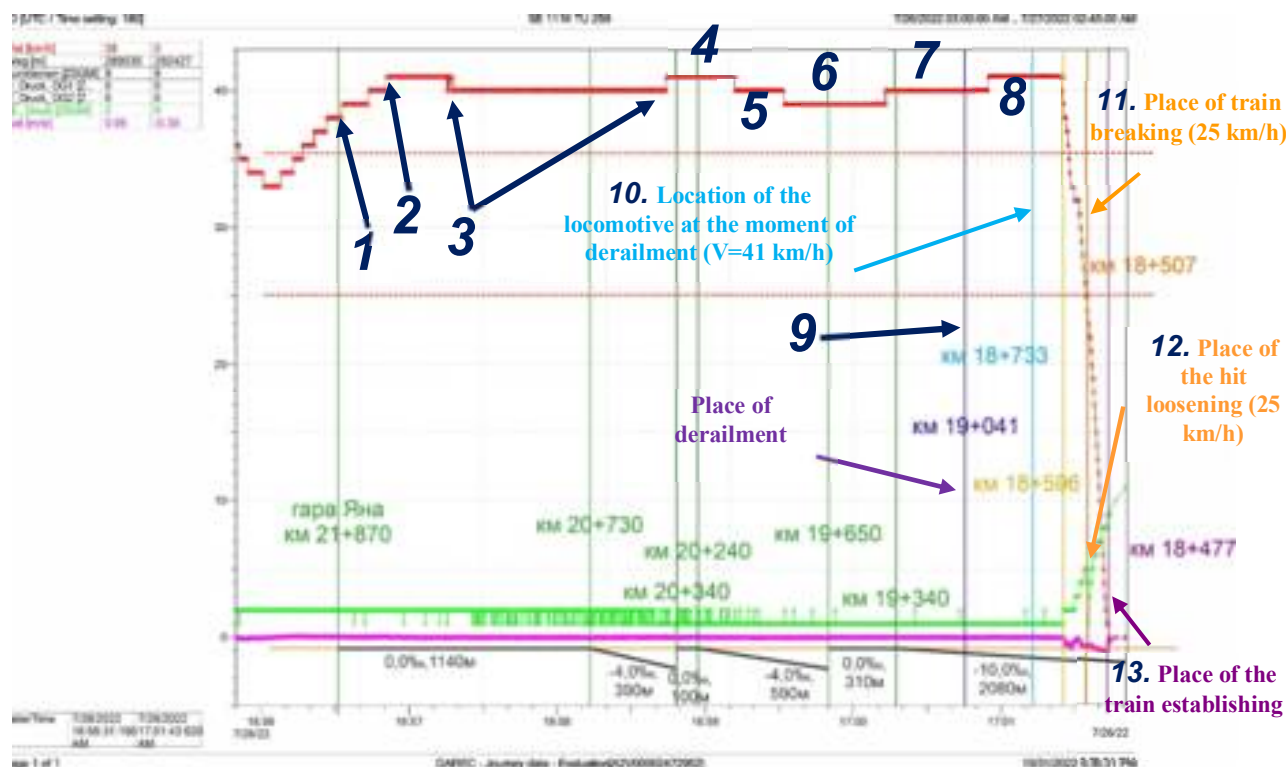
and directed along the Yana - Kremikovtsi interstation (Fig. 4.5, pos. 1), and then the speed increased to 41 km/h (Fig. 4.5, pos. 2) and thus it moved until 16:57:16 p.m. when the speed decreased to 40 km/h and for 1 minute and 27 seconds and travelled 970 meters until 16:58:43 p.m. (Fig. 4.5, pos. 3). At that point the speed increased to 41 km/h, travelling 322 meters from 16:58:44 p.m. to 16:59:12 p.m. for 28 seconds (Fig. 4.5, pos. 4). That was followed by a reduction in speed to 40 km/h from 16:59:12 p.m. to 16:59:31 p.m. for 19 seconds, covering 215 meters (Fig. 4.5, pos. 5), and then a further reduction to 39 km/h from 16:59:32 p.m. to 17:00:13 p.m. for 41 seconds, the train travelled 443 meters (Fig. 4.5, pos. 6). That was followed by an increase in speed to 40 km/h from 17:00:13 p.m. to 17:00:55 p.m. for 42 seconds, covering 477 meters (Fig. 4.5, pos. 7) and a further increase to 41 km/h from 17:00:55 p.m. to 17:01:25 p.m. for 29 seconds, the train travelled 337 meters (Fig. 4.5, pos. 8).

The leading locomotive was located at km 19+041 at 17:00:45 p.m., and the movement speed was 40 km/h (Fig. 5, pos. 9). The 2 locomotives and 14 wagons passed through the place without any problems. After travelling 108 meters, the speed increased to 41 km/h (Fig. 5, pos. 8). When the leading locomotive was located at km 18+733 (fig. 5, pos. 10), the 15th wagon of the train derailed and after it another 4 wagons derailed successively. In that condition, the train travelled another 137 meters. When the leading locomotive was located at km 18+596 at 17:01:25 p.m., i.e. 445 meters and 20 seconds after the derailment, the speed began to decrease, due to a reduction in pressure in the main air conduct, as the engine driver performed several stages of service holding with the automatic train brake. An impact loosening followed and immediately after it a rapid arrest, which was a consequence of the splitting (breaking) of the train between the 14th and 15th wagons (fig. 5, pos. 11). The train split at one more place – between the 12th and 13th wagons. The break between the 14th and 15th wagons was caused by contact of the running gear of the 15th wagon with the ballast prism. The train was also broken in a third place - between the 17th and 18th wagons due to the tilting of the 17th wagon in relation to its longitudinal

Fig. 4.5. Final meters from the movement of DFT № 30592 with the indicated longitudinal inclinations of the rail track.

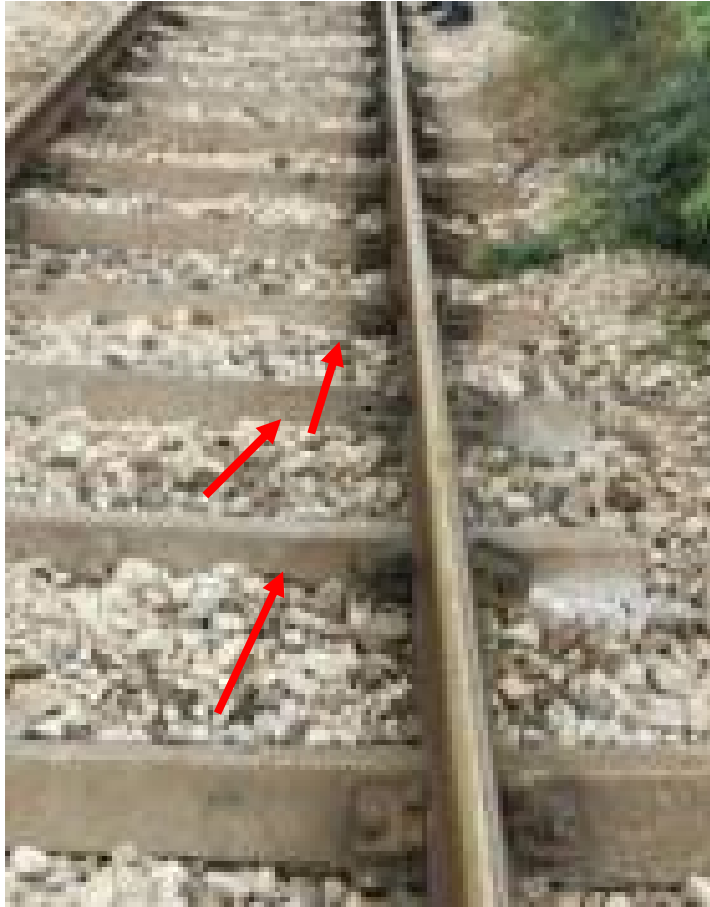
- Great number and a couple consecutive half-inverted sleepers ST-4 (fig. 4.9).

Fig. 4.9. Half-inverted reinforced concrete sleepers ST-4 before the derailment area

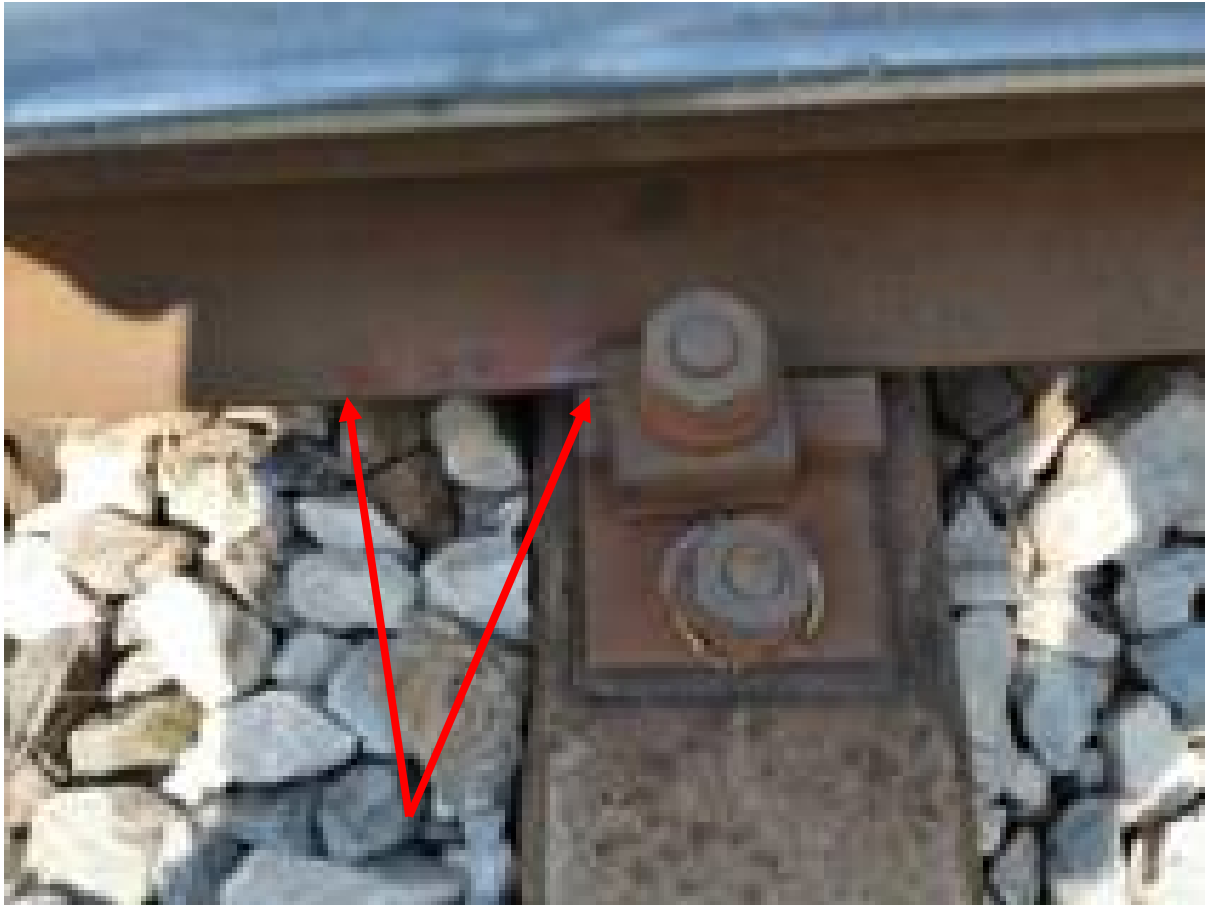
The rails of the continuously welded track on the concrete sleeper gird slide in longitudinal position up to 130 mm in the train movement direction (to the jointed rail track on a wooden gird) (fig. 4.10).

Untightened fastenings (rails with sleepers) were found, which at high temperatures and the direct exposure of the rails from the sun, caused a longitudinal slip of the rails up to 130 mm in the direction of the border of the continuously welded track with the jointed track (Fig. 4.10)

Fig. 4.10. Longitudinal displacement of the rails.

- Recommendation 3, suggests that the SE NRIC restore the whitewashing of the continuously welded rail track during the summer season in order to limit the increase in temperatures in the rails due to the solar heating.

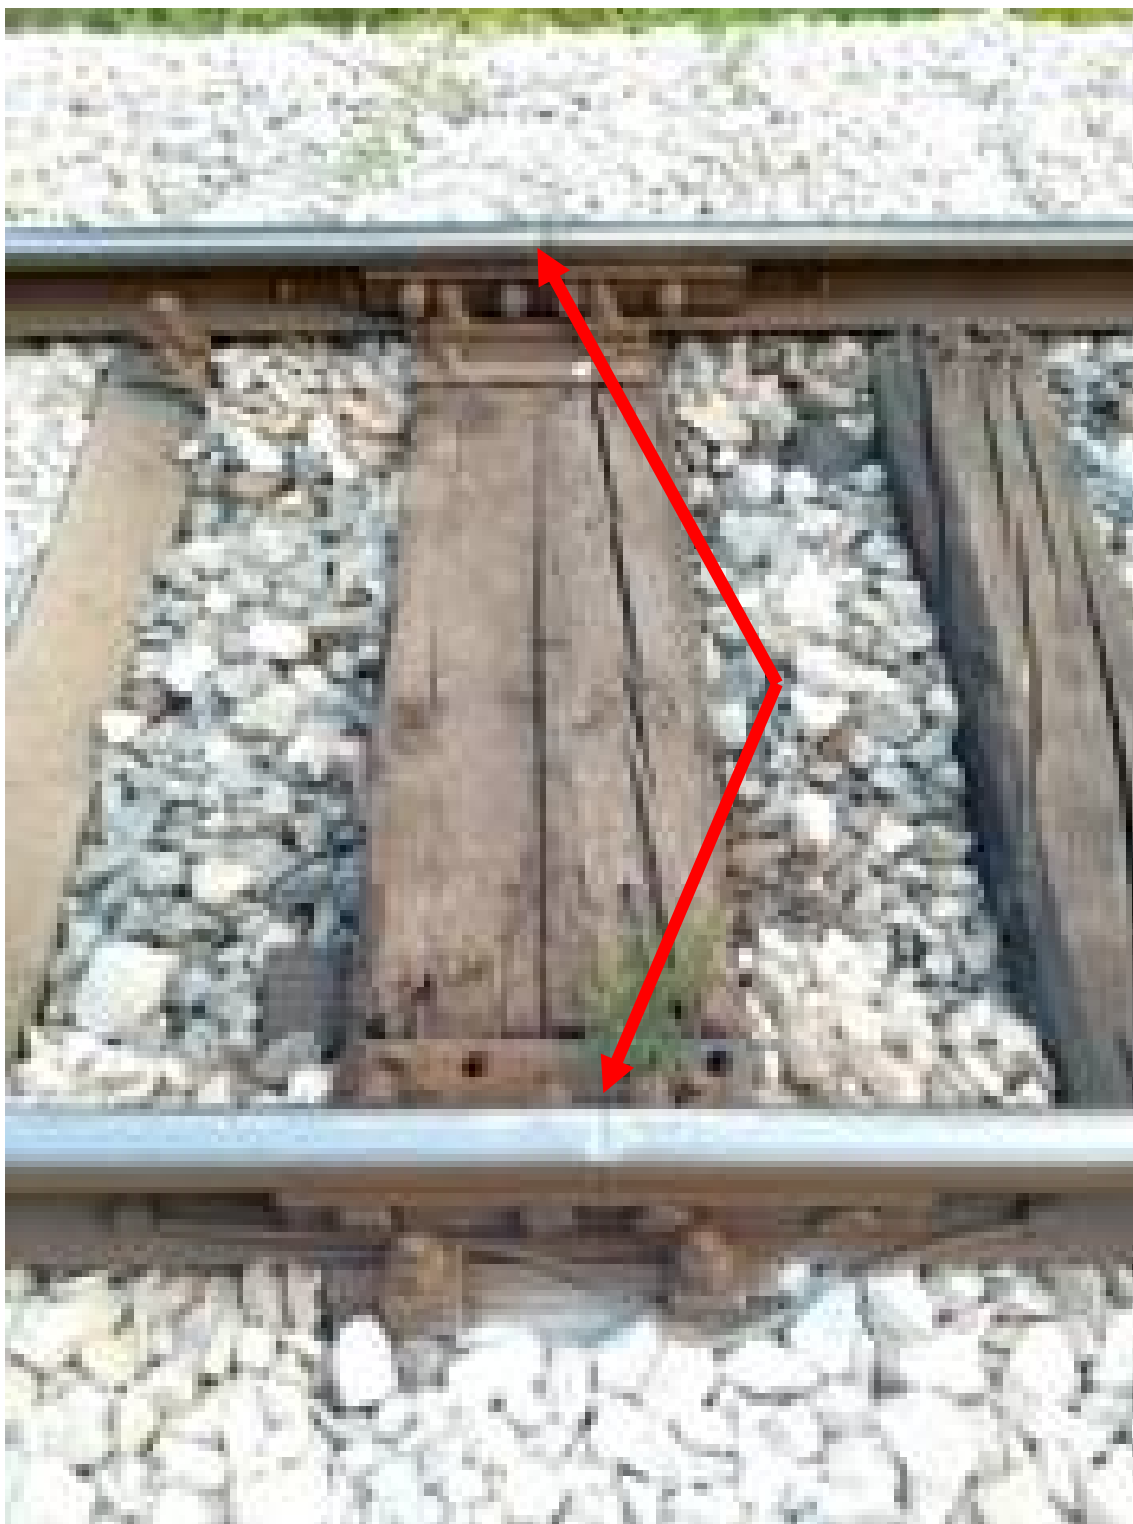
Around 19:00 p.m., the thermal gaps in the jointed track were apparently completely closed (Fig. 4.11). At 9.30 a.m. from the border between the continuously welded track and the jointed track at km 19+050, i.e. at km 19+041 at the point of derailment, there is a sweep of the rail track up to 150 mm, to the left in the train movement direction, starting immediately after the beginning of the jointed track. In the next 94.70 m, the wooden sleepers and rails were completely destroyed.

Fig. 4.11. The thermal gaps are „closed“.
