REPUBLIC OF BULGARIA
NATIONAL AIR, MARITIME AND RAILWAY TRANSPORT
ACCIDENTS INVESTIGATION BOARD (NAMRTAIB)

FINAL REPORT

**Investigation of railway accident – fire in locomotive № 91520044169-8, servicing fast train
№ 2610 in Mezdra South station on 06.01.2023**

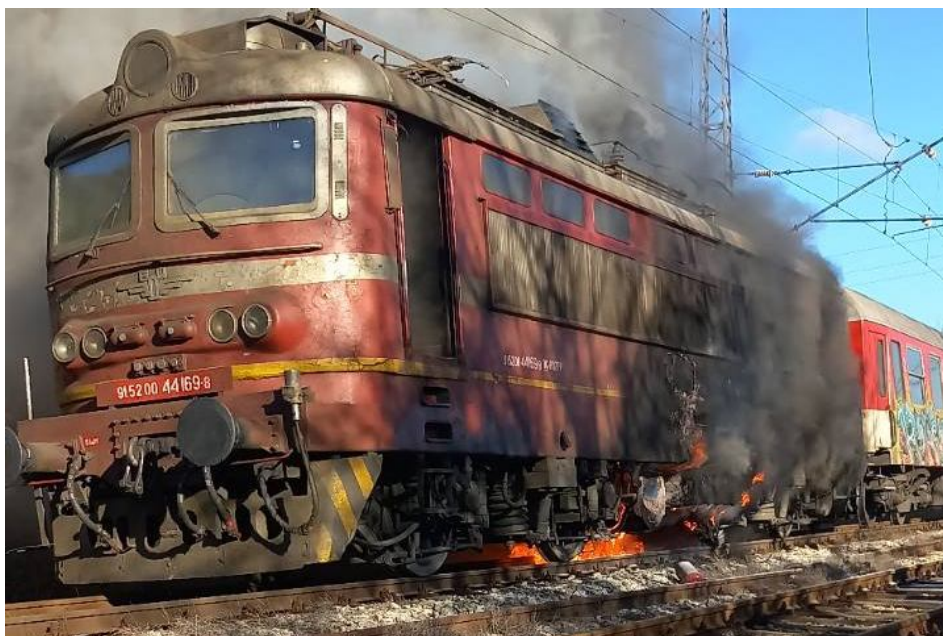
Fig. 1.1. Locomotive № 91520044169-8 of FT № 2610 in Mezdra South station.

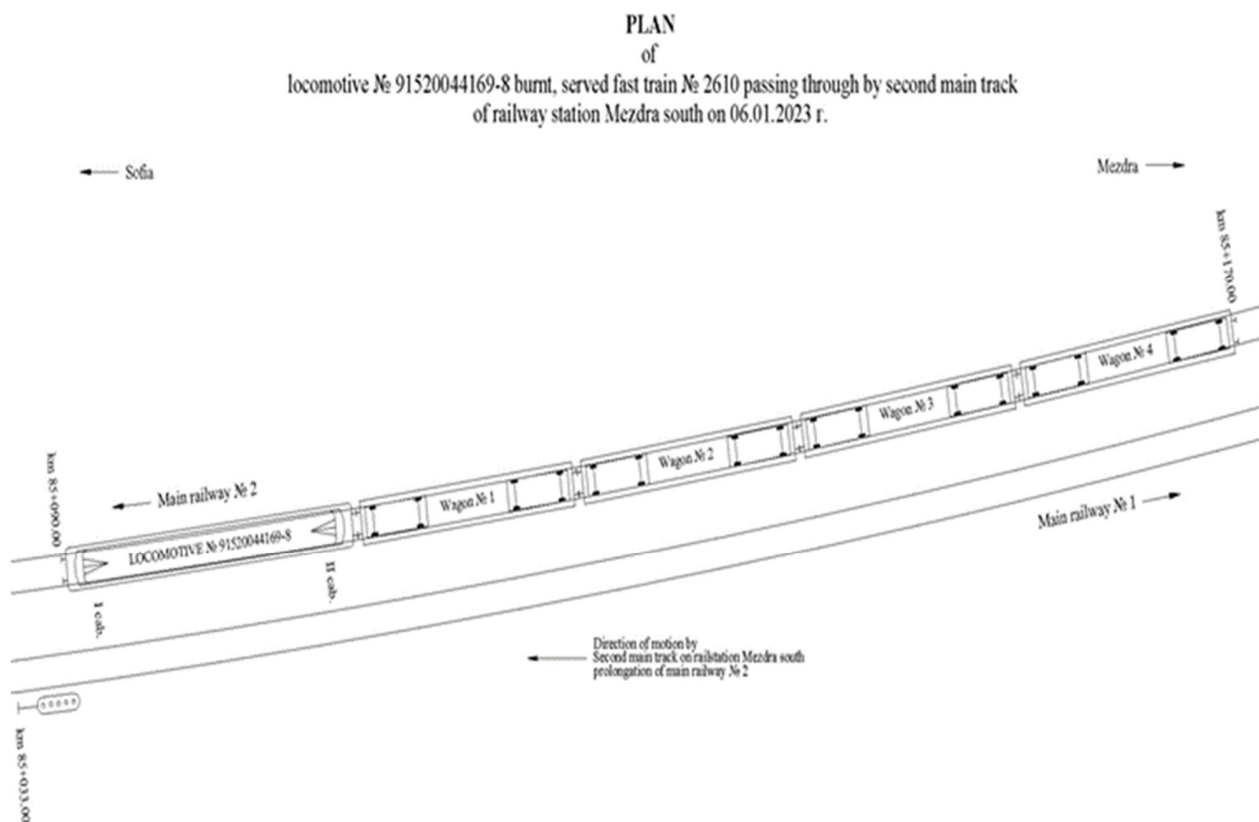
Fig. 1.4. Scheme of the spot of fire occurrence in locomotive № 91520044169-8.

The accident occurred as a result of breaking the integrity of the flexible rubber joint of the first cooling circuit, which led to the leakage of transformer oil. The high-temperature leaked oil exceeds the flash point, causing it ignition. When the FEI was activated by the driver, it did not work. That allowed the fire to spread and caused great material damages. Due to heavy smoke in the engine compartment, extinguishing with manual fire extinguishers was not possible.

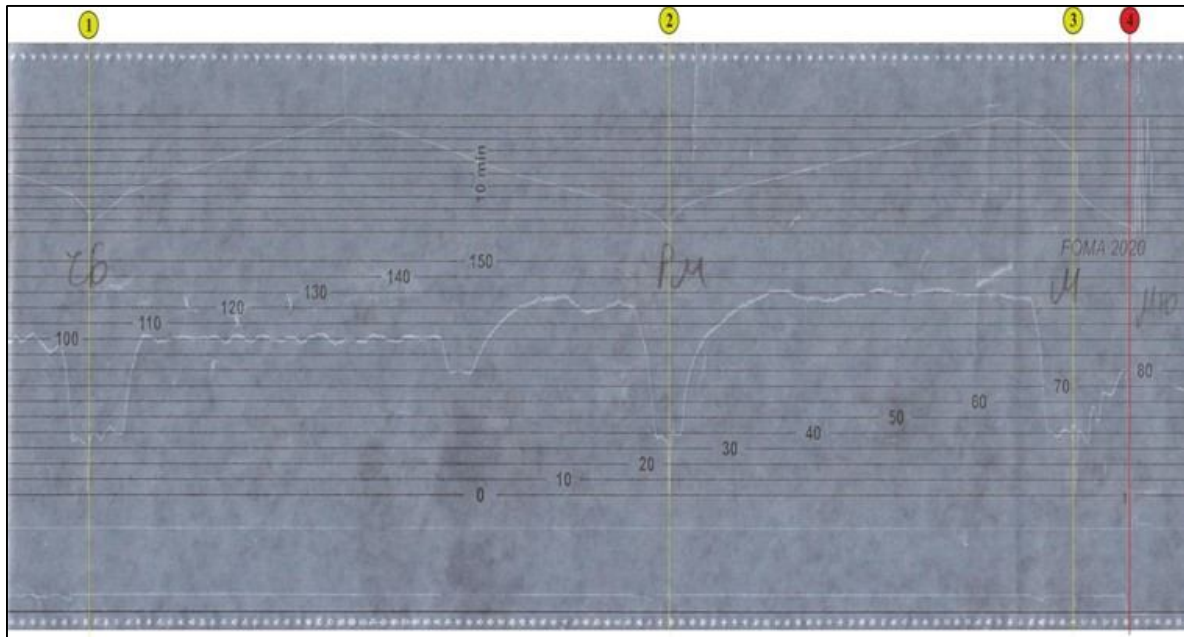
Fig. 4.3. Speedometer tape of locomotive № 91520044169-8.

The start of stopping is at the point marked ④* at a driving speed of about 80 km/h, and reaching zero speed is at the point marked ④. According to the additionally added distance scale in red colour, the stopping distance of the train is 250 meters.

From the above graphs, no over speeding by the locomotive is found, therefore it is not relevant to the accident that occurred.

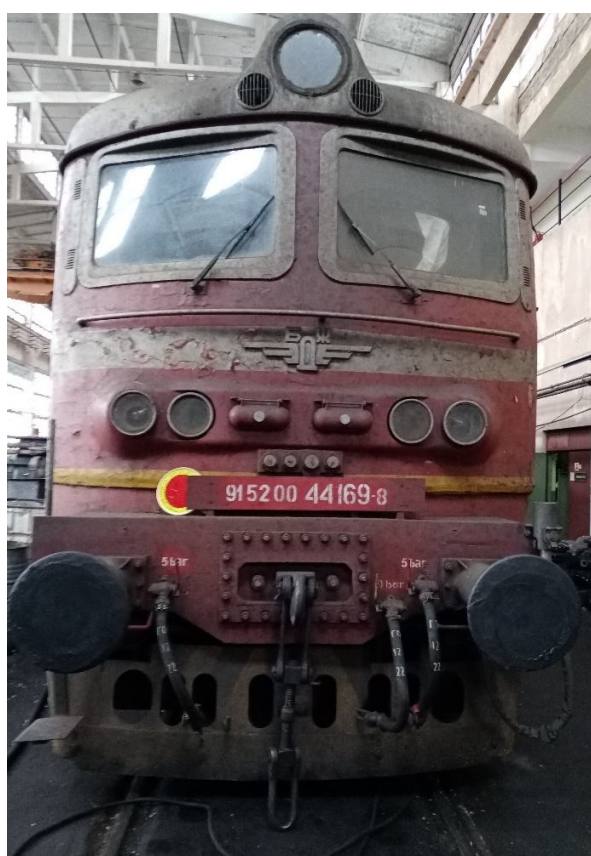
Fig. 4.8.

The Commission performed several inspections of locomotive № 91520044169-8, located in Gorna Oryahovitsa locomotive depot (fig. 4.8).

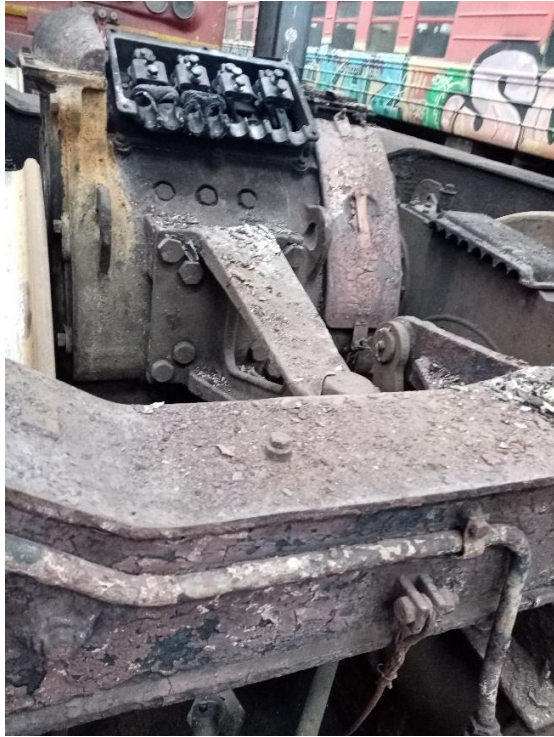
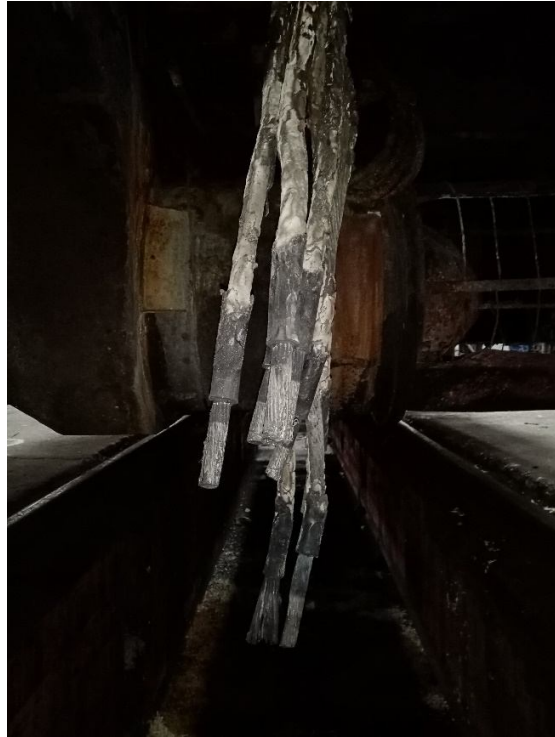
Fig. 4.12.

- Burnt voltage cables of the 3-rd traction engine (fig. 4.12);
- Burnt traction current rectifier 022 (fig. 4.13 and 4.14);
- Burnt high temperature hose of the engine-pump and 2-nd circle for cooling the oil transformer;

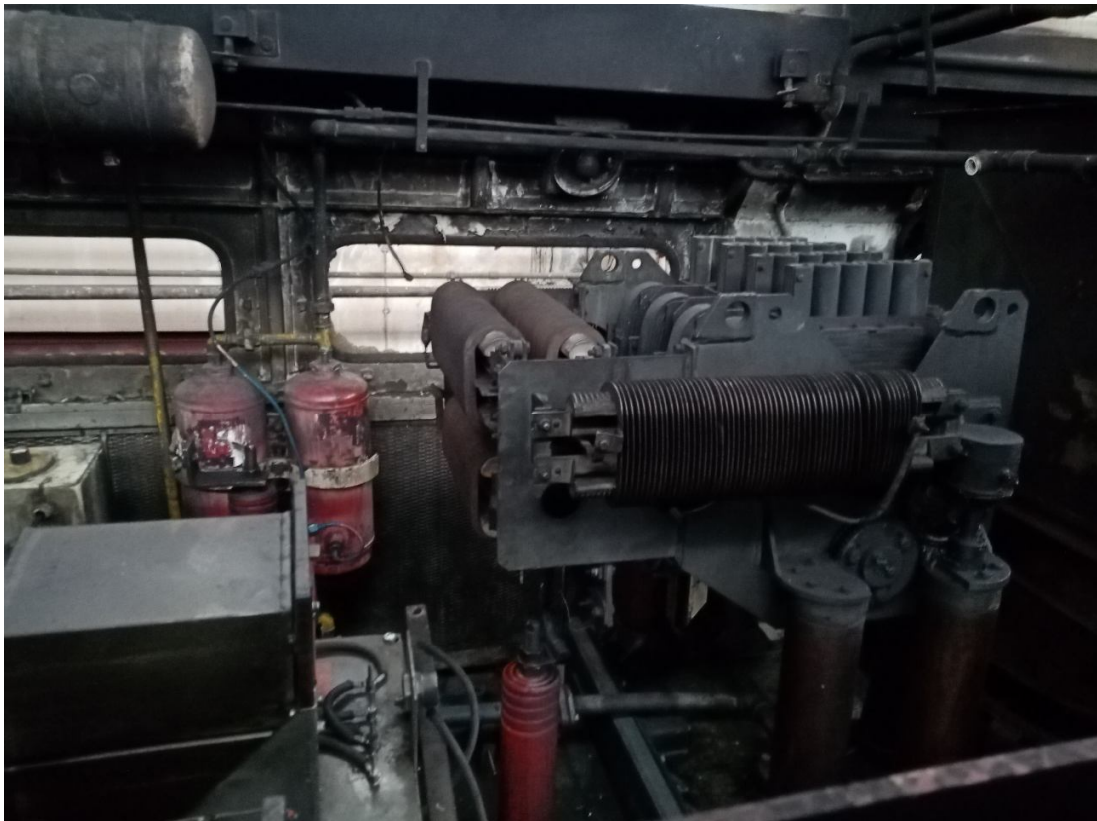
Fig. 4.16.

After carrying out the inspections on the outside of the locomotive, as well as the dismantled assemblies, the Commission proceeded to inspections in the engine compartment. First of all, it was established that the fire-extinguishing installation of the locomotive was activated by the locomotive crew (Fig. 4.15, item 1 and item 2), but it did not actually work, because no traces of fire-extinguishing powder were found in the engine compartment, with which it was loaded (Fig. 4.16).

The Commission found that in the accident, after the fire extinguishing installation (FEI) of locomotive No 91520044169-8 was activated, the structurally intended effect of extinguishing the fire in the locomotive did not follow (fig. 4.16).

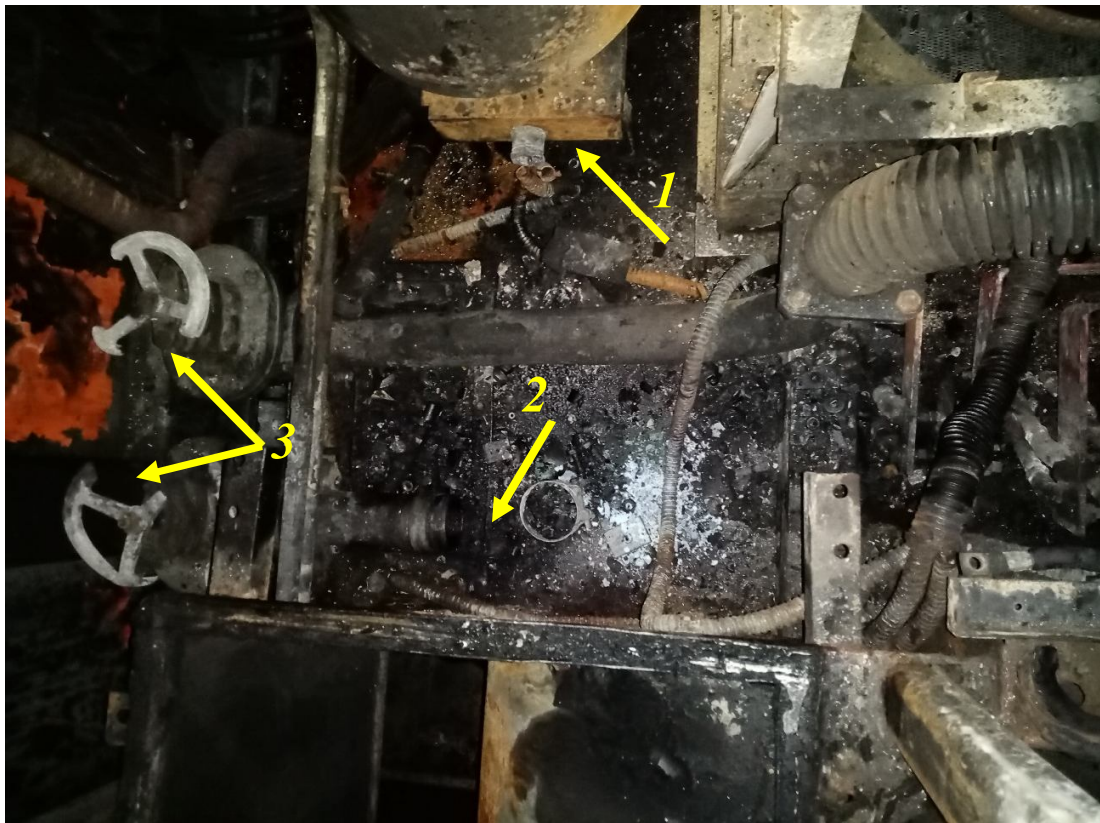
Fig. 4.17.

The Investigation Commission focused on the most charred part of the engine compartment, namely the engine-pump, as all traces of combustion indicated that was the place from which the fire originated and spread (Fig. 4.17).

Spots of high-temperature burning were found on the metal parts (Fig. 4.17, item 1), as well as burnt insulation. It was also found that the flexible connection of the engine-pump with the traction transformer - a rubber joint - was burnt and completely missing (Fig. 4.17, pos. 2), and the taps leading from and to the transformer were partially melted (Fig. 4.17, item 3)

From the analysis, it can be concluded that the focus of the ignition was located in the area of the engine-pump on the side of the second traction group.

- Recommendation 3, proposes that BDZ PS EOOD replace all the elastic joints in the cooling circuits of the transformer oil of locomotives series 44 and 45 with metal elastic joints;

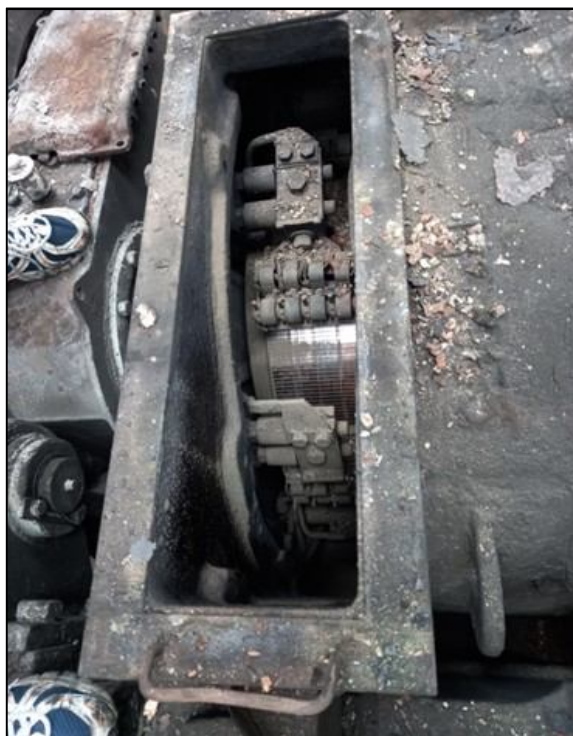
Fig. 4.27. TE №2

It was established that in traction engines (TE) No. 2 and No. 3, located under the fire zone, the so-called "round fire" in them (Fig. 4.27 and Fig. 4.28 show pictures of the collectors of the two TEs). Therefore, this cannot be the cause of the fire in the locomotive.
