ROMANIAN RAILWAY INVESTIGATING BODY

INVESTIGATING REPORT

on the railway accident occurred between
Ciocanesti railway station and Baldana railway station, at km 26+700,
on February 7, 2010

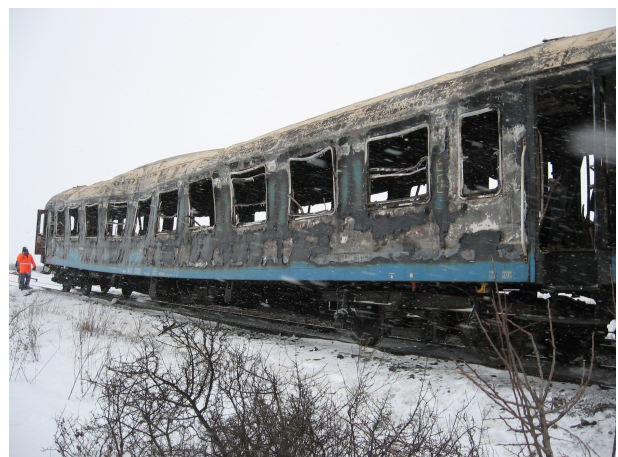
- the wagon no. 50532057480-7 – was insulated on the line I, at the km 26+700;
- the wagon body was fired about 95%;
- the frame of the wagon was twisted, the vertical bend of the frame was 170 mm;
- the running gears had no specific traces of braking run;

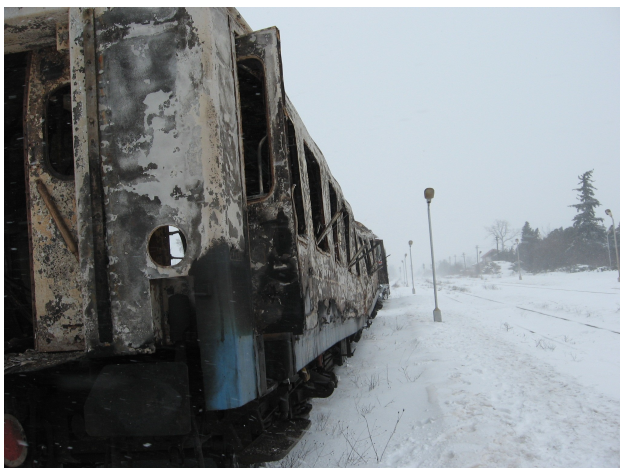
- the buffing and coupling gears in good operation condition, not being affected by the fire;

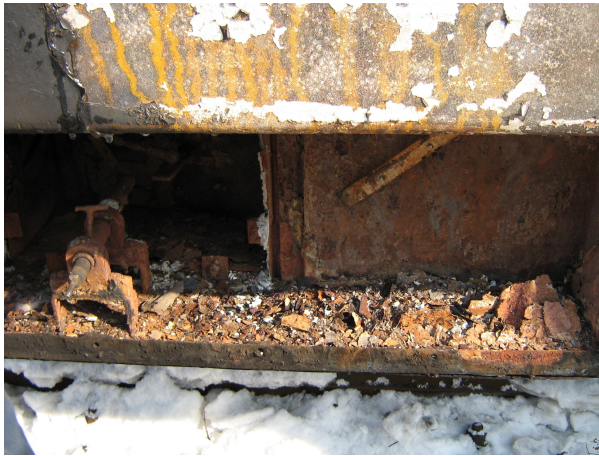
- the handle for the valve for the mixture of the re-circulated air was put and assured thus the air circulation can be done only on the position “re-circulation” (without acceptance of external air);

- after opening the inspection cover of the mixture chamber, one found out that the mixture valve put on so the air circulation can be done only by re-circulation, as well as traces of open flame burning, affecting seriously the air admission pipes from the interior of the wagon as well as of the pipes to the filtration chamber;
- at the opening of the inspection cover from the filters chamber, one found out traces of open flame burning, that affected the air filters, metallic hall as well as the admission area to the blower;
- the air filters were affected from the thermic point of view progressively decreasing from the mixture chamber to the fan blower;
- from the filter room it was found that the air blower was partially thermic affected;
- the fan does not have traces of thermical damage or soot deposits.

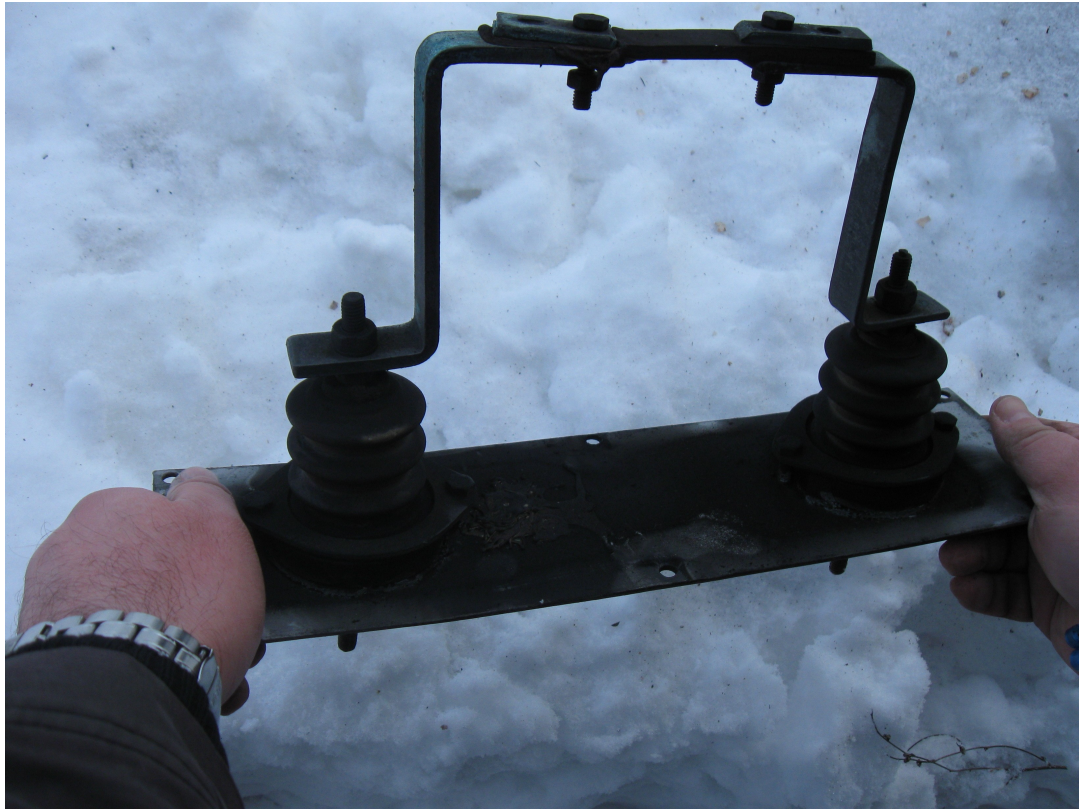
- after opening the over-voltage plate fuse support (SST), it was found that the fuse was in good conditions of operation and had traces of soot deposits on it;

pipes on compartment branch line 1-5 and 6-10, no evidence of thermic damage from interior to its exterior was found, in exchange there was found evidence of thermic damage from exterior to its interior;

- the air pipes from the compartment no. 9, had deeper evidence of thermic damage against the air pipes of the other compartments, and areas where the metal plate was perforated due to thermic damage.

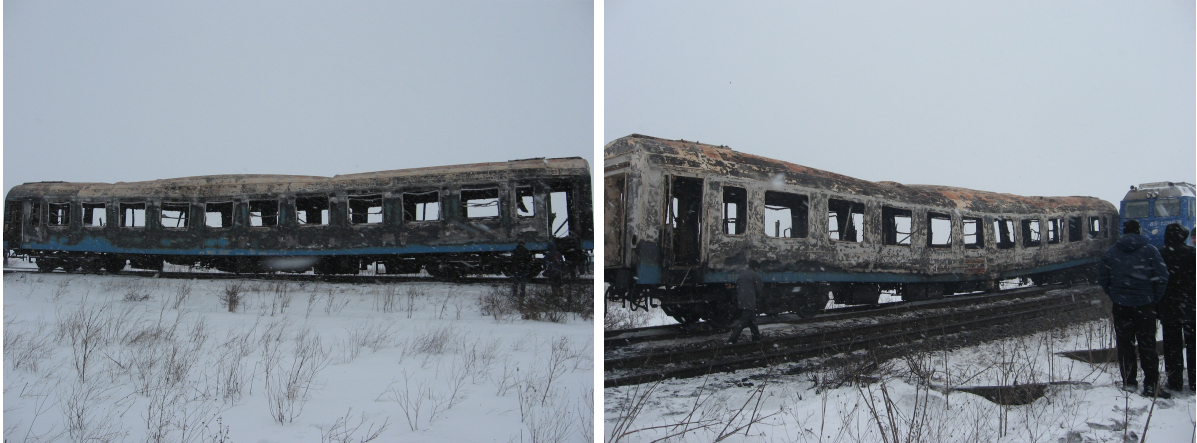
Thus the data recorded by the report in connection with the verification of the wagon by the technical commission and from the photos taken at the time of the accident result that the wagon was more damaged on the right side in the traffic direction, respectively the side with the passage corridor where it can be observed a high degree of destruction by melting the window frames.

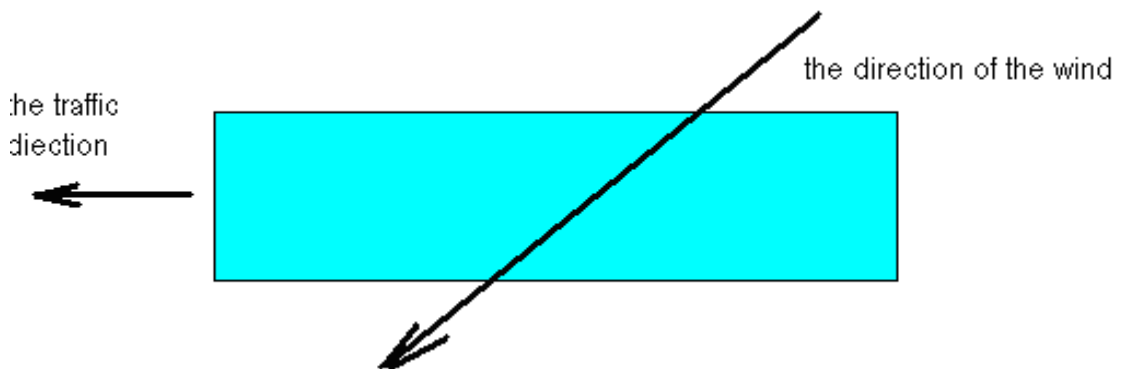
Also taking into account the maximum chassis flexure of 15 cm of the wagon box in horizontally plane on the right side in the traffic direction, can be concluded that the combustion process has been intensified on this side due to the strong wind that blew on the transversal-oblique direction of the wagon from left to right in the traffic direction.

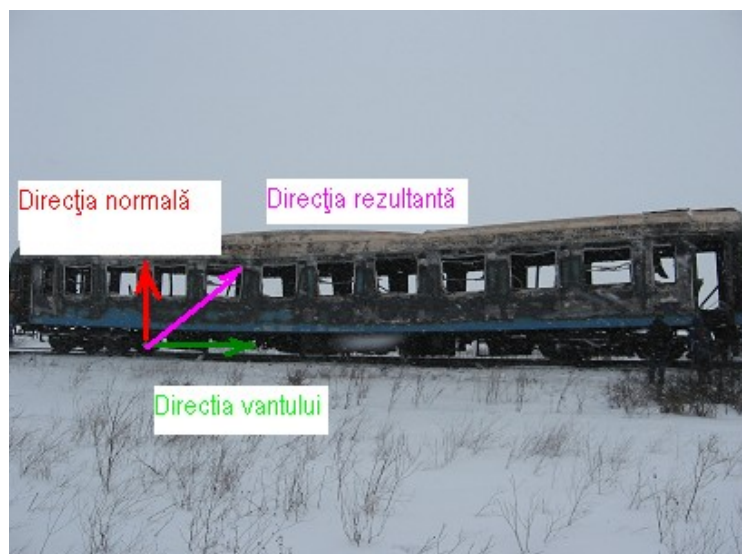
The roof is more damaged between the compartments no. 6 and 7 due to the fire intensification on a oblique-vertical direction resulted from two forces from two directions (vertical direction given by flame and horizontal direction given by wind).
