THE MINISTRY OF TRANSPORTS  
THE ROMANIAN RAILWAY AUTHORITY – AFER  
THE ROMANIAN RAILWAY INVESTIGATING BODY

# INVESTIGATION REPORT

of the derailment of the freight train no. 60373 on February 22,  
2007 to H.m Cricov railway station, that belongs to the RAILWAY  
TRANSPORT COMPANY SA

*Final report*  
*February 12, 2008*

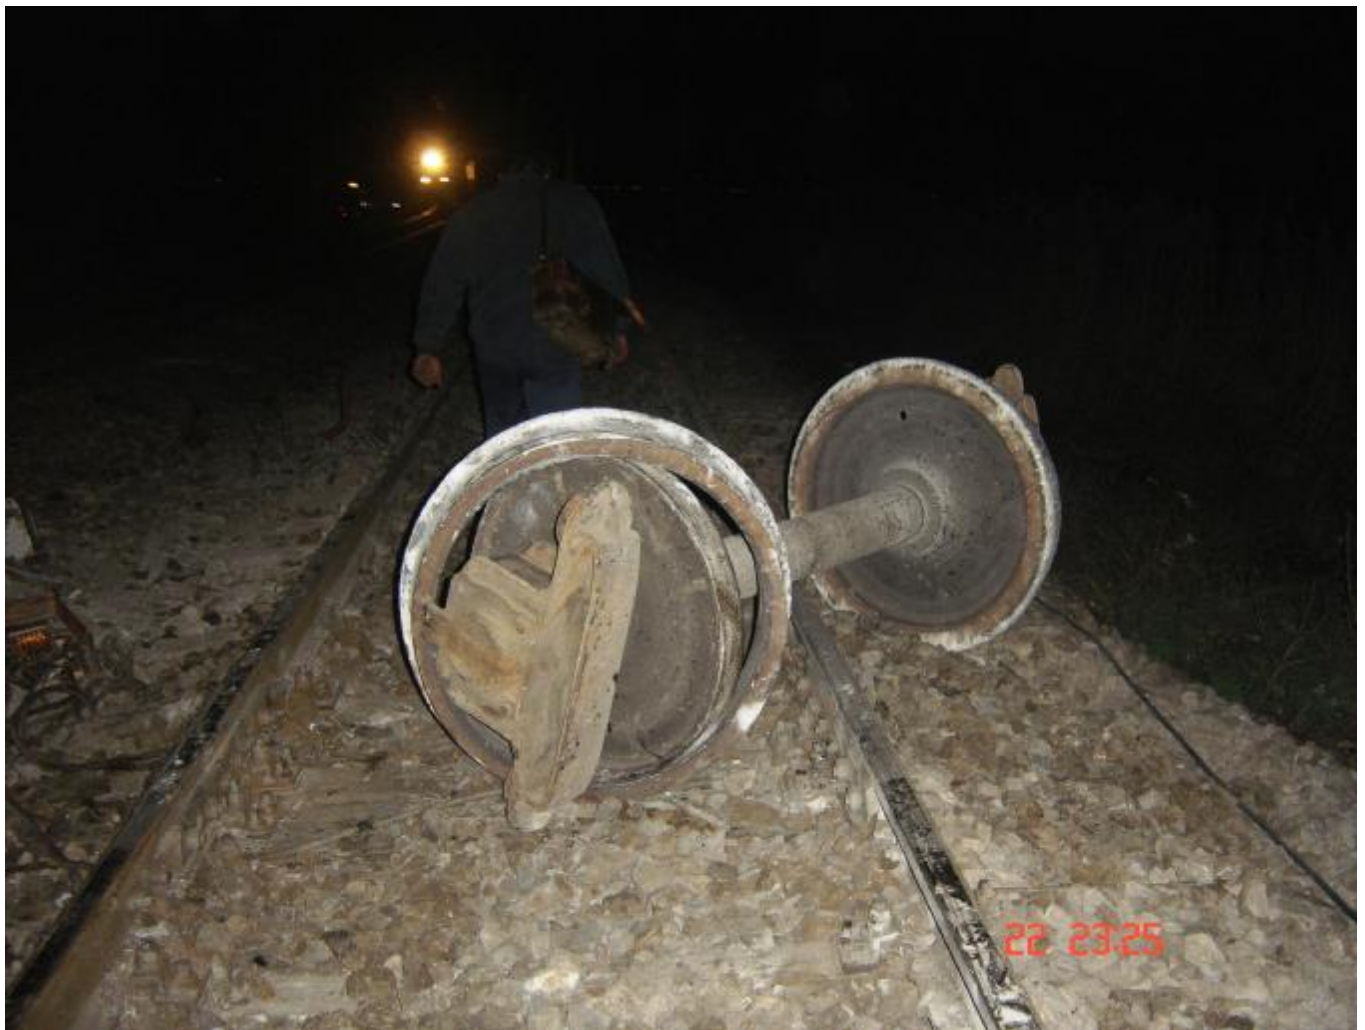
- When the train stopped and the driver's assistant made the inspection, he established the following:
    - the wagon no. 88536657717-3 ( the last but one wagon of the train composition) has derailed on all axles and was inclined to the second running line and the axle no. 3 ( corresponding to wheels no 5-6) was found at 60 metres behind the last wagon , the wheel no.5 had the tyre axial displaced from the rim, into an oblique position, having contact with the rim in two points diametrically opposed;

**Figure no.2 – the wheel no.5 of the wagon no. 88536657717-3 having the tyre displaced from the rim**

- the concerned axle showed traces of new impacts and as regards the wheel no. 5 ( on the left side of the traffic direction), the tyre is axial displaced from the rim, into an oblique position, having contact with the rim in two points diametrically opposed;

- the change of the fitted axle track gauge as result of the transversal displacement of the wheel tyre no. 5 of the wagon no. 88536657717-3 (the last but one wagon) led to the derailment of the respective axle on the point switch no. 9 of H.m Cricov railway station.

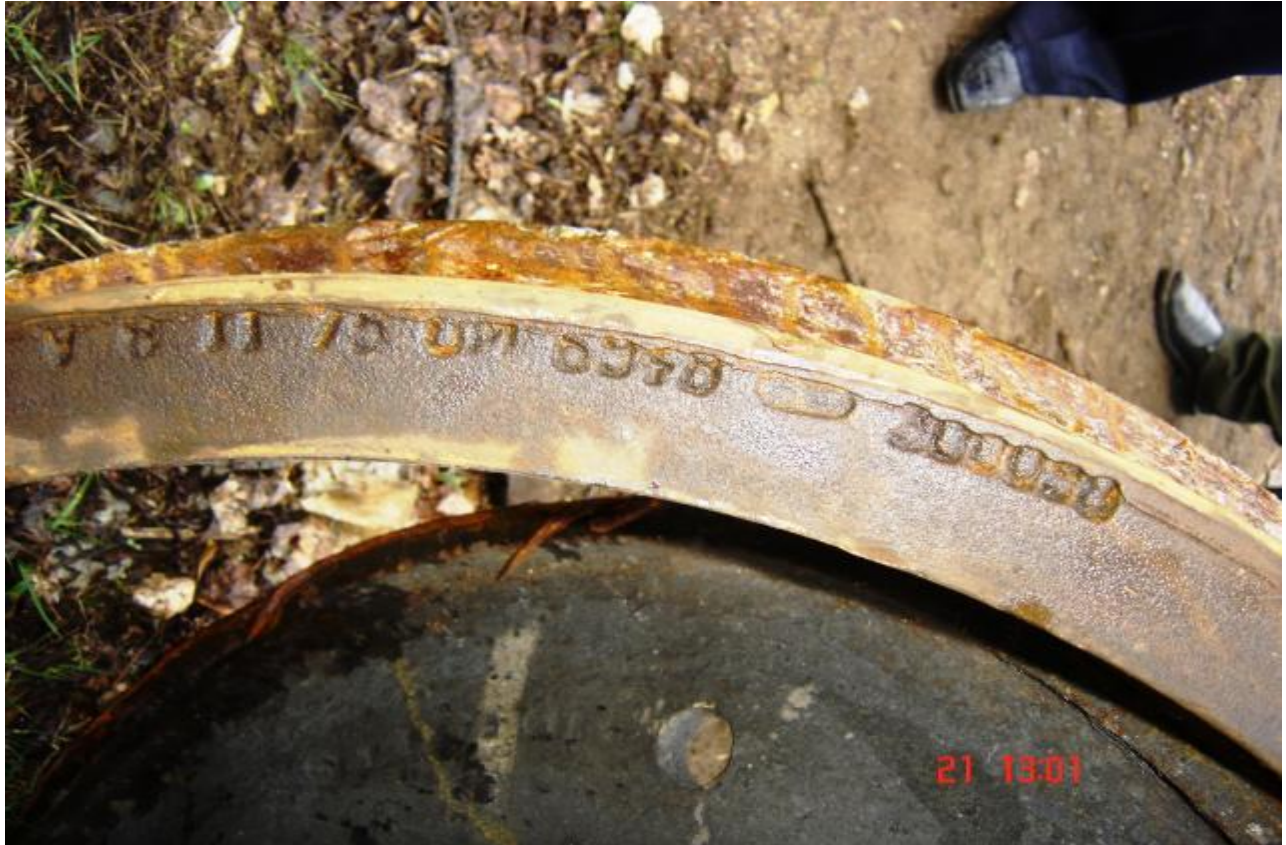
- to wheel no. 5 were identified the following dates:
  - on the tyre : V 8 11 75 OM 6948 300090;
  - on the rim: 57747 CSR;
- the axle no. 3407007 was fitted on the wagon no. 88536657717-3 with the occasion of the wagon periodical inspection on November 4, 2003;

- on the wheel tyre no.5 it can be seen traces of heat density (colour changed to blue) as result of the temperatures used during the fastening ring grinding of the wheel rim.

**Figure no.3 – the mark of the wheel tyre no. 5**

- the tyre was manufactured on November 8, 1975 by Reşita Integrated Iron and Steel Works (CSR) from “wagon steel” produced in furnace type Martin;
- the tyre is a component of melting charge no. 300090, having a serial number 6948;

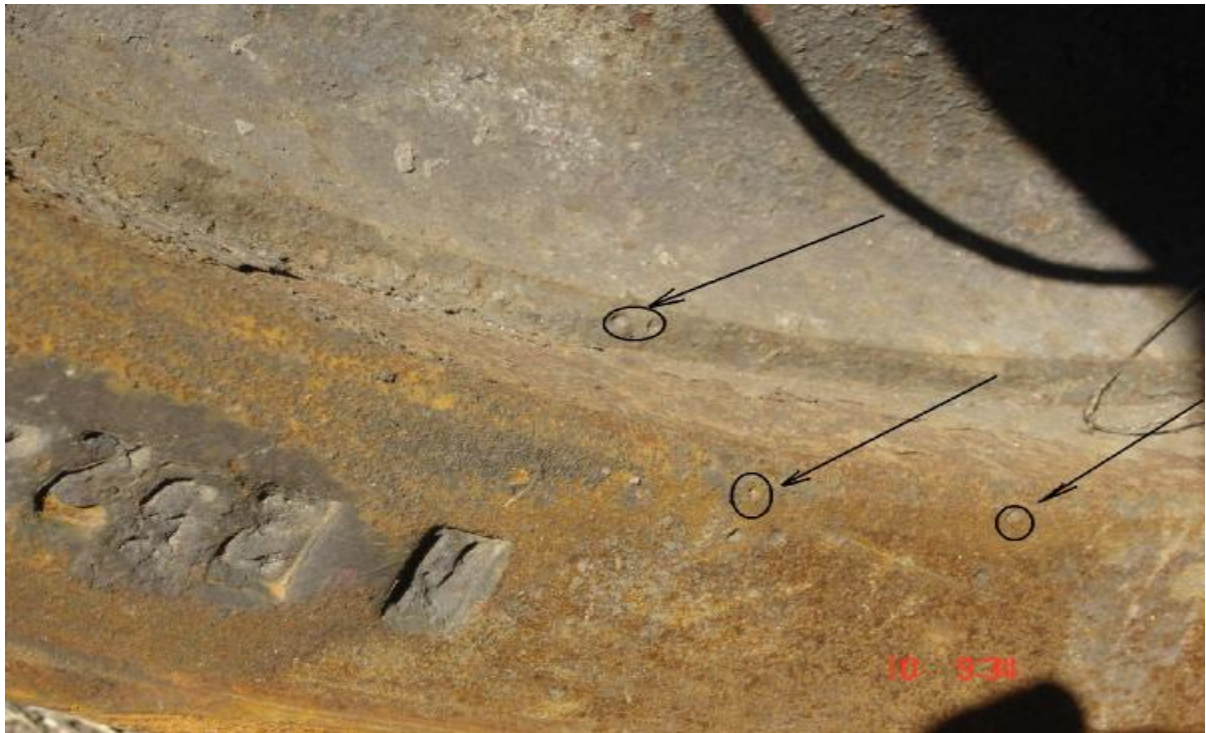
- as result of the visual examinations carried out on the axle no. 3511680 ( axle no. 4 – corresponding to wheels no.7-8 of the wagon no. 88536657717-3) it was established that the tyres of both wheels were switched from the rim ( the control marks used to fit the tyres were changed with 3-5 centimetres one from another);

- also, for the wheel tyres no.7-8 of the wagon 88536657717-3 are available two mechanical control marks – see figure no.4. According to the article no. 29 of the " Instruction no.931" on the repair of the fitted axles of the railway vehicles, this type of stamps are given once with the occasion of fitting the tyre on the wheel rim.

Figure no. 4 – the changed marks of the tyre and the wheel rim no.7

- the existence of double mechanical marks on the wheels tyres no. 7-8 indicates the rotation of those during their operation, a new mark being realized previous to the tyre’s fitting on the rim, that is contrary to the repair instructions;

The non-observance of the provisions referring to the mark of the tyre position of the wheel rim, when the repairs were done - a fact established to the axle corresponding to wheels no. 7 - 8, the stamping being performed twice (the axle that was equipping the bogie with that who produced the derailment) - represents a irregularity that might be a possible factor for the tyre detachment from the wheel. The second stamping was made after the tyre was rotated on the rim and when the wagon was repaired he was running with a "turning round tyre" – fact that acts contrary to the *Instructions on the technical inspection and the maintenance of the operating wagons - no. 250/2005*, which on article no. 87 – chart no.1- current no.10 provides that:

- 10.4 The freight railway undertakings will check if the wagons have a double mark of the tyre position from the wheel rim by stamping, being removed from the circulation in order to replace the respective axles.

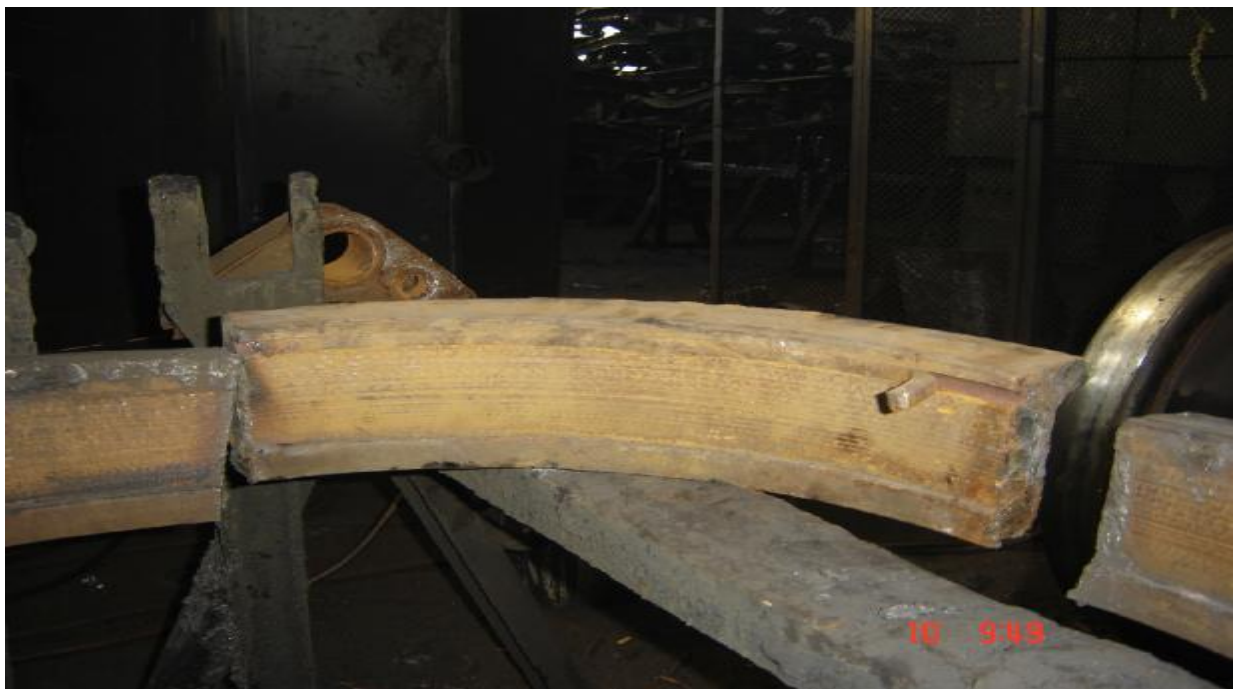
- the wheel tyre no.5 was removed from the axle no. 3407007, a piece of 50 centimetres being cutted from this and being deposited to the bogie section.

Figure no.5 – the wheel tyre no.5 removed from the wheel rim
