RAILWAY ACCIDENT AND INCIDENT INVESTIGATION DIVISION

Number: 010-138/2008/402

Date: 27 November 2008

## FINAL REPORT ON THE INVESTIGATION INTO THE RAILWAY ACCIDENT AT THE CEŠČA VASPRI NOVEM MESTU LEVEL CROSSING ON 20 AUGUST 2008

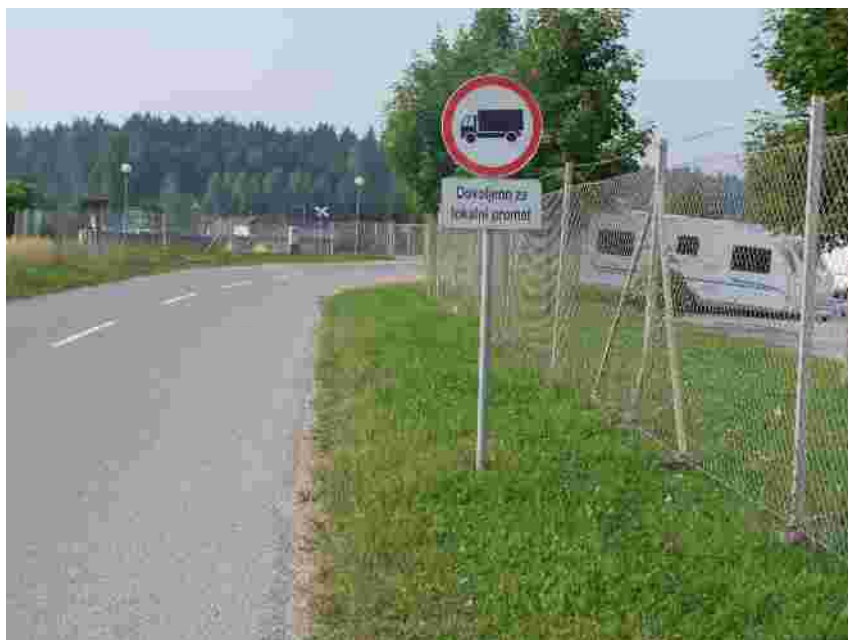
The vegetation and caravans in the yard in the vicinity of the road strongly hindered a clear view of the level crossing of both road users as well as train drivers. At this time of year, there is dense vegetation.

Figure no. 7: View of the level crossing, obstructed on account of the lush vegetation causing poor visibility.

One of the indirect causes of the accident was the insufficiently marked level crossing, which – at this time of year on account of the lush vegetation – is not clearly visible and the railway line hardly noticeable when the train is travelling from the direction of Straža towards Novo Mesto and road vehicles from the direction of Bršljin towards Zalog.

Another indirect cause of the accident was poor visibility at the level crossing due to parked caravans blocking the view of road and rail drivers alike.

On account of poor visibility of the railway line and of the St. Andrew's Cross road sign, blocked by vegetation at the Češca Vas level crossing from the direction Bršljin towards Zalog, we recommend:

- additional marking of the level crossing for the benefit of road users by means of I-37 road signs (approaching the level crossing of the road with a railway line without barriers or half-barriers);
- reducing the maximum permitted speed of road vehicles at an appropriate distance before the level crossing, for the Bršljin-Zalog direction, from the present 50 km/h down to a maximum 30 km/h.
