### **DERAILMENT OF TRAIN 41328**

**on 9 September 2007**

**Österreichische  
Bundesbahnen (*Austrian  
federal railways*), route 13201  
in Wien (*Vienna*) Donaukaibf  
station**

Investigation report

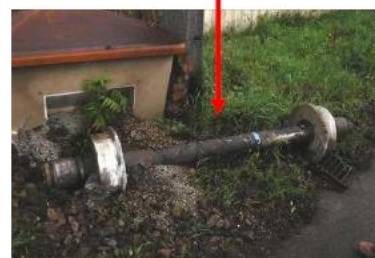
Escaped 8th axle

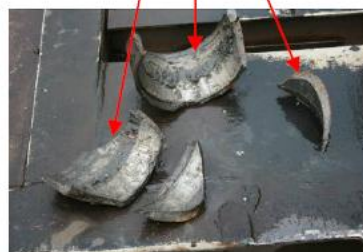
Broken bearing  
of 7th axle

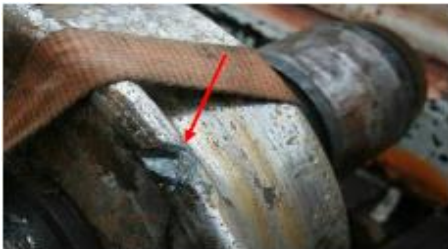
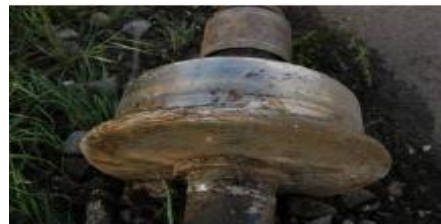
- The following was established about the derailed 8th axle:
  - notch about 15 mm deep (impact point)
  - abrasion and traces of impact (damage because of rotating loosely)
  - normal wear on running surface
  - correct state of wheel flange
  - no bearing damage

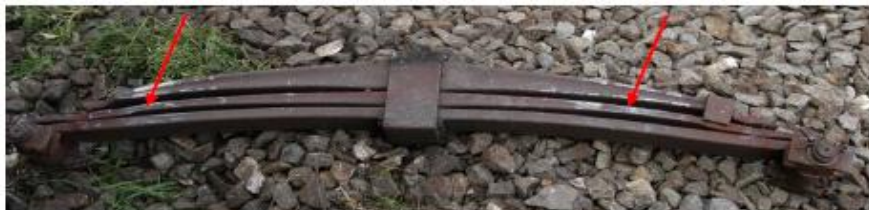
- Suspension spring (parabolic spring) - traces of abrasion inside (because of the missing spring support, the suspension spring slipped)

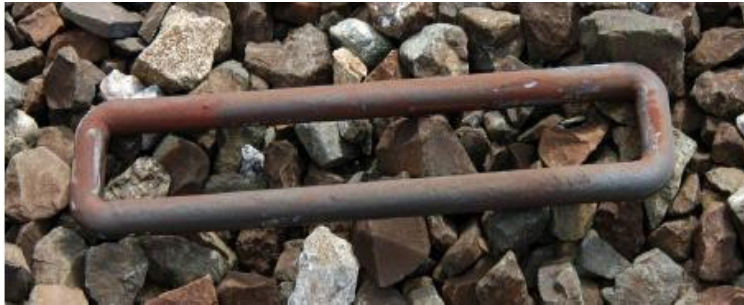
- Secured suspension rings
  - no damage such as cracks or deformation could be established

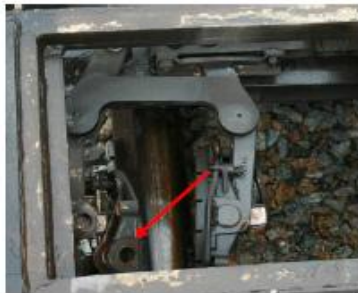
- Brake system
  - the brake system was partly damaged in the derailment (missing bolts)

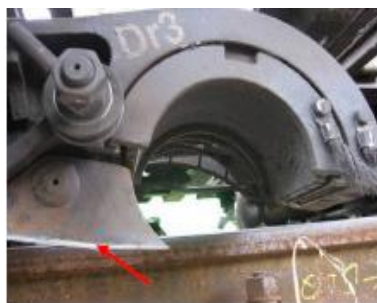
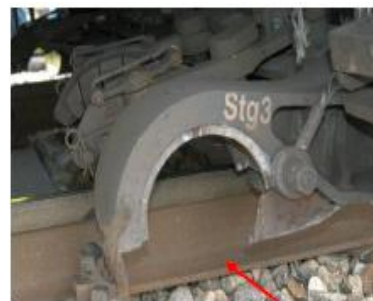
- Lift-off safety system of eighth axle
  - traces of abrasion (because of the dropping of the running gear, track magnets of the PZB came into contact with axle counters)

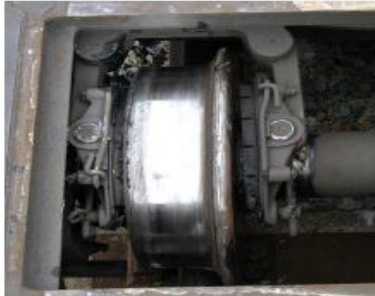
- Preceding seventh axle

- traces of abrasion on running surface and wheel flange (damage because of loose rotation of eighth axle)

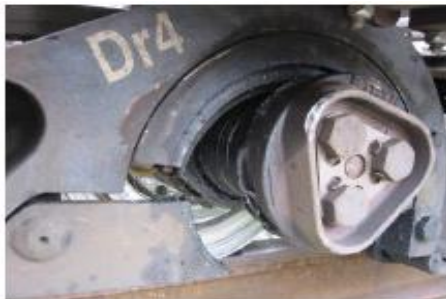
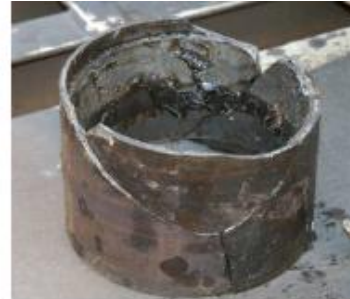
- Axle bearing of seventh axle

- bearings were destroyed on both sides (broken by force, not hot running)

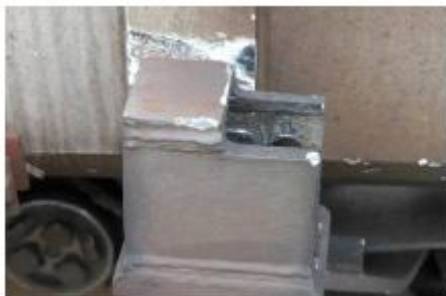
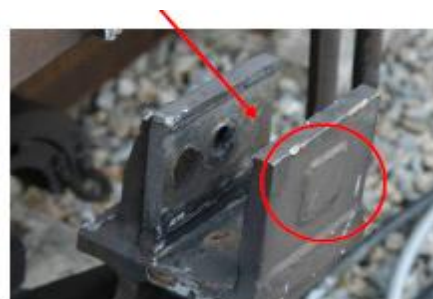
- Spring support bearing

- traces of abrasion in region of bearing surface of spring support (this indicates that the spring support was broken)
- the hole to secure the bolt of the spring support was fused

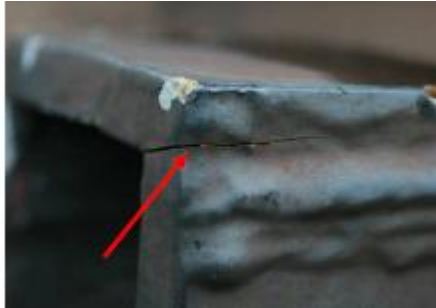
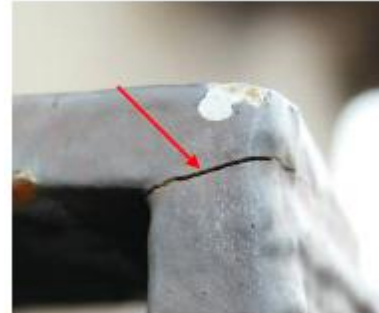
- Securing shackle of spring support bearing

- crack approx. 4.5 cm long (indicative of the broken spring support )

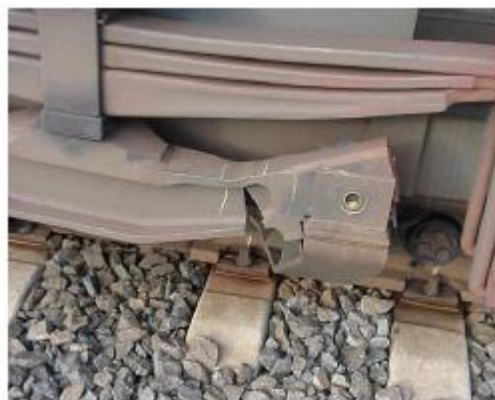
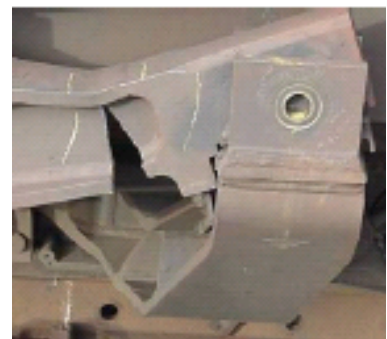
Tear in a spring support in May 2004 on a RoLa waggon of CFR.

The result of the inspection was a faulty weld seam.

On the basis of the inspection, the faulty spring supports were replaced and acceptance action No 100 was cancelled.

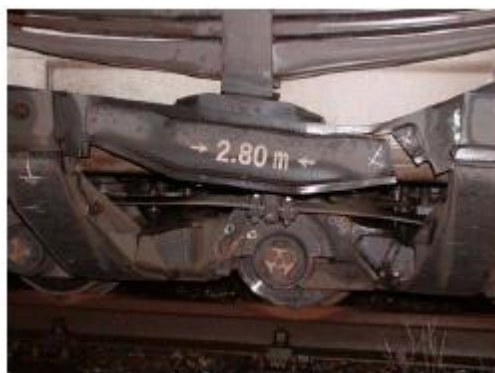
Tear in the spring support on 7 September 2007 on a CFR waggon.

The result of the inspection was a faulty weld seam.

Action: For waggon engineering inspections of RoLa waggons, INFO No 186 of ÖBB, which refers to tears in spring supports, was issued to staff of the waggon service.

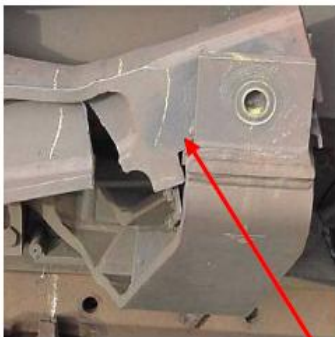
Tear in spring support, 2004

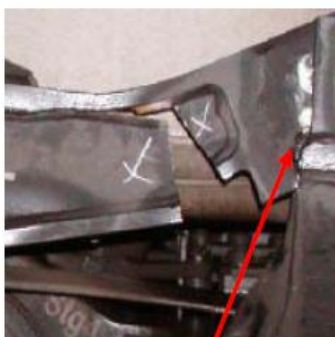
Tear in spring support, 2005

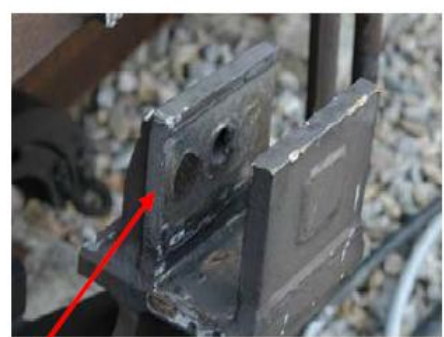
Spring support bearing of waggon  
No 81 53 4983 066-2

Because of the buckling of the spring supports, there are traces of abrasion in the region of the spring support bearing

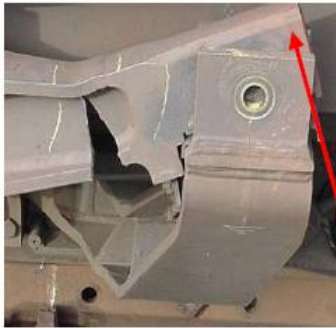
Tear in spring support, 2004

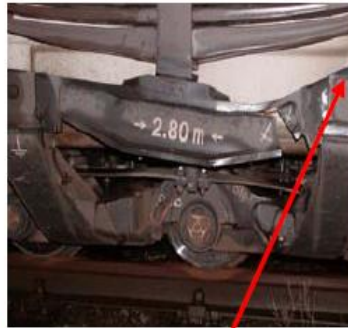
Tear in spring support, 2007

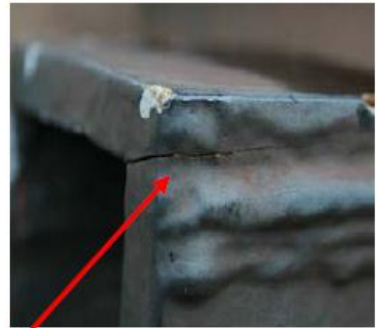
Securing shackle of waggon  
No 81 53 498 3 066-2

Because of the buckling of the spring supports a lever effect occurs, thus breaking the securing shackle of the spring support bearing

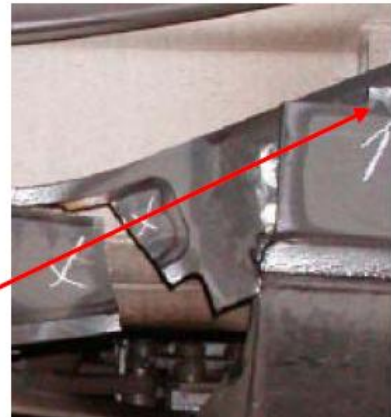
Securing shackle of  
spring support bearing  
broken

Spring support 'WITH' damage

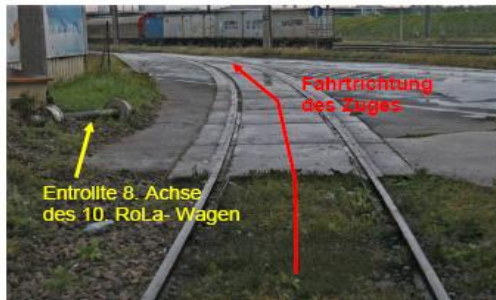
Entrollte 8. Achse des 10 RoLa-Wagen = Thrown 8th axle of 10th RoLa waggon

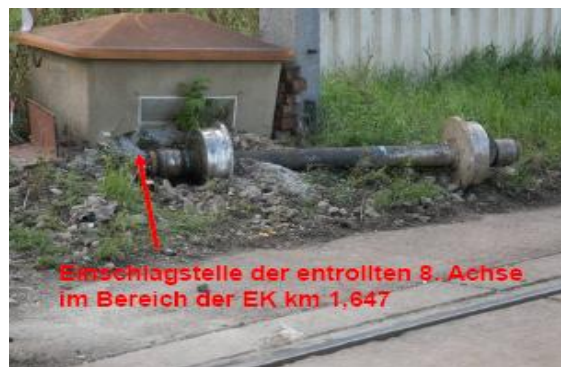
**Einschlagstelle der entrollten 8. Achse im Bereich der  
EK km 1,647 = Point of impact of the thrown 8th axle in area  
of railway crossing, km 1.647**
