Information note on the progress of the survey
On-line derailment of SNCF freight train on the Paris to Lyon line
at Sens / Saint-Julien-du-Sault (Yonne)
18 August 2020

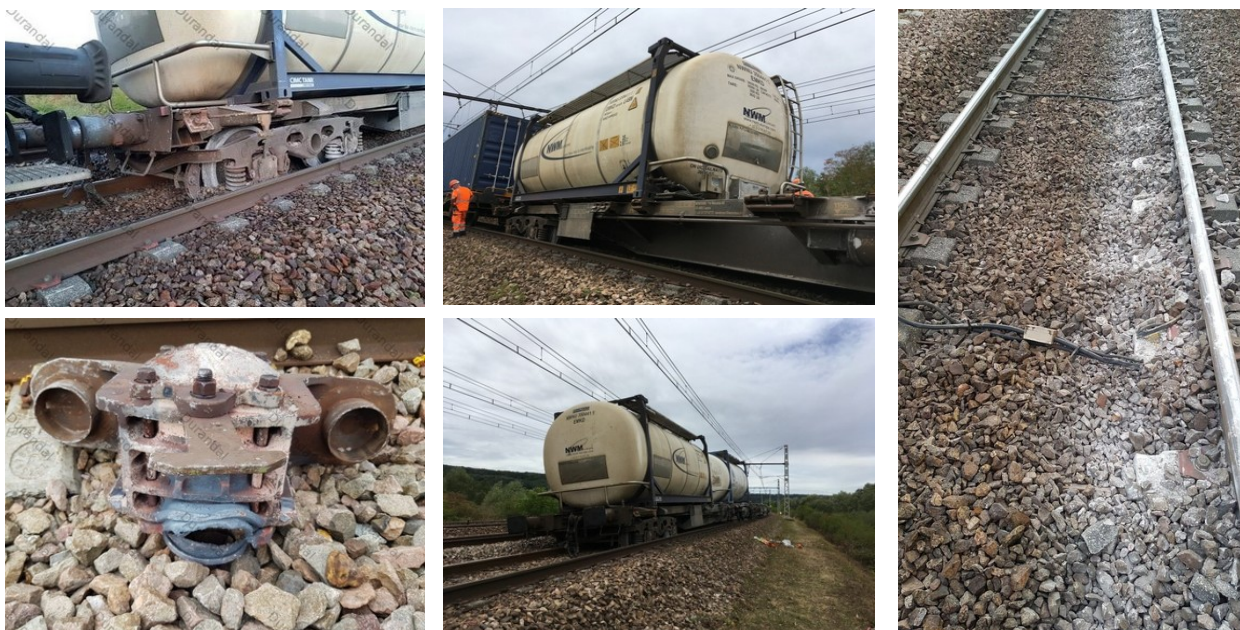
The derailment was caused by a broken bearing box on the first axle of the 29^e wagon, a swap body carrier loaded with two portable tanks.

The track had to be completely replaced from Pk 123.450 to Pk 131.950.

Derailed wagon and track in situation

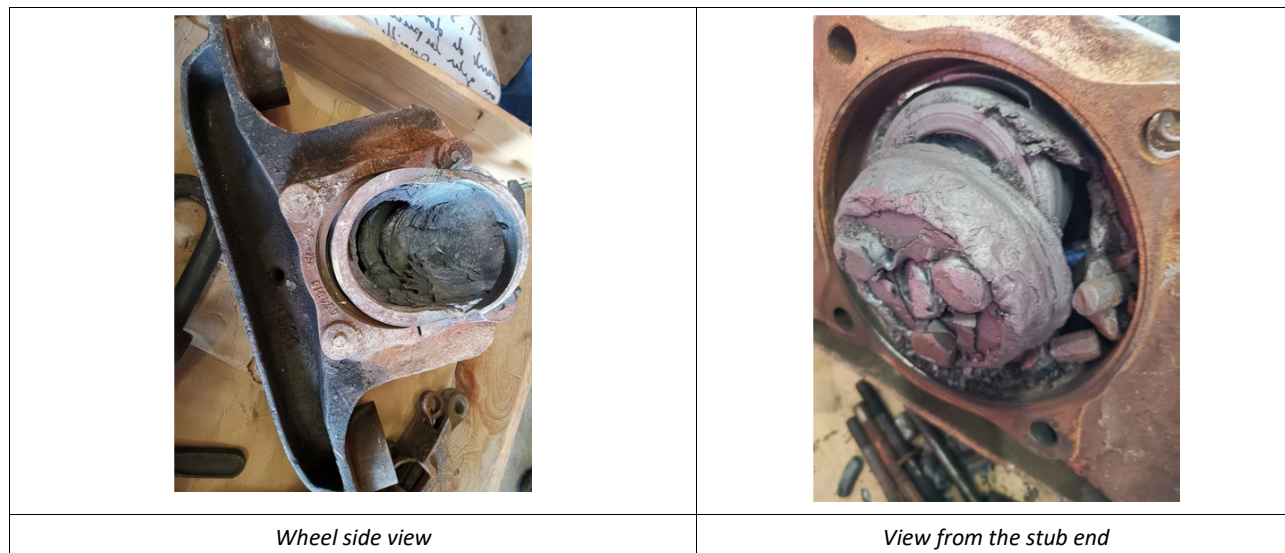
The axle box of the wagon (29^e mentioned above), first and right-hand side in the direction of travel, heated up until the axle journal melted. The derailment of the first axle seems to have occurred when this stub axle broke and the axle box was ejected.

The nature of the deformations, illustrated in the following figures, shows that the axle box would have melted and flowed with metal, resulting in a stub axle failure and derailment.
