**SPECIALIZED UNIT FOR INVESTIGATIONS OF ACCIDENTS AND INCIDENTS IN
RAILWAY TRANSPORT AT MTITC**

FINAL REPORT

**From
investigation of a railway accident – fire occurred
in
electric locomotive №43310.9 while IDFT № 40772 moves between stations
Belovo and Kostenets on August 11, 2019**

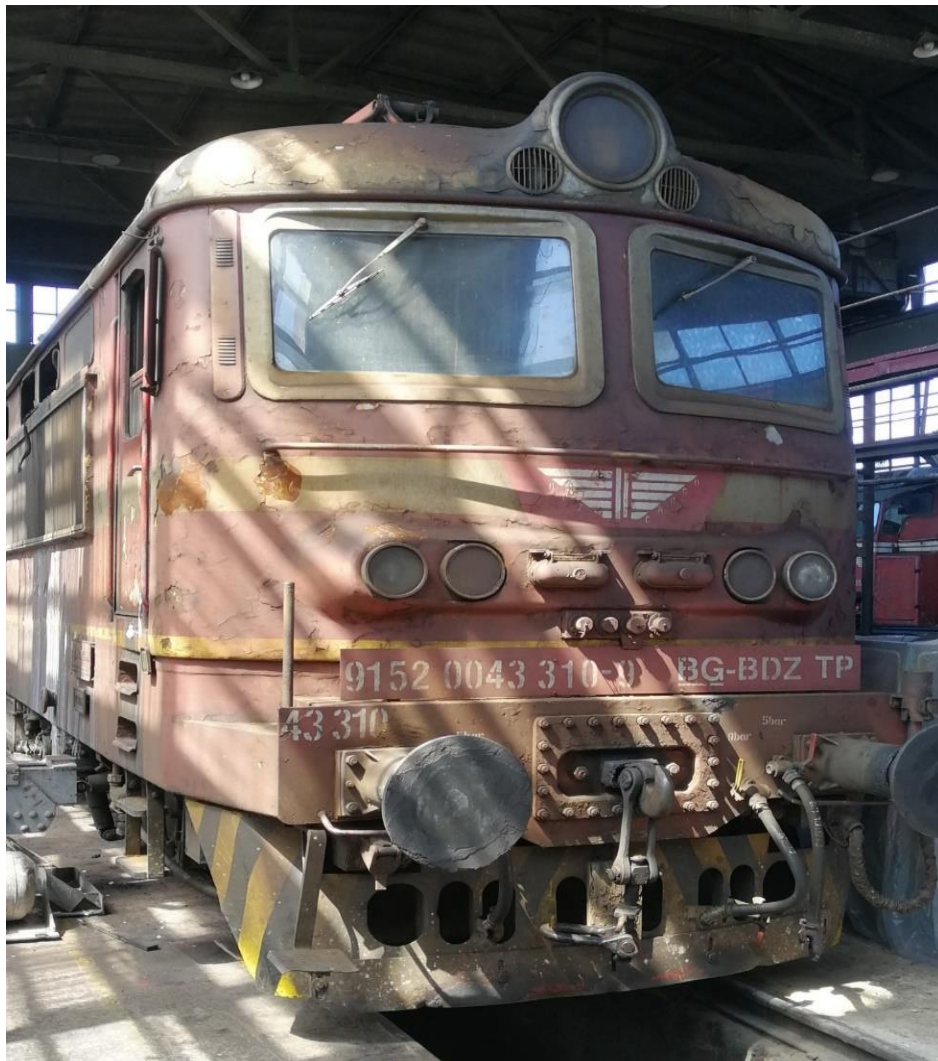
Fig. 1

The motorman of the auxiliary locomotive № 43533, after receiving a call from the motorman of locomotive № 43310, moves to the burning locomotive for assistance, breaks the Brake Coupling Sleeves between locomotive № 43310 and the wagons, but fails to unscrew the screw coupling. They call the motorman of train locomotive № 43515 by mobile phone and move the train forward to an accessible location for fire extinguishing with the specialized vehicles of the FS&PP, approximately 1000 m, about km 77 200 - (Figs. 1 and 2).

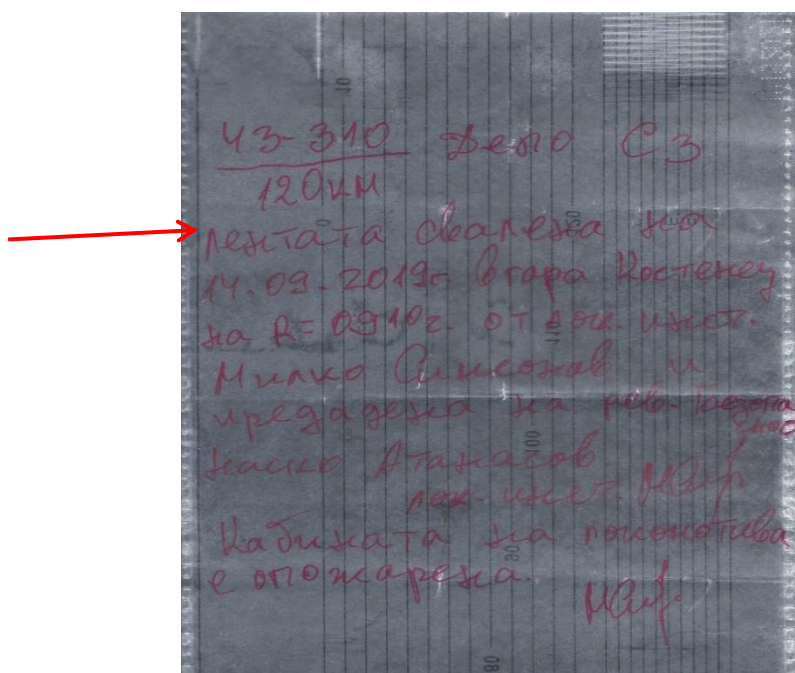
Fig. 11 shows part of a speedometer tape with inscriptions referring to locomotive № 43310, downloaded from the registering speedometer of the locomotive on August 14, 2019, at 09:10 hrs by a locomotive instructor from Locomotive Depot Dupnitsa and submitted to the head of the operational unit of RINC. It is explained that the cab of the locomotive is fired. There are no visible and usable records on the tape due to damage to the speedometer. The damage is established by a protocol on November 12, 2019, after measurements by a speedometer test stand in Locomotive Depot Plovdiv.

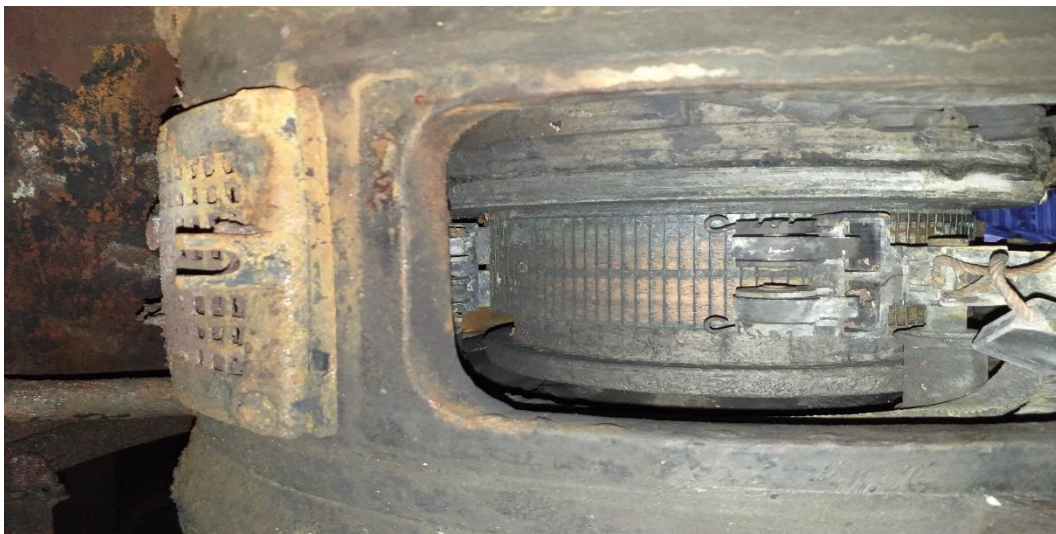
Fig. 18

From the studies, measurements and analyses of the locomotive and the technical documentation of its condition, the Investigation Commission concludes that the quality of the repairs carried out is reduced due to the non-compliance with the regulated repair technologies which is established during the investigation.

An immediate cause of the fire is the transient short-circuit occurring in the motor-fan (233) which cools the rectifier unit of the second traction group (022). The short circuit in the motor-fan 233 has caused the temperature in the rectifier 022 to increase (Fig. 18). The significant increase in temperature has caused the heat up of the R-C groups for protection against switching surges, the blow-up of the capacitors and the self-ignition of the electrolyte in them.

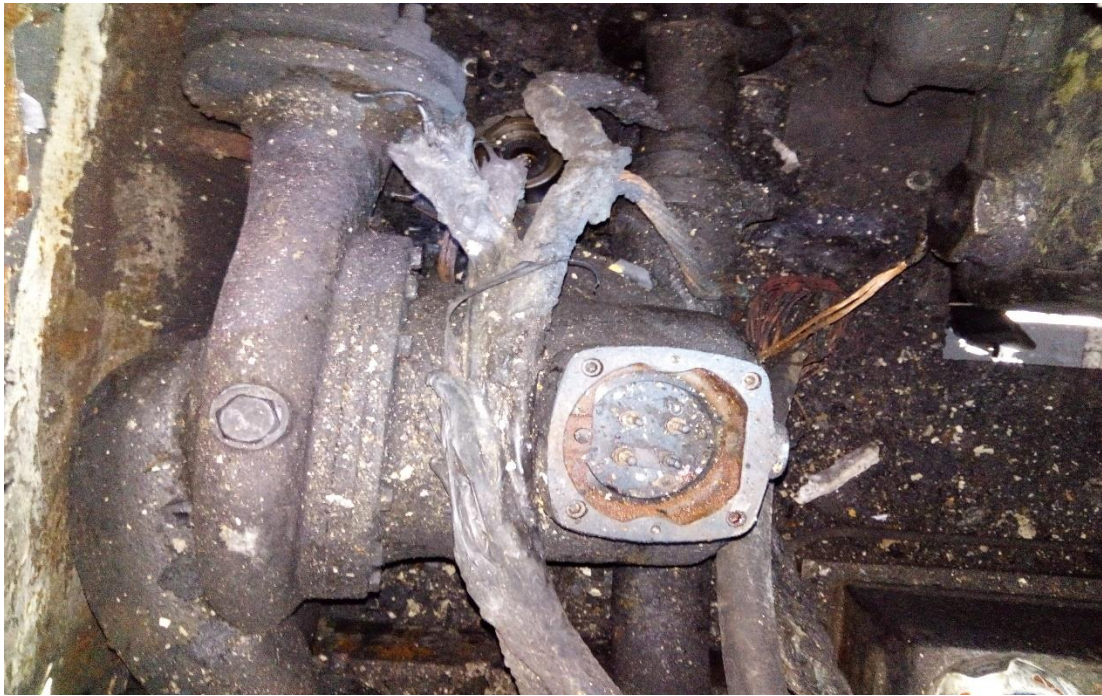
Fig. 19

The short circuit in the operating coil of the oil pump 238 has led to a lack of circulation in the second oil cooling circuit in the traction transformer 0151, Fig. 19. The increased oil temperature greatly raises the temperature in the oil cooler of the transformer. This results in a severe overheating of the auxiliary rectifier 220 (for compressor 234), which is located near the oil pump. When MAT is switched off, the 020, 220 rectifiers remain uncooled. The temperature rises significantly and a fire occurs from the exploded capacitors of the R-C group. By switching on MAT again, fan 231 kindles the fire further. After leaving the hill and entering Belovo station, the motorman lowers the positions and switches off the motor-fans.

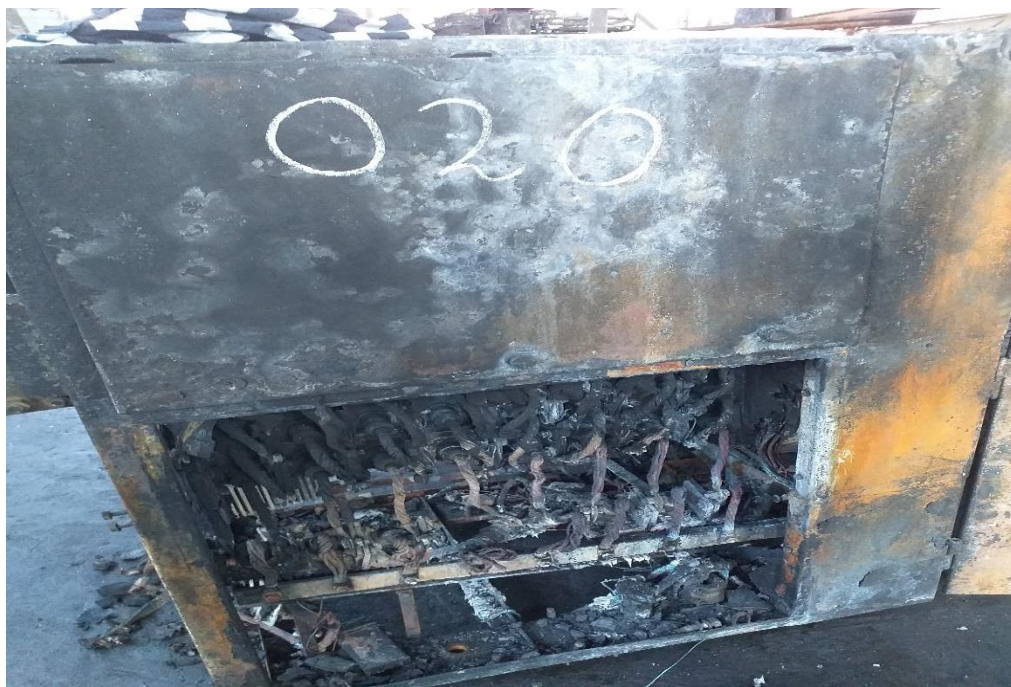
- Power rectifier 022 completely destroyed, only the rectifier (frame construction) is left. Fig. 21.
- On the first rectifier 020, only the auxiliary 220 and 221 rectifier modules are burned (Fig. 20).

Fig. 20 and Fig. 21 show photos of rectifying cabinet 020 of the first engine group (bogie 1) and of rectifying cabinet 022 of the second engine group (bogie 2). Cabinet 020 fire damage is partial at the bottom of the cabinet, while cabinet 022 is completely destroyed by fire. The arrangement (location) of both cabinets in the engine room of the locomotive is such that a conclusion is drawn for two independent fires centers (in each cabinet). A confirmatory circumstance is ascertained in the inspections that no oil has leaked from the cooling circuits of the main transformer of the locomotive, i.e. the fire is not spread as in other accidents - from bursting oil compounds and spilled burning oil.

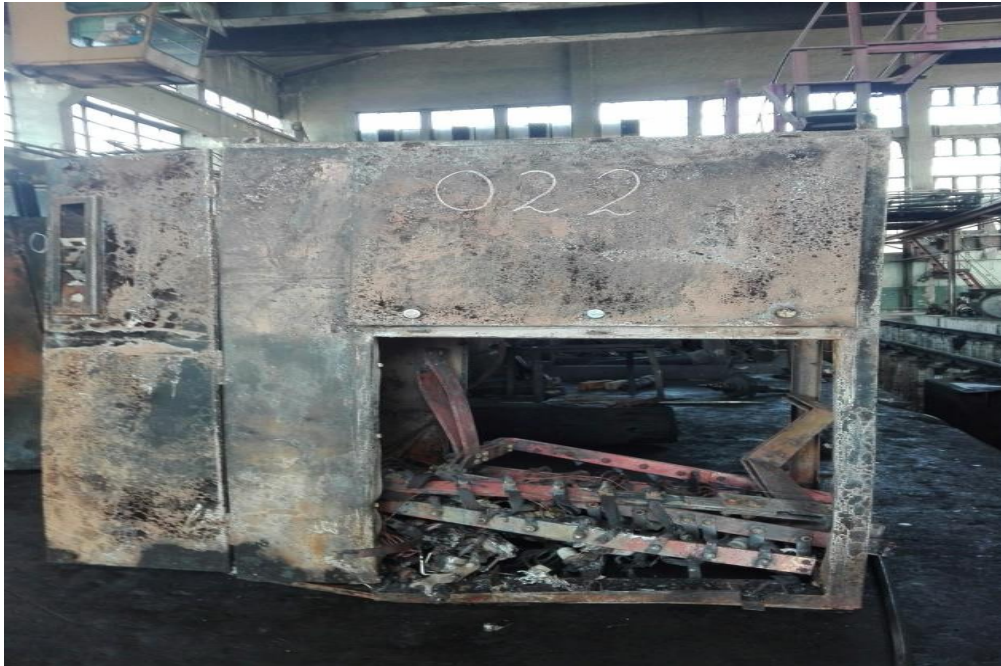
Fig. 21

The main causes of fire in electric locomotive № 43310.9 are the continuous operation of the locomotive with an increased temperature of the second traction group and of the first traction group, as a result of a short circuit in the cooling fan of the second rectifier unit and a short circuit in the motor pump. For this reason, a breakthrough has occurred in some of the elements (thyristors, diodes, etc. - Figs. 20, 21), which has operated under high current and without cooling. Due to the increased temperature in the capacitors for protection against switching surges, the temperature of the electrolyte in them has increased. This has resulted in the unpressurized metal housings and the dispersion of the electrolyte on the heated elements of both rectifying units, resulting in the almost simultaneous ignition and expansion of the fire.

Recommendation No. 1 proposes that when performing technical inspections and repairs (TI and BRM) of diesel and electric locomotives, to comply strictly with the prescribed order laid down in Order No. 01-01-191 / June 29, 2017 of BDZ "FT" EOOD Manager, to prevent the premises for occurrence of fires in locomotives owned by BDZ "FT" EOOD.
