INVESTIGATION REPORT OF A RAILWAY ACCIDENT

Fire on the traction unit of train R 766 while underway between Přovany railway station and Vranov u Stříbra railway station on the Pilsen hl. n. to Cheb open railway line

Wednesday, 30 July 2008

Ref. No.: 6-08/2469-ÚI4

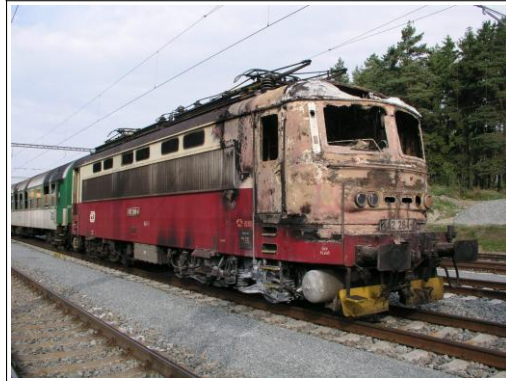
- completely burned out driver cabin No 2, including the dividing wall;
- cabling and other parts of the whole engine room affected by heat;
- defective roof-mounted lightning arrester;
- burned out intermediate terminal board of the 4th traction motor ("TM") including the cabling to the TM;
- cracked supporting insulator of the 2nd accumulator;
- burnt paint on the brackets of the 2nd accumulator;
- damaged piping for the lubrication flange for the 4th axle;
- 4th TM affected by heat;
- burned sleeve of the 4th TM;
- heated connection of the intermediate terminal board of the 4th TM.

The immediate cause of the incident was a loose power cable on the intermediate terminal board of the 4th traction motor of the traction unit, which resulted in the origin of an arc discharge and, through the increased temperature thus produced, the ignition of flammable materials around the intermediate terminal board.

Photo 1: View of the traction unit after the fire

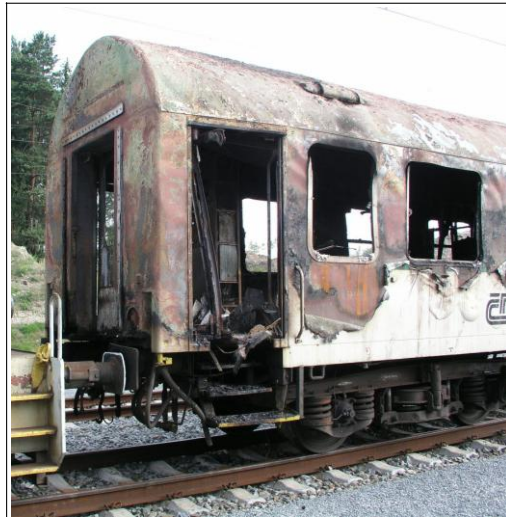
- half the interior of the wagon was completely destroyed by the fire, while the remainder was irreparably damaged by the heat and smoke. In view of the extent of the damage, this wagon will no longer be operated. The final total of the damage will be stipulated on the basis of an assessment by an expert witness.

Photo 2: View of the wagon after the fire
