December 2010

**Land Transport Accident
Investigation Bureau**

Case N° BEATT-2009-005

**Technical investigation report on the collision between a train and a
load on a crossing train which occurred on 20 May 2009 in the tunnel of
Livernantt in Charmant (16)**

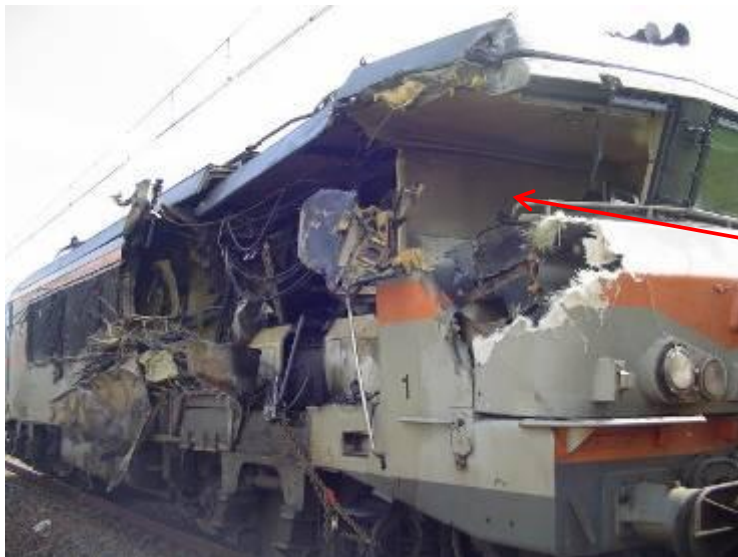
Figure 2: Locomotive 407220 after the accident

- On train 56724, locomotive BB 407220 was perforated from the front right-hand side of the driver's cab to about 1/3 of the length of the locomotive, with damage to the various elements of the engine and other items of equipment. As well as the locomotive, sixteen wagons were damaged to varying extents, and an axle of the second wagon was derailed.
- On train 41249, as well as the machines on the TWA 800 wagon containing the front two

**Perforation of the front
right-hand side of the
driver's cab on train 56724**

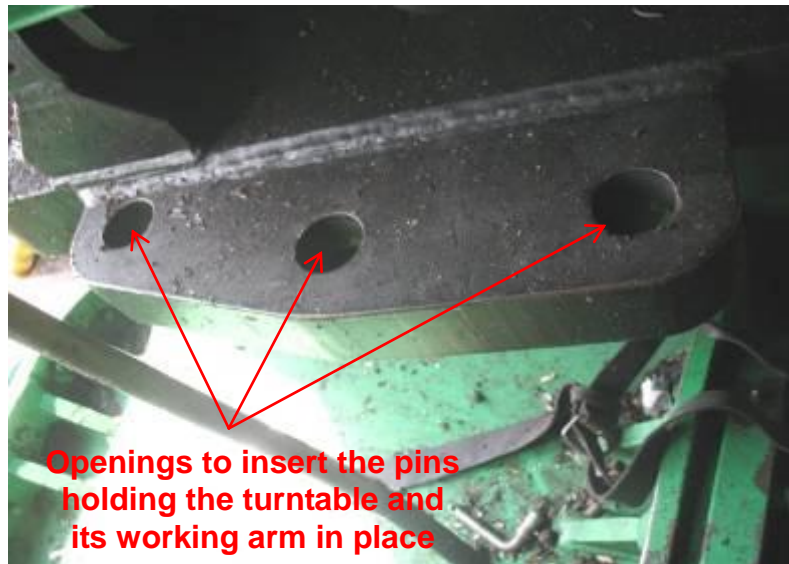
Figure 16: Openings used to immobilise the Skogsjan 487XL

The shipper failed to lock the turntable using the pins provided for the purpose.

Such locking may not have been possible in the diagonal position in which the arm of the machine was placed.

The photo below shows the turntable after the accident, without the pins that should have been inserted; no trace of the pins was found. The absence of the pins enabled turntable rotation movements, as it was not held in place by the limit stops.

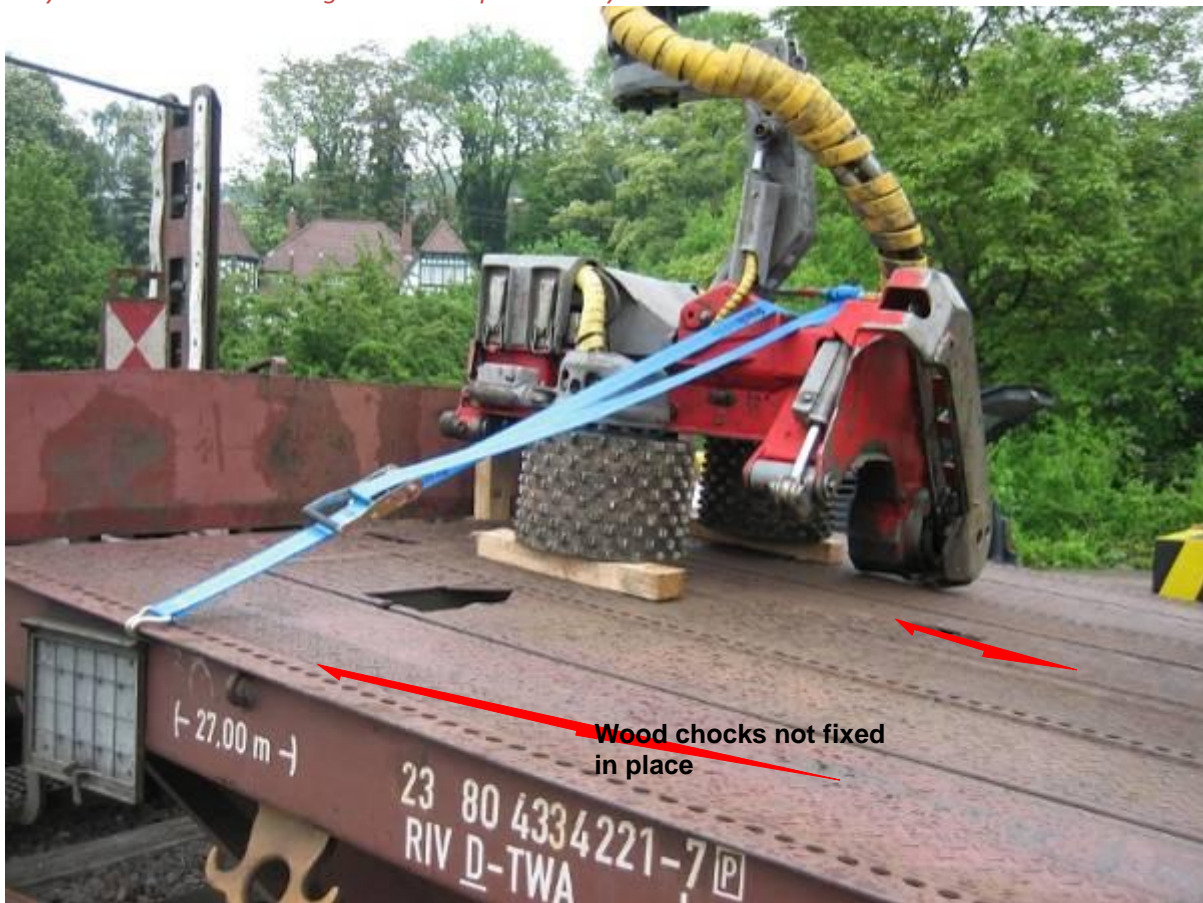
Figure1: Felling head not fixed to the bed of the wagon
In red, the possible transversal and longitudinal movements

The shipper chocked the felling head with narrow wood battens (100 X 100 mm) that were not fixed in place, and completed immobilisation of the felling head by attaching it indirectly with a strap hooked on the edge of the wagon.

This system did not comply with any rules, and it was bound to come loose during transport.

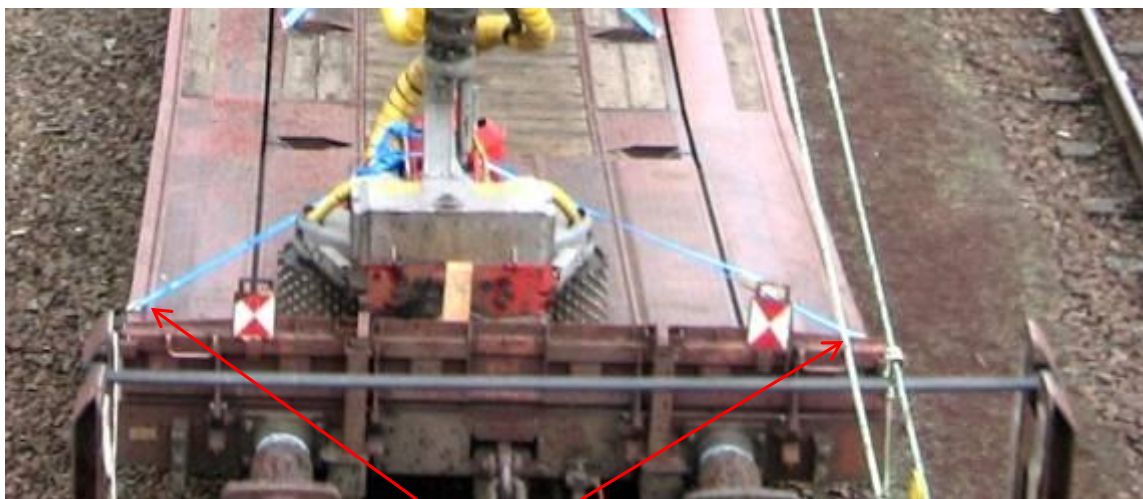
Figure 18 - Straps on edges of bed

This solution does not comply with the instructions:

- Indirect attaching with a single strap does not enable satisfactory transversal immobilisation of the arm and the turntable
- The strap was not strong enough; sheet 7.3 sets out a minimum strength level of 4 000 daN.

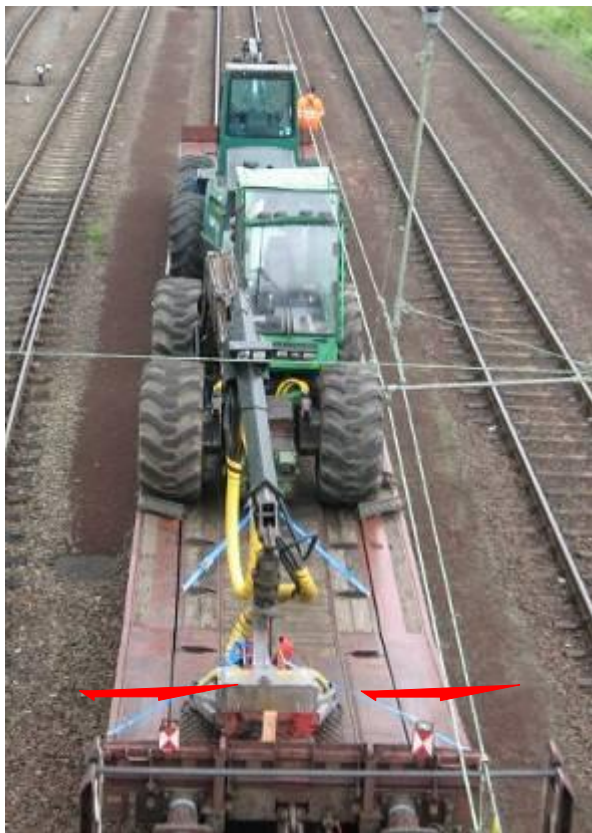
Photo taken after loading of the Skogsjan at Mosbach-Neckarelz station

In red, the oscillating movements of the Skogsjan 487XL arm and turntable

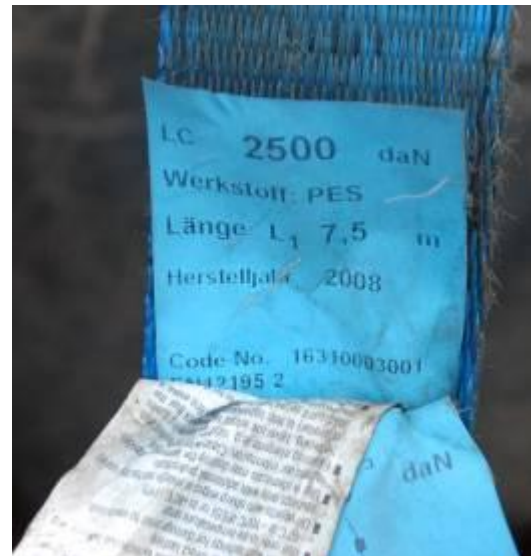
Figure 20: 2 500 daN strap found on the load

The type of strap shown in Figure 20 was found at various points on the wagon carrying the Skogsjan machine. Some of the straps were so worn and faded that it was no longer possible to make out their reference (cf. Annex 4).

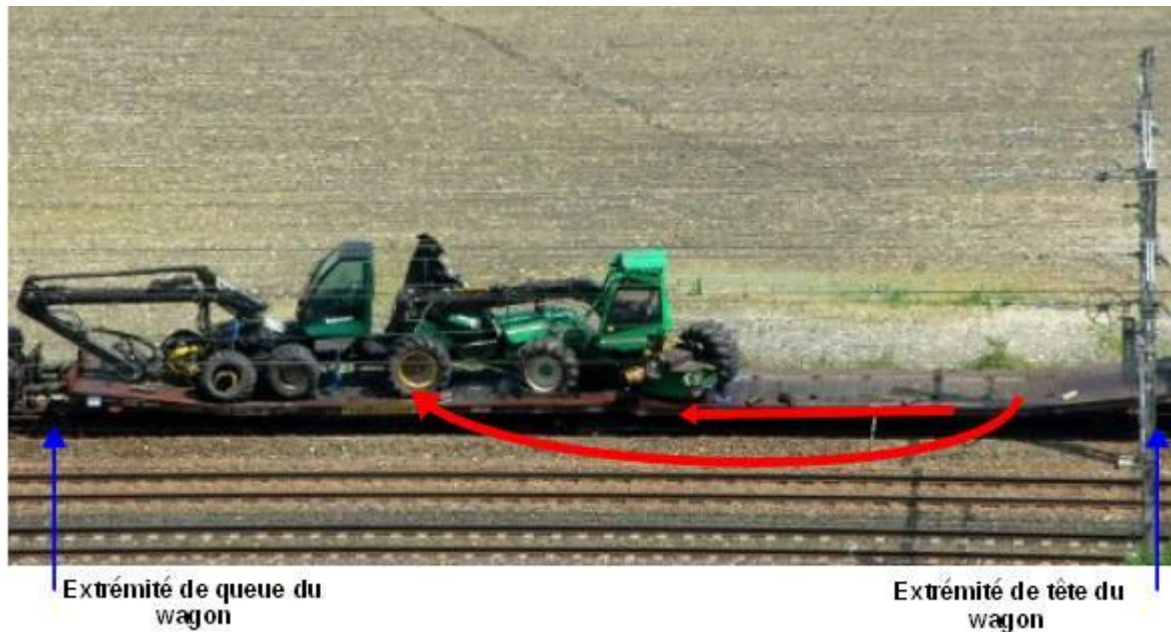
Figure 27: Wagon carrying the Skogsjan 487 after the accident

In the accident caused by the impact, the forestry machine moved across the TWA 800 wagon, the right front wheel hit the SNCF train and was ripped off in the tunnel.

The pivoting movement continued through 180°, and the remains of the Skogsjan 487XL's arm hit the "Timberjack" forestry machine placed immediately behind it on the same wagon, damaging that machine's engine. The judiciary authorities found various parts from the Skogsjan 487XL in SNCF train 56724. Annexes 8 and 9, set out in the form of summary tables, give details of the findings for all the equipment after the accident.

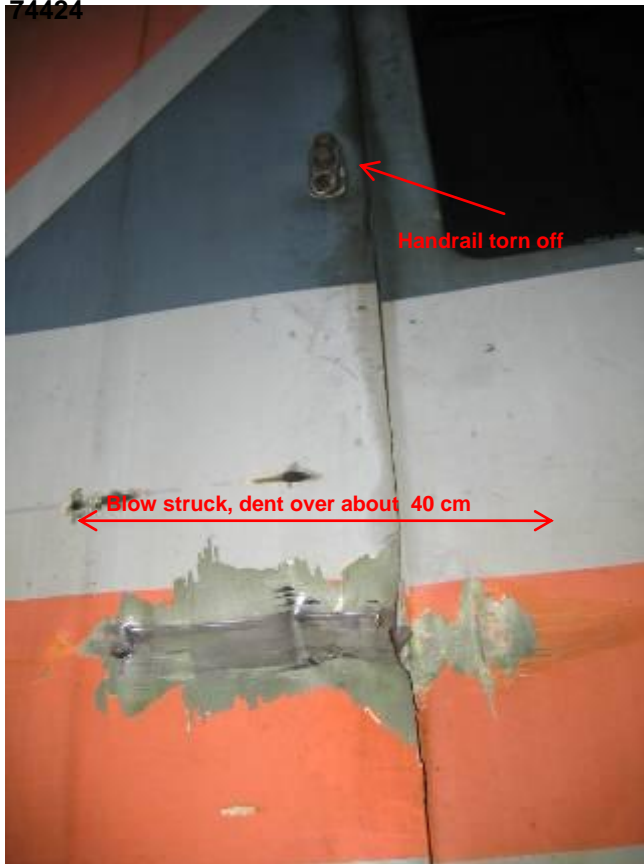
**BB 407360 of train
74424**

The driver of train 74424 thought at the time that a ballast stone had been thrown up, and continued on his way. When he stopped at Châtellerault, at about 1:55 a.m., he noticed the damage to the right-hand side of the locomotive: traces of blows, handrails ripped off, and ventilation grille louveres torn away.

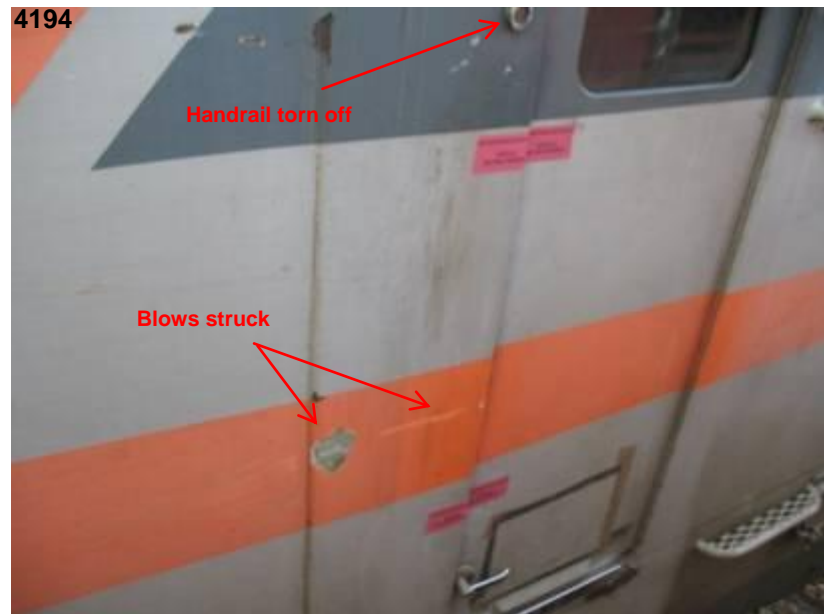
**BB 22267 of train
4194**

It was when he arrived at Angoulême, for a change of personnel, that he noticed the damage done to the locomotive: traces of blows, handrails and ventilation grille louveres torn off. He called the controller at 0:43 a.m., too late to avoid the accident.

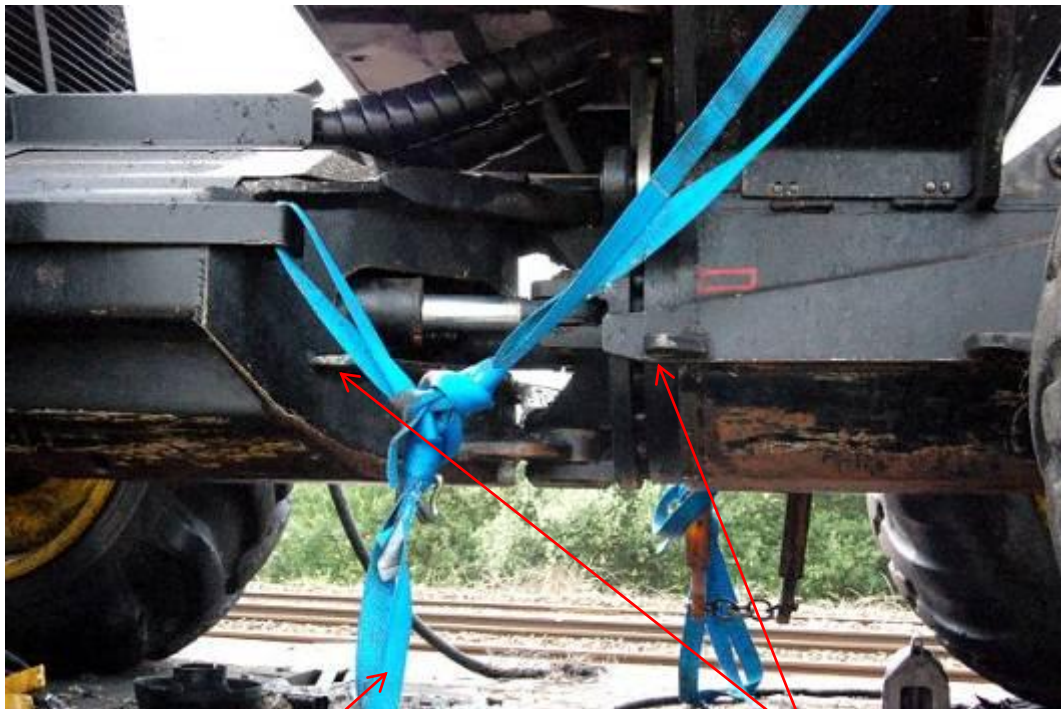
Straps found after the accident, not fixed carefully

Orifices to house the red immobilisation bar

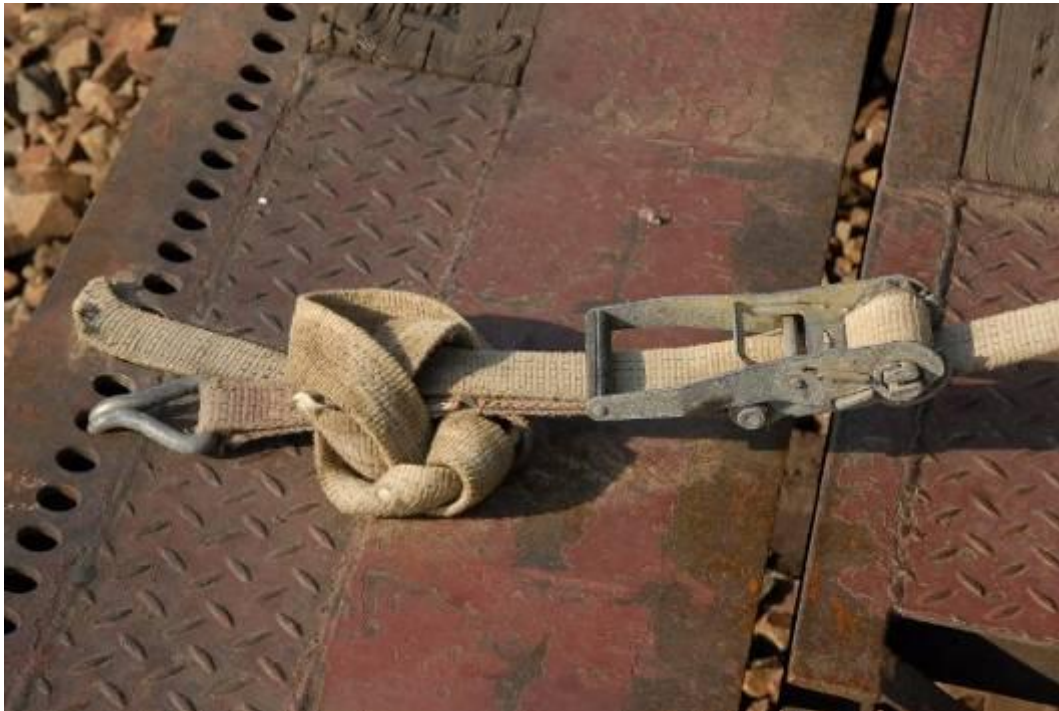
Well-worn strap found on the second wagon, which was only slightly damaged in the accident

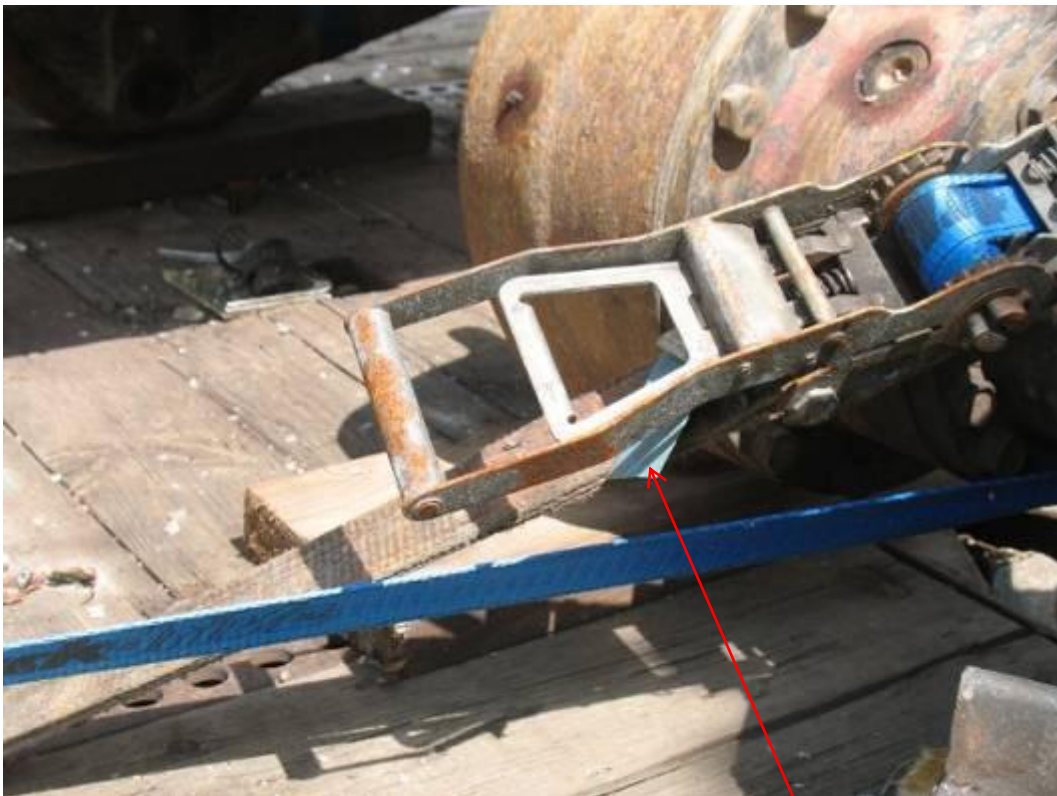
Strap found on the first wagon with a faded validity label
