*Bureau d'Enquêtes sur les Accidents de Transport Terrestre
(Land Transport Investigation Bureau)*

*Report on the derailment
of dangerous goods wagons
on 22 May 2010
at Neufchateau (88)*

date 02/02/2011

**Progress report on the derailment of dangerous goods wagons
on 22 May 2010 at Neufchateau (88)**

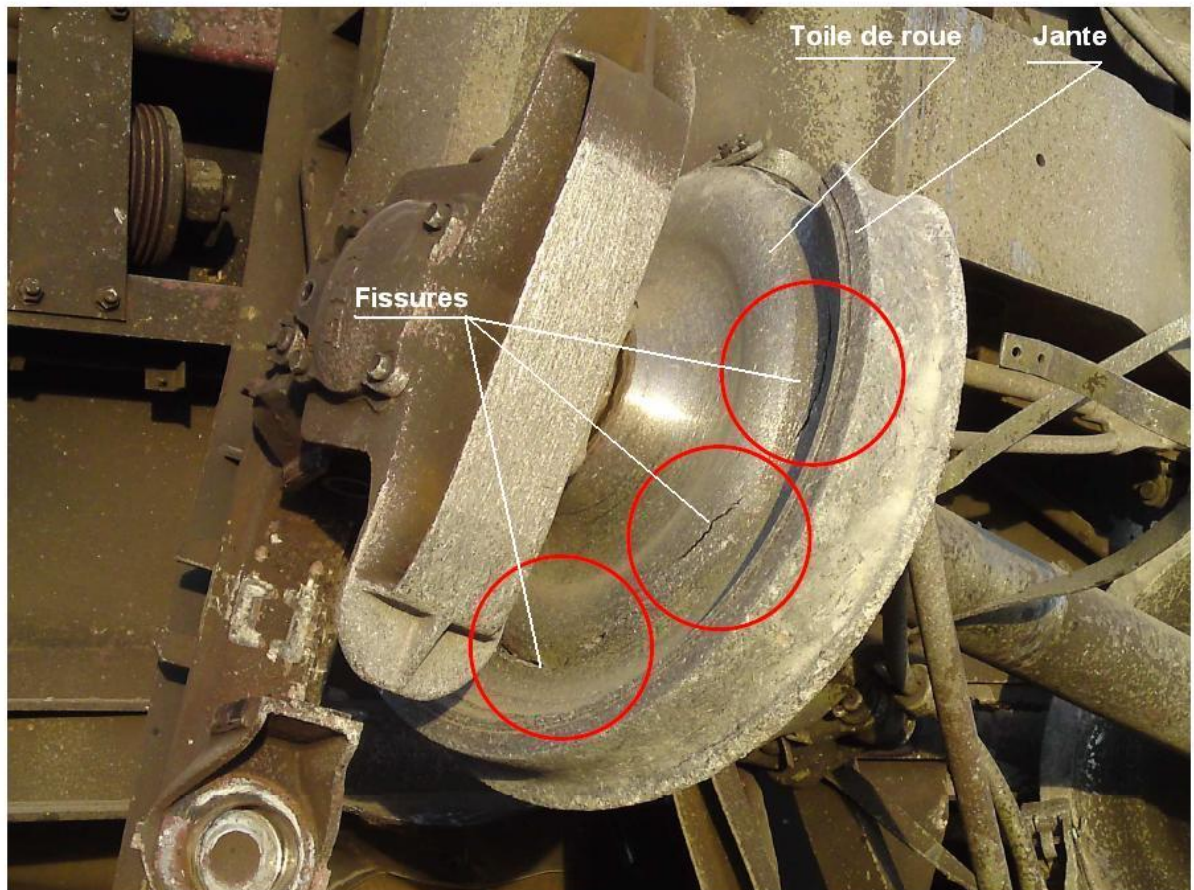
The front left wheel of the first derailed wagon is broken. Approximately one third of the rim is missing and the plate has circular cracks in an area located approximately 300 mm from the axle.

Figure 1 View of the damaged axle, on the wagon that derailed and keeled over

Toile de roue	Wheel plate
Jante	Wheel rim
Fissures	Cracks

The cause of the derailment of the first wagon involved in the accident appears to be related to the front left wheel breaking, resulting from a crack forming on the wheel plate during operation.
