***Technical Investigation Report
on the Derailment
of a Coal Train on
29 July 2010
at Bully-Grenay (62)***

August 2011

Case No. BEATT-2010-012

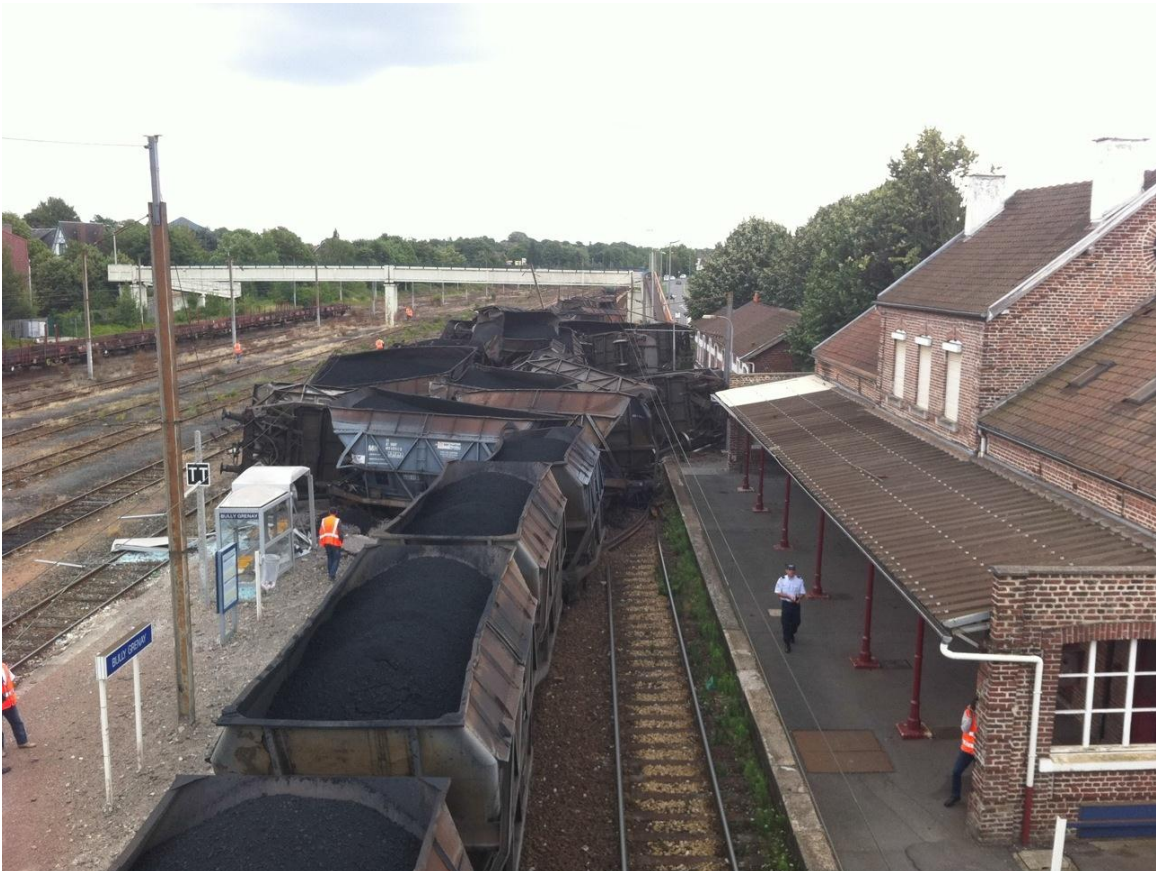
On 29 July 2010 at 11.10 am the 19 leading wagons of freight train SNCF 88214 became derailed on line 2 at the entry to Bully-Grenay (62) station. These wagons, loaded with coal, finished up sideways and resting on the tracks just past the station building, blocking the two main lines. They came to rest without causing any injuries but there was serious damage to the railway infrastructure over about 600 m.

Illustration 1: General view of the accident

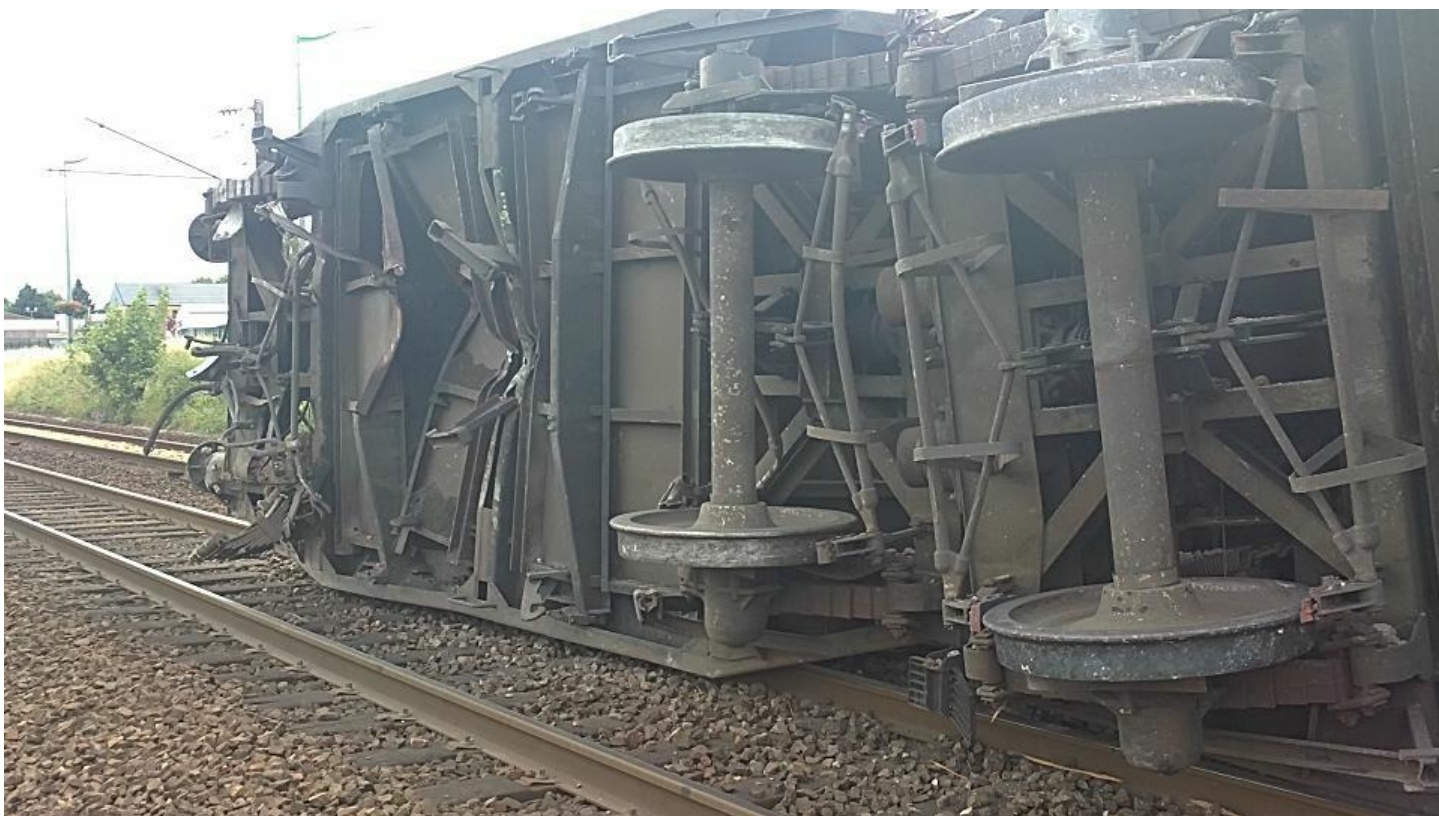
Illustration 8: The first wagon of the rake, lying on its side

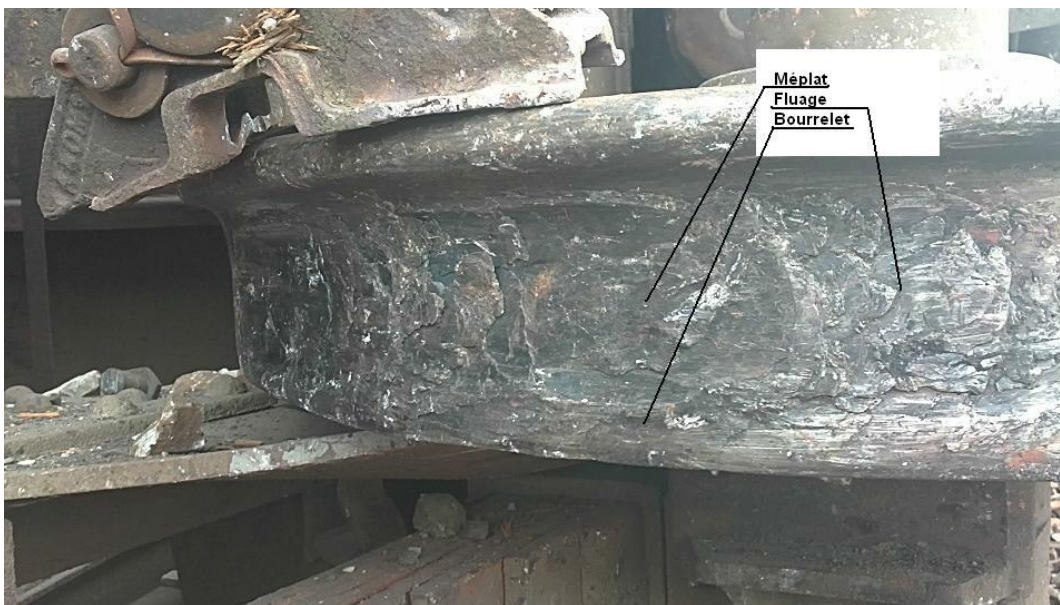
The brake blocks that were still present were in good condition and did not have any indication of overheating. The treads of the two wheels of the wheelset still present (wheelset 5-6) had three very large flats, the longest of which was about 20 cm long. At this size of flats the tread is hollowed at the centre forming a projection near the external side of the tread. By the flat which was the most marked, this projection reached a height of 8 mm.

At the back of these flats in the direction of rotation the metal had flowed and formed waves. The other wheelset of this half-wagon (wheelset 7-8 at the head of this train in the direction of travel) was found later. On the two wheels of this wheelset there was a flat similar to those on wheelset 5-6 but longer (25 cm) and more hollowed with a projection reaching a height of 13 mm. Moreover, one of the wheels of the wheelset had moved and was free on the central part of the axle.

Illustration 10: Wheel of wheelset 5-6 with flat, plastic flow and projection

In view of these indications it was concluded that the rotation of the wheelsets of the first half-wagon had been locked and that they had slid on the track for several dozen kilometres. Wheelset 5-6 had turned on several occasions causing three flats spread around the circumference of the two wheels. Wheelset 7-8 had not turned which explained the presence of a single flat on each wheel but longer and deeper.

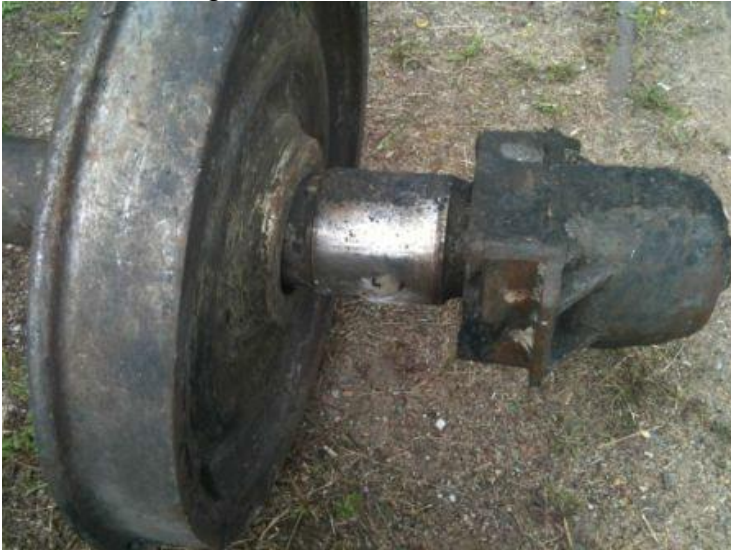
It was noted that the brake blocks still present on this half-wagon did not show any trace of heating and were not worn.

Illustration 11: Wheel shifted on wheelset 7-8

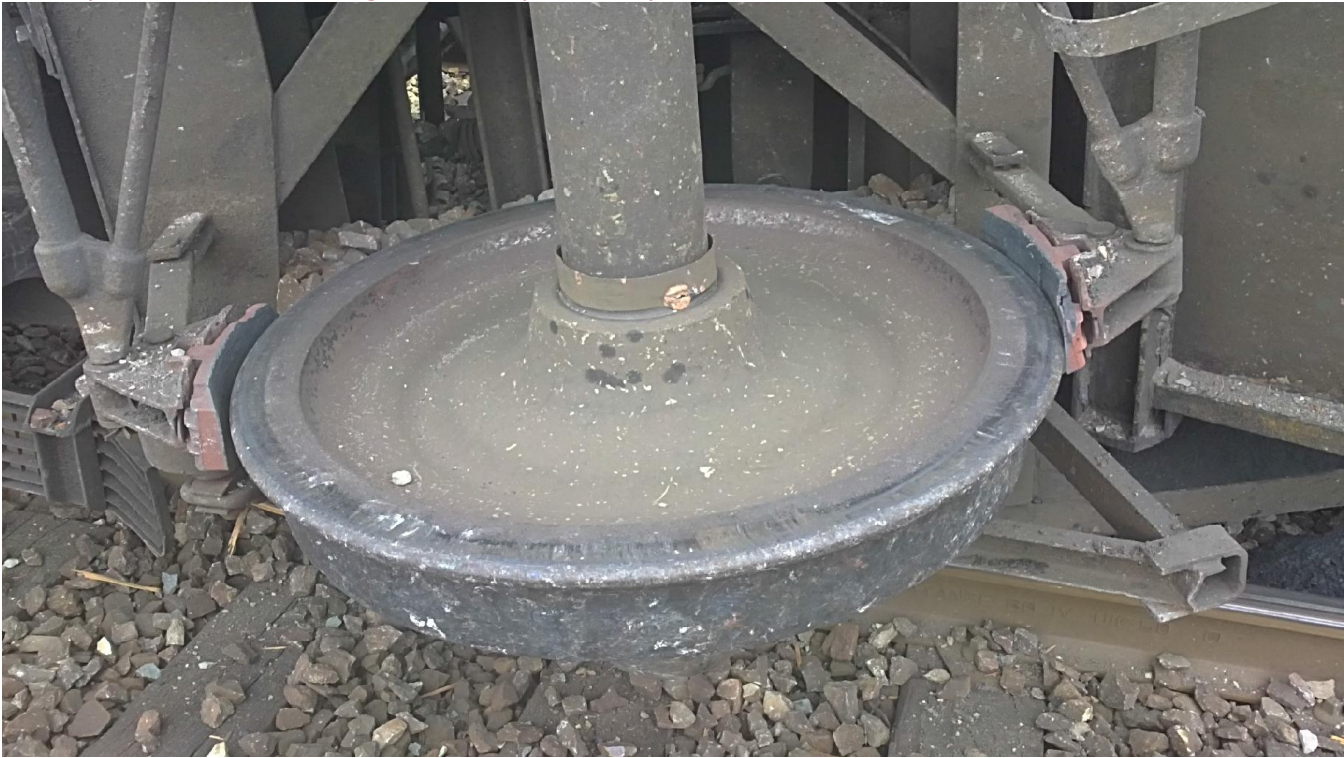
The wheelset in position 3-4 was present on the wagon; it had indications of serious overheating (metal blued, paint burnt). The four brake blocks of this wheelset were still in place but showed traces of overheating and heavy wear, the blocks being almost completely worn out.

The wheelset in position 1-2 was missing; it was located and identified. It had the same appearance as the wheelset 3-4. The same is true of the corresponding brake blocks.

It appeared, therefore, that the second half-wagon had run with the brakes applied for a considerable distance causing the overheating of the wheels and the blocks which were almost completely worn out. The absence of a flat on the tread indicated that the wheelsets of the second half-wagon had not been locked, unlike those of the first half-wagon.

Illustration 12: Wheelset 3-4 with its brake blocks very badly worn

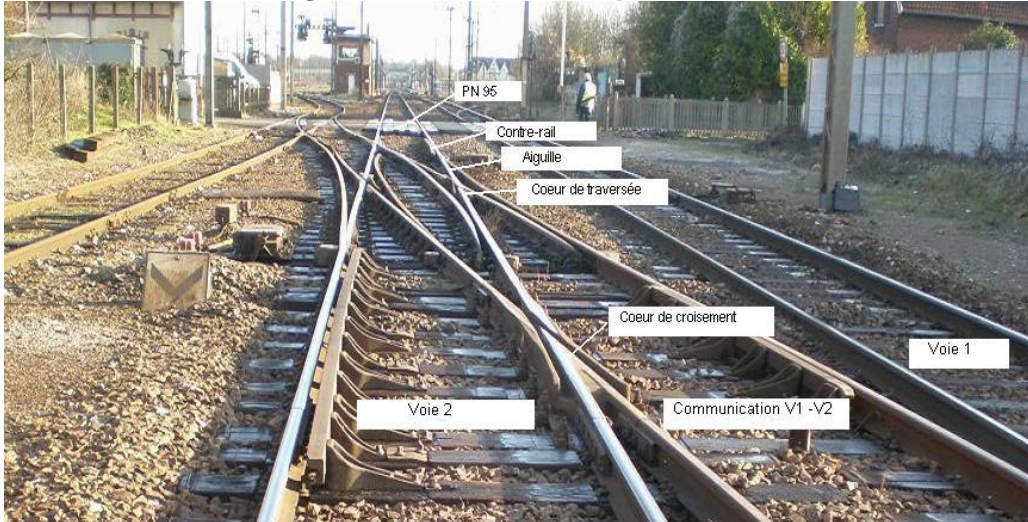
Illustration 14: General view of the double diamond crossing 22/23 on line 2

The last recording of the geometric characteristics of the track (Mauzin record) was done on 9 February 2010. A distortion of 9 mm on 3 m was found on the diamond crossing 22/23. This distortion corresponds to a warning level which does not require a speed restriction to be imposed; it was rectified on 1 March 2010. The crossing 22/23 was laid new in 1972. Before the accident the last annual check on its safety dimensions was carried out on 20 January 2010.

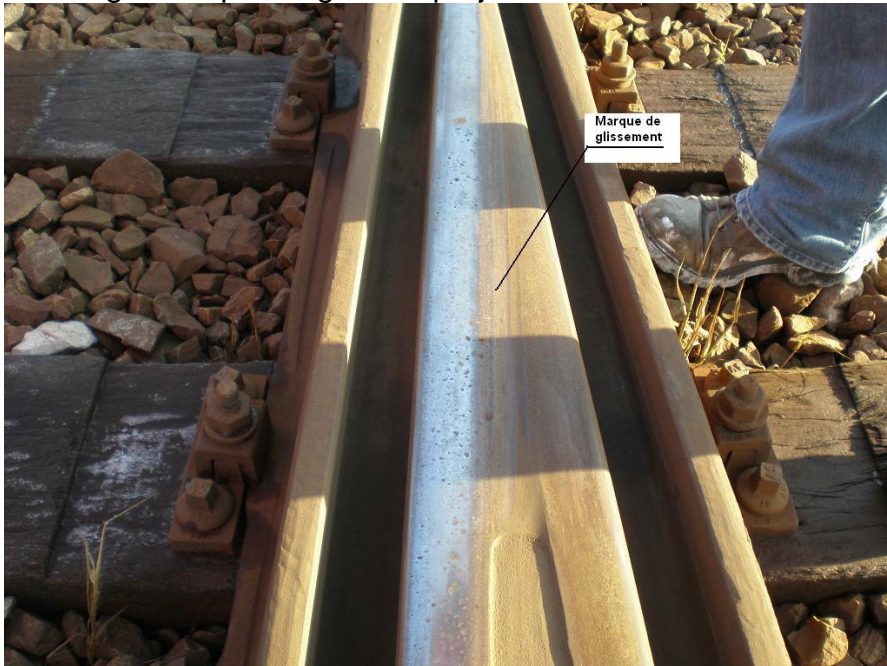
Longitudinal rubbing marks could be seen on the common crossing and the obtuse crossing corresponding to the projections of the wheels of the first half-wagon.

Illustration 15: Common crossing with marks

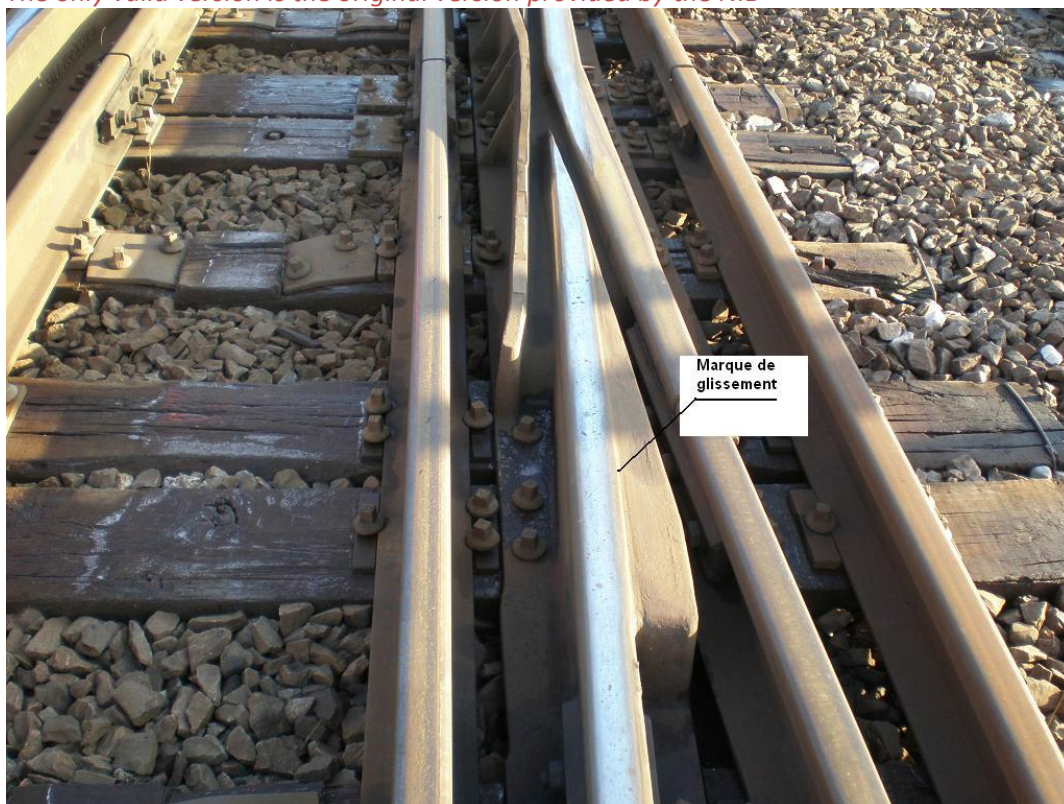
Illustration 16: Obtuse crossing with marks

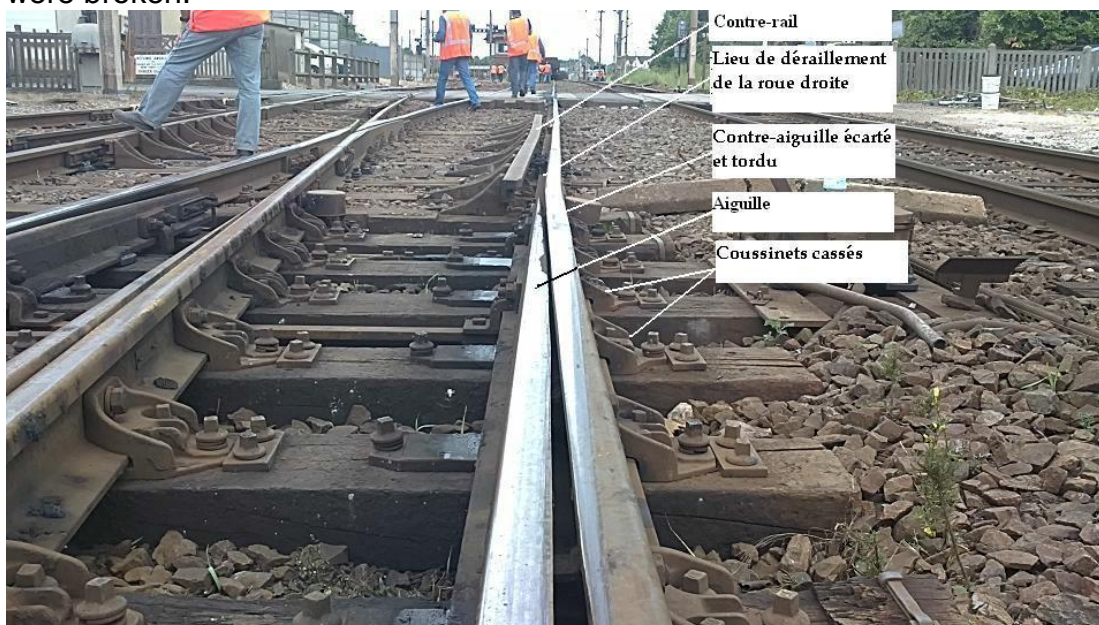
It was noted at the switch that the stock rail had been forced outwards and the chairs were broken.

Illustration 17: View of the switch and the stock rail

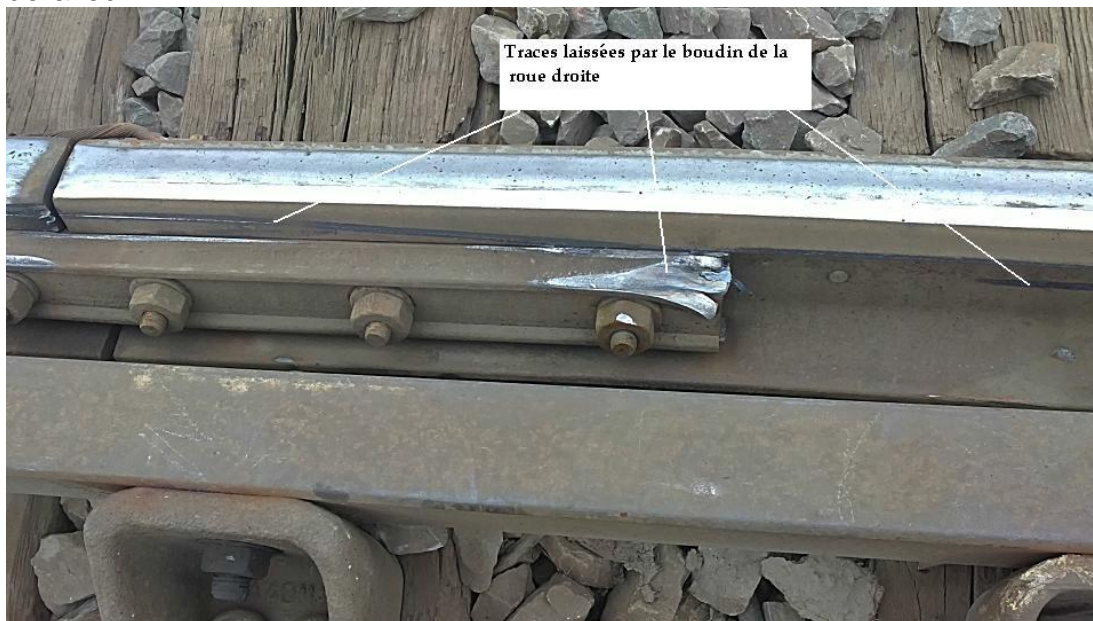
On the check-rail there were traces showing that the rail had been displaced towards the outside and that the flange of the wheel bore on the web of the rail and on the fish

Illustration 18: Traces of derailment on the check rail

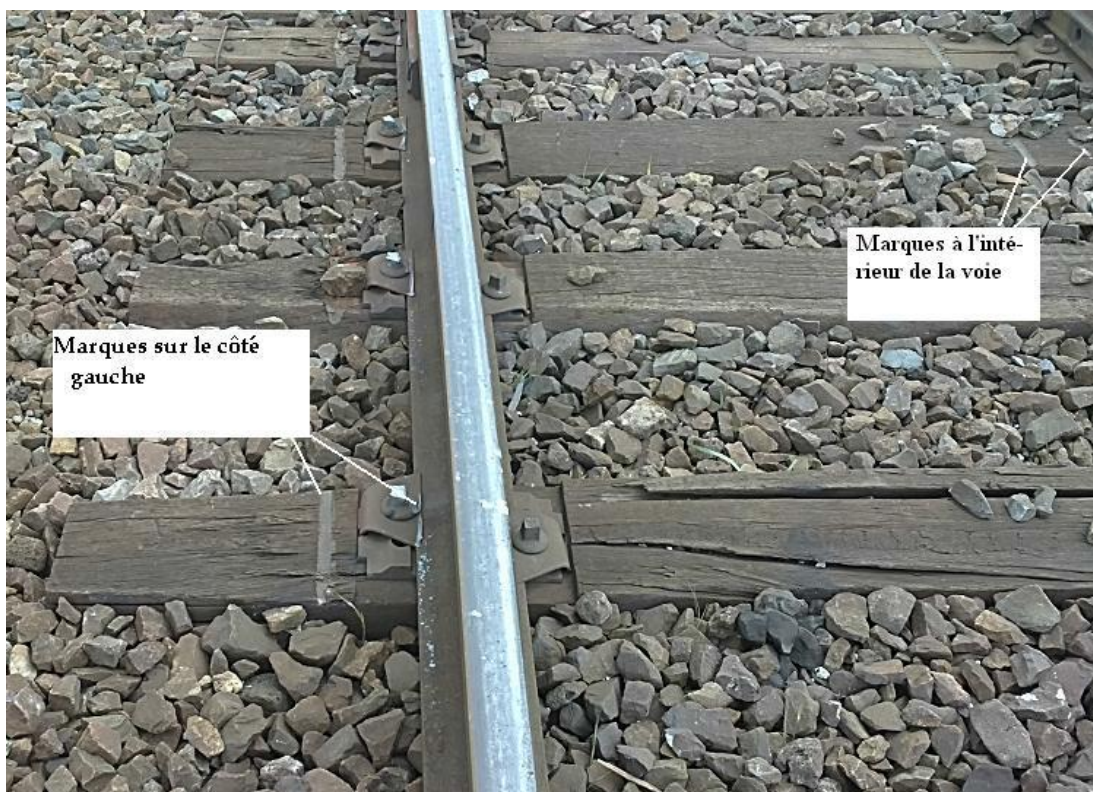
plate. Beyond the level crossing there were traces of wagons running on the sleepers inside the track and on the outside on the left side indicating that three wheelsets had derailed.

Illustration 19: Marks on the sleepers beyond the level crossing.

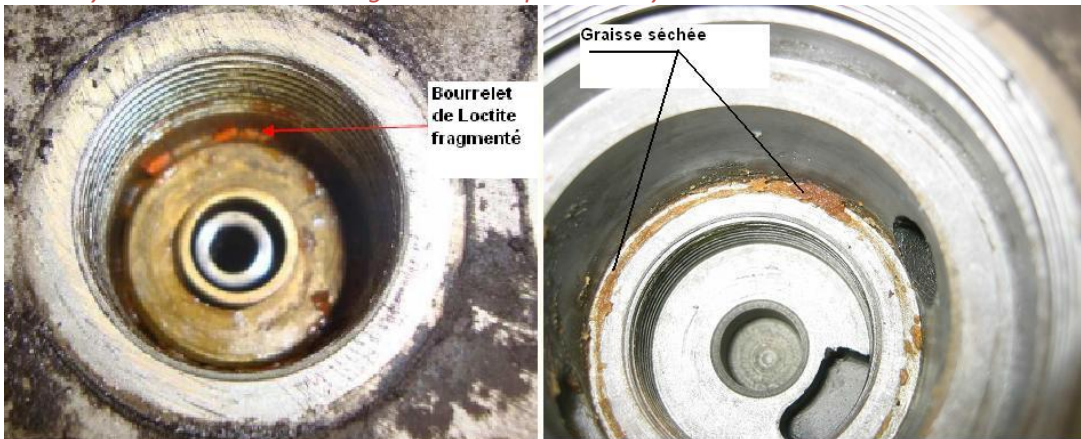
The tightness and functioning tests showed non conformities on the supply, application and release times as well as an exit pressure greater than the standard. However, these anomalies are not such as to explain the braking incident. During the dismantling a strip of Loctite orange product was found around the seat of the main valve and particles of this product in the sieve of the interface filter with the auxiliary reservoir on distributor side. Some accumulations of hardened and dried grease were also seen.

Illustration 21: Dismantling of the distributor

The presence of these materials which are likely to block the pipes of the distributor in an intermittent manner is not normal.

The bench tests showed that there was a serious leak and a utilisation pressure slightly higher than normal in the "empty" position. During the dismantling, swarf was seen inside the relay and on the seats of the valves. This pollution explains the leak found on the bench. It probably came from the cutting of the pipes after the accident, during the removal of the relay for it to be sent for assessment. A strip of adhesive was also found around a check valve seat from which fragments might have broken off.

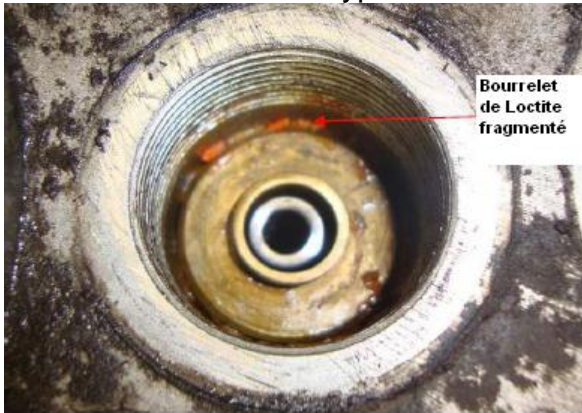
During the dismantling of the brake distributor from wagon 43 87 6531 611-4 on 26 November 2010 at the Technicentre of SNCF Rennes, the remains of a strip of adhesive of the Loctite type was found around the seat of the main check valve.

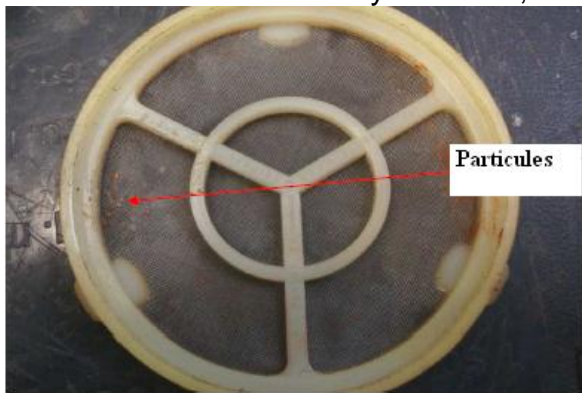
Some particles from this strip were found in the sieve in the interface between the distributor and the auxiliary reservoir, on the distributor side.

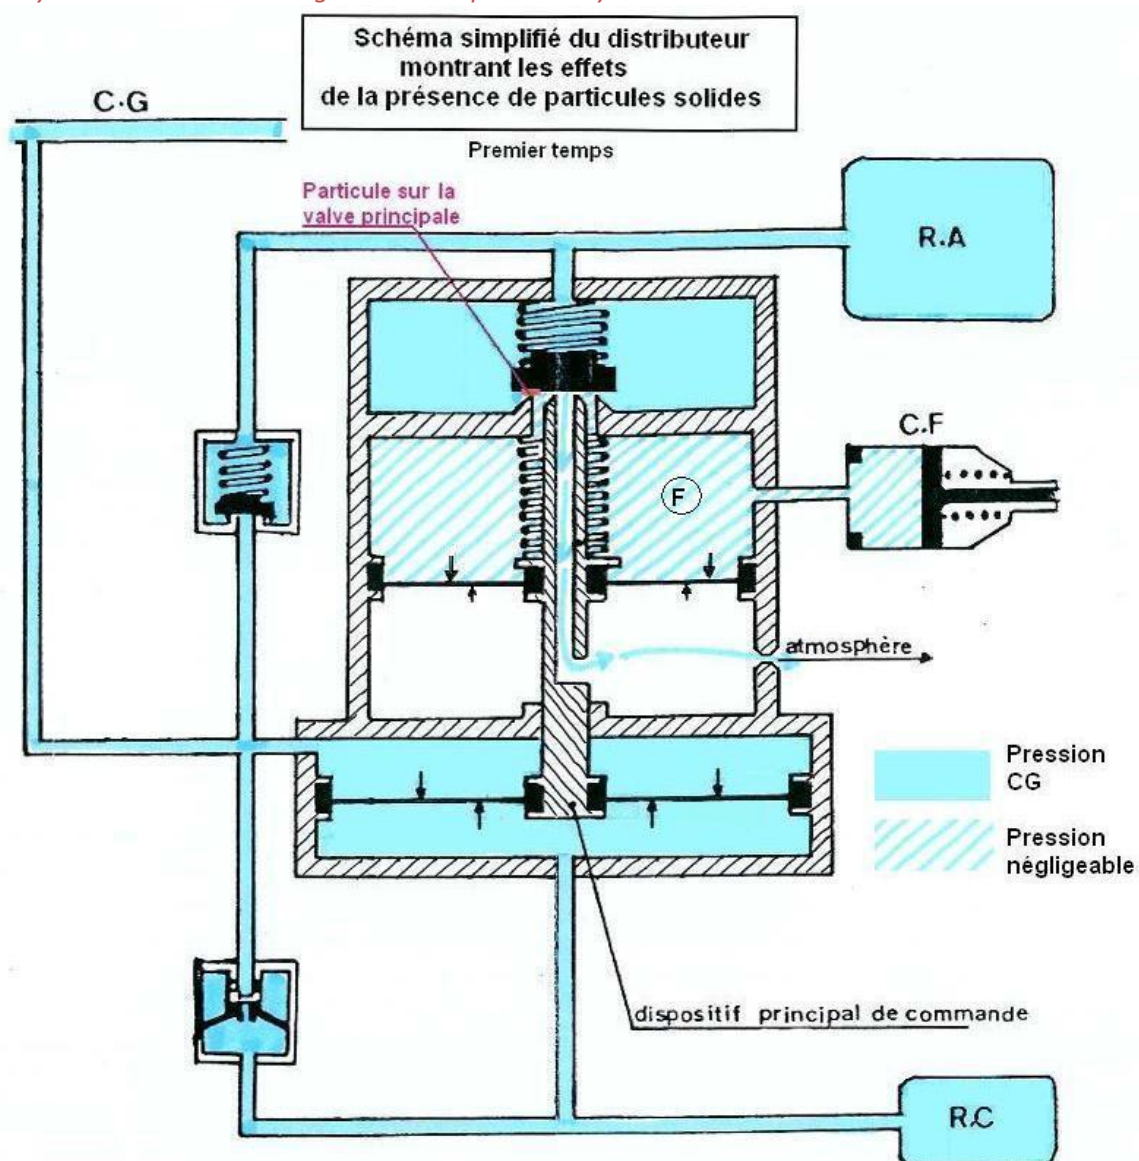
Initially

A particle came to rest on the face of the main valve; the air of the auxiliary reservoir entered the chamber F but, as soon as the pressure in this chamber increased the pressure on the membrane caused the hollow shaft of the main device to move down and the air escaped to the atmosphere.

At this stage the malfunction just resulted in a slight leak which remained within the tolerances of the brake tests. This situation could last for an indeterminate time without being detected.

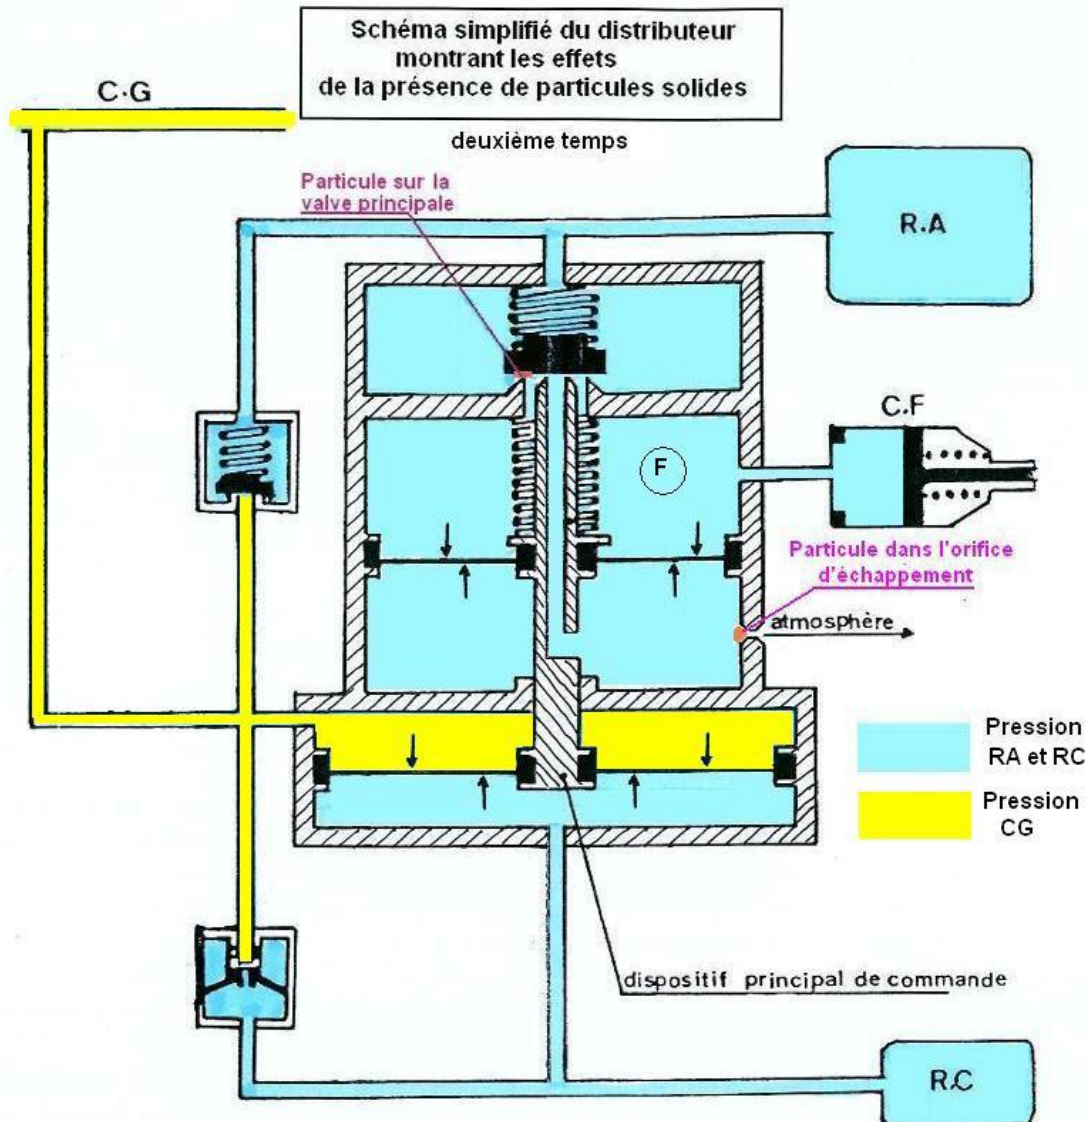
Afterwards

During the braking carried out at Hazebrouck, a second particle, drawn by the air flow, obstructed the orifice for venting to atmosphere, the diameter of which is about 1 mm.

The air in chamber F and the brake cylinder increased in pressure to 5 bar, exerting a very high braking force. As the air could not escape, the wagon brake remained applied with a pressure of 5 bar in the brake cylinder regardless of the pressure in the main brake pipe. Such a pressure in the brake cylinder is 30% more than that of a maximum service brake application or an emergency brake application which is 3.8 bar.

This abnormally high pressure, associated with the slowing down to 20 km/h of the train enables the locking of the wheels of the two leading axles of the wagon to be explained.
