DERAILMENT OF TRAIN 46676

on 16 June 2010

**on the Arlberg line
between Hintergasse and Braz stations**

Accident Investigation Report

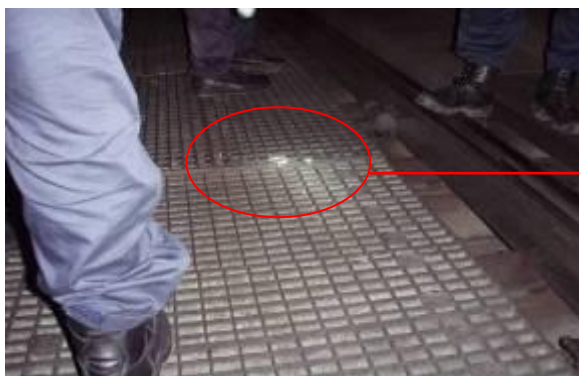
When running through Langen am Arlberg station, the brake coupling between the sections of the first wagon had sunk so far that it reached the level of the rail surface or slightly below it. Right from the entrance to the Blisadona Tunnel (leaving Langen am Arlberg station) the first signs of scoring and shearing were evident on the decking of a crossing between the rails of the track that was used.

Figure 10 Signs of shear in Blisadona Tunnel

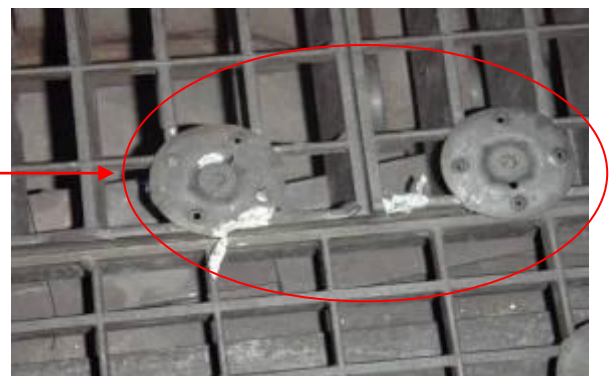
Figure 11 Detail of the signs of shear

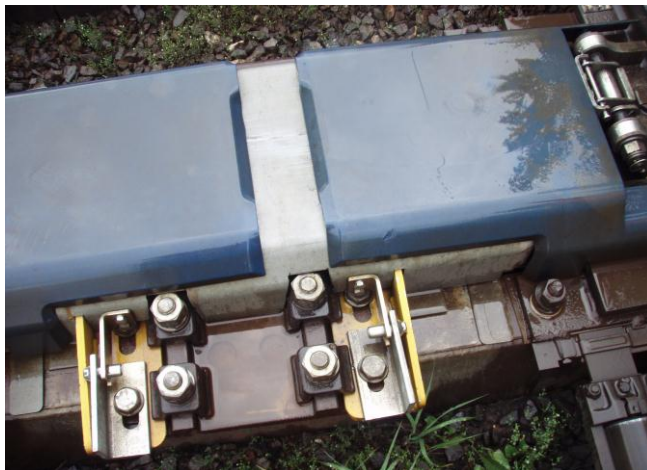
As the journey continued downhill, the brake coupling, which was hanging down, struck the covers of the point mechanisms in Wald am Arlberg and Dalaas stations.

Figure 12 No 251 points Wald am Arlberg station

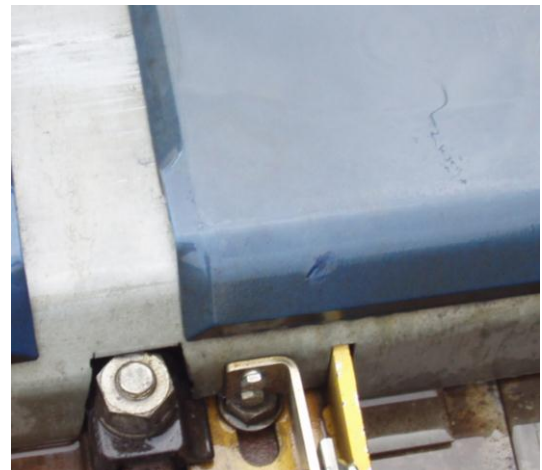
Figure 13 Detail of No 251 points

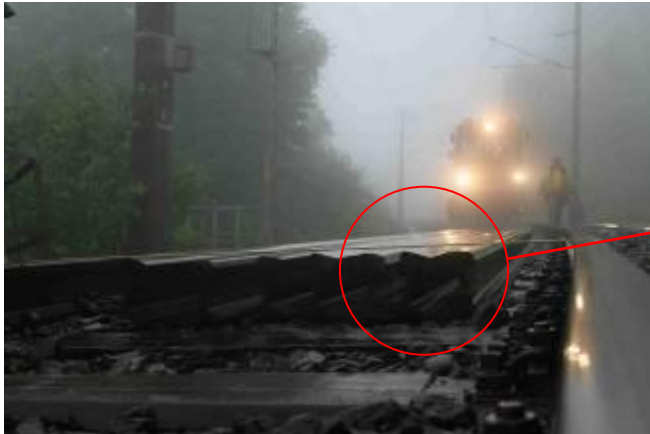
Between Dalaas and Hintergasse stations starting at km 122.722, used rails were being stacked on the track in accordance with the regulations and outside the normal loading gauge. As train 46676 ran over this section, the brake coupling which was hanging too low hit the end of the stacked used rails.

Figure 14 Stacked used rails

The rails at 122.722 km were stacked for disposal in such a way that the normal loading gauge in accordance with ZOV 7 [Lineside structure gauge] was clear. The minimum clearance of a maximum of 50 mm above rail level to be maintained for the storage of solid objects in accordance with ZSB 9 was observed. The lateral minimum clearance to the running rails of at least 40 mm in accordance with ZSB 9 was not exceeded.

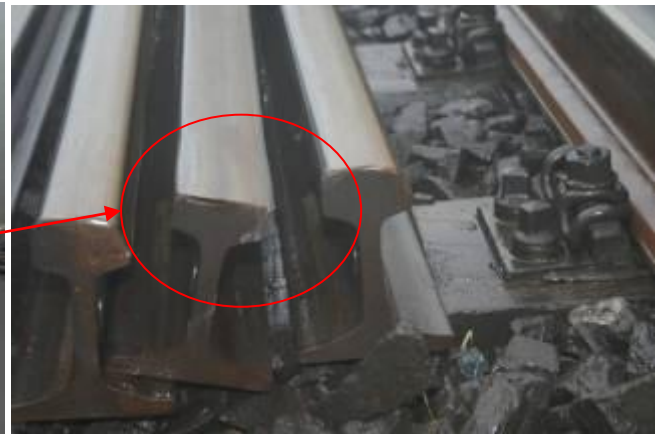
Figure 15 Point of impact

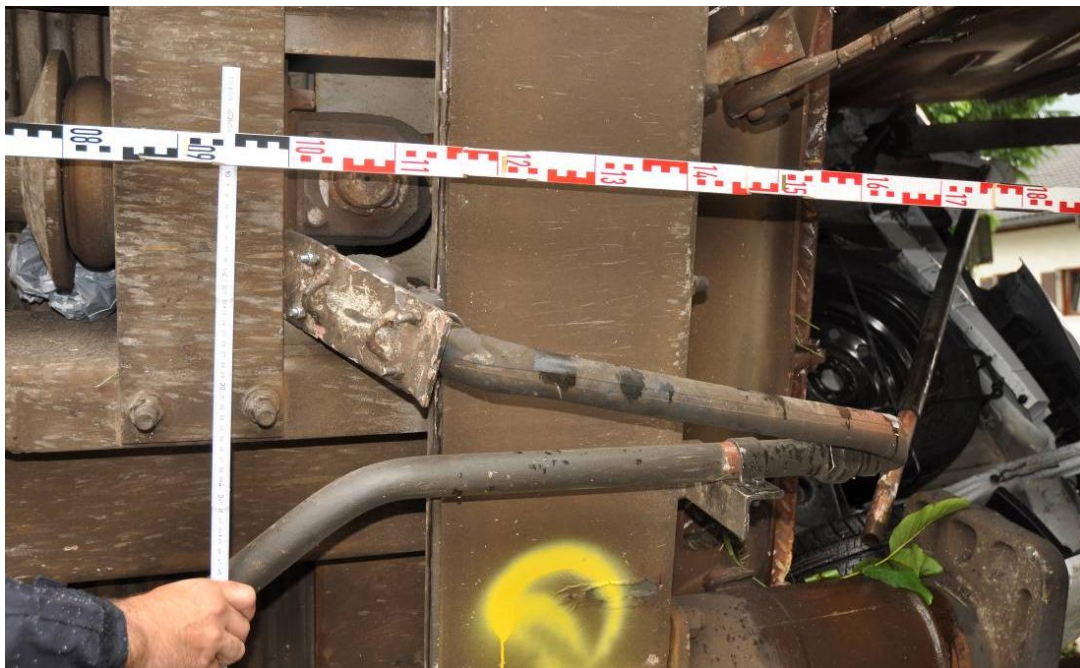
The impact pulled the coupling off the brake hose of the leading section of the wagon. In consequence, the coupling of the following section of the wagon together with the brake hose was thrown back and upwards and become wedged in the underframe between the buffer beam and the plate covering the springing of the draw gear of the following section of the wagon. In this way the brake hose was kinked at the point at which it met the main brake pipe so that air could not escape. (Figures 16 and 17).

Figure 16 Kinked air hose with brake coupling (source: Bregenz CID)

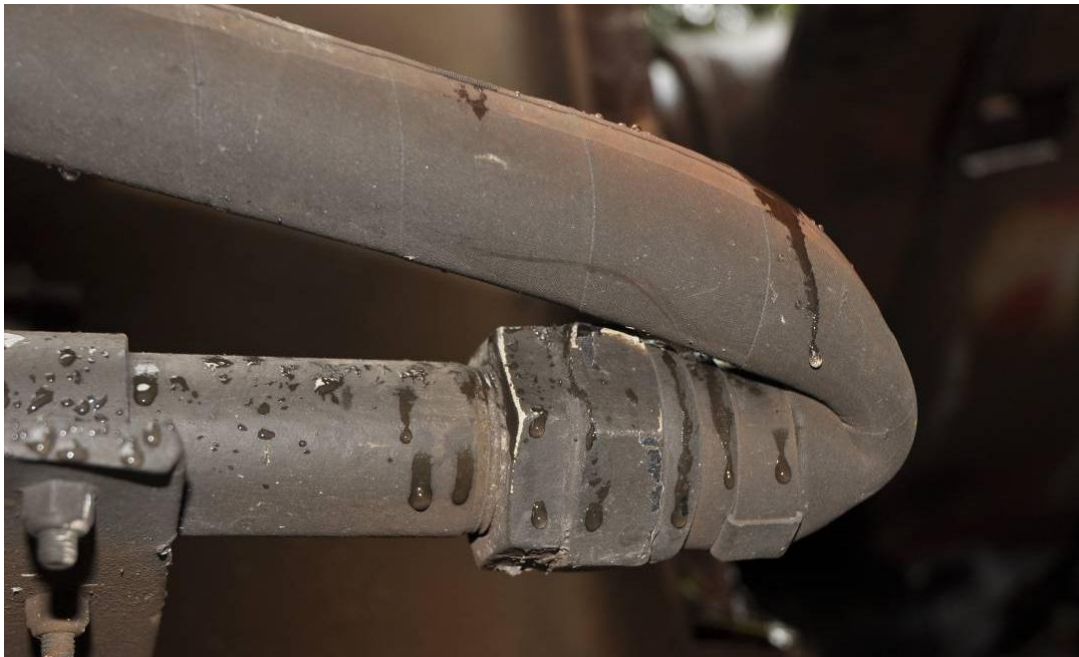
Figure 17 Detail of the kinked air hose (source: Bregenz CID)

The main brake pipe in the front part of the train (locomotive and leading section of the wagon) was open across most of cross-section and caused automatic braking of the locomotive and the first section of the wagon. The kinked brake hose prevented the air coming out of the following 15 ½ vehicles. The main brake pipe thus remained sealed so that no automatic braking took place on the following vehicles.

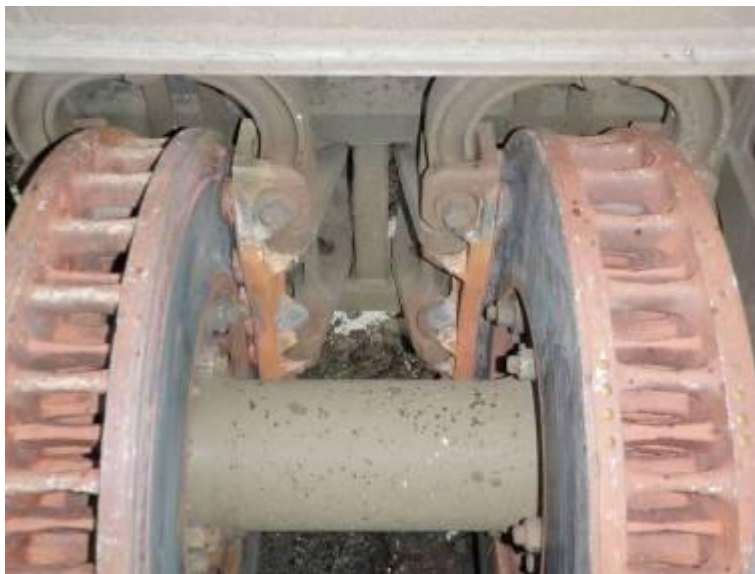
The derailed locomotive was given a close inspection on site. After the derailment the locomotive rolled on to its side and came to rest close to km 129.116. Both bogies were separated from the underframe and the rear bogie was readily accessible. It was noted that on this bogie the disc brakes were hard on. Clear signs of discoloration through heat could be seen on the brake disks. This was a clear indication that the brakes on the locomotive had operated and of significant thermal stressing.

Figure 28 Brake discs on the rearmost brake shaft

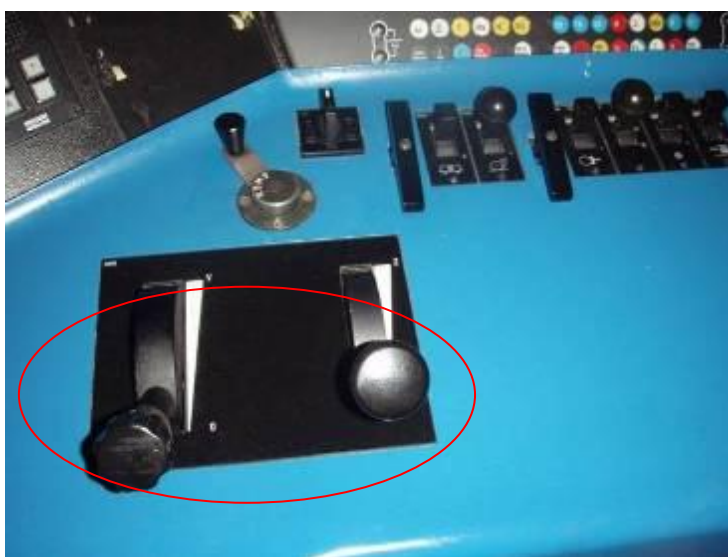
In the cab, the position of the traction controller and the brake handle were documented. The speed and traction/braking controller were in position “0”.

Figure 29 Traction controller

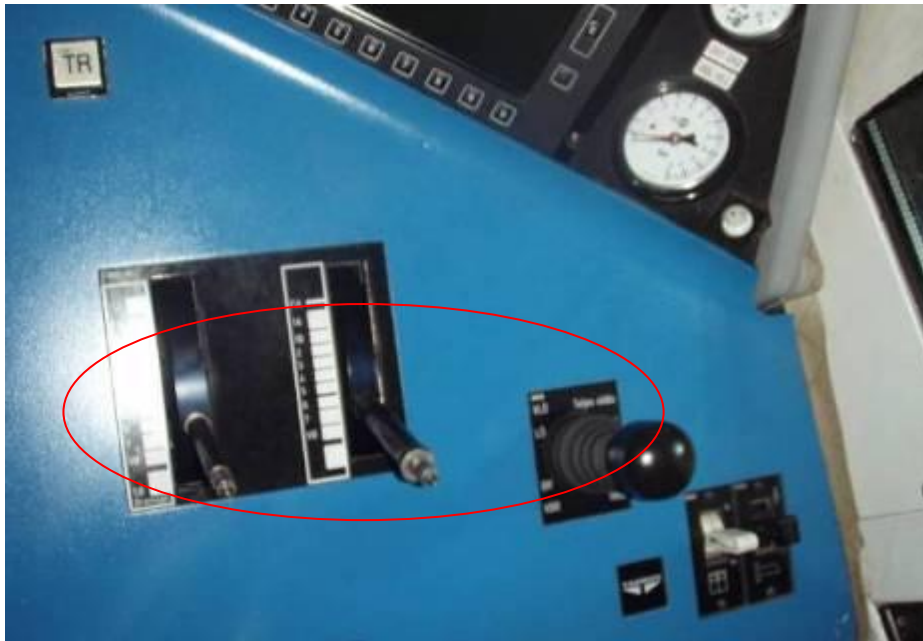
direct brakes was in the central position and was not in the “complete release” position. That meant that the brake lever for the indirect brakes had also been operated.

Figure 30 Brake handle

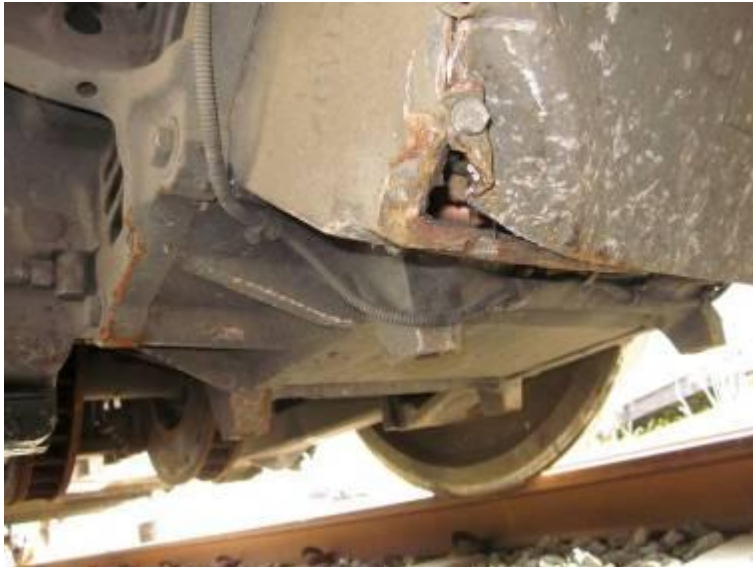
The bottom of the locomotive was visually examined in Bludenz station on 23 July 2010. The bottoms of both bogies were severely damaged by the derailment and by sliding over the embankment and road. That damage is to be regarded as the consequence of the derailment.

Figure 31 Bogie No 2

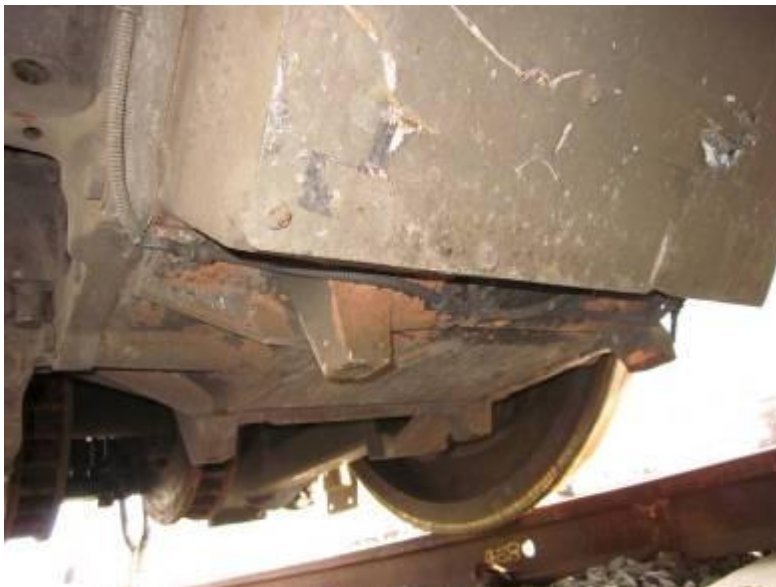
Figure 32 Bogie No 1

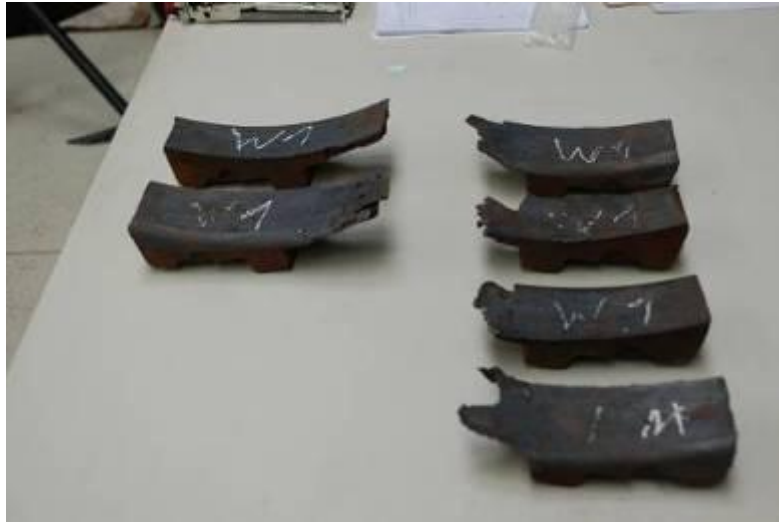
The derailed wagon was examined on site. After the derailment, the front section of the wagon came to rest with the underframe on top and the rear section of the wagon ended on its side. All four wheel sets were separated from the underframe. It was possible to recover six of the eight brake shoes of the front section of the wagon. These were completely worn through in places.

Figure 36 Brake blocks of the front section of the wagon

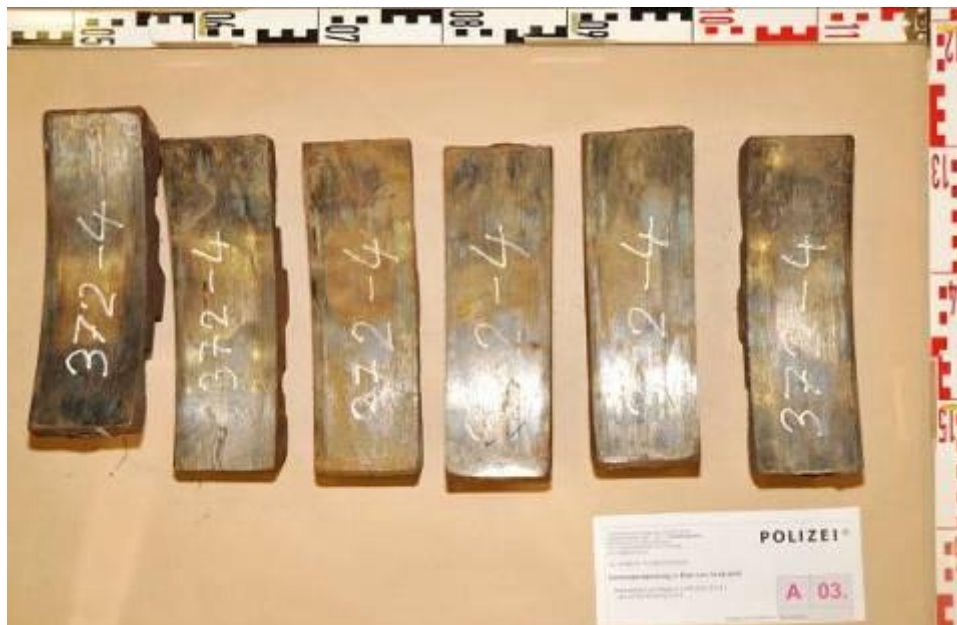
Likewise, it was possible to recover six of the eight brake blocks from the following section of the wagon. These showed normal signs of use.

Figure 37 Brake blocks from the following section of the wagon (source: Bregenz Criminal Investigation Department)

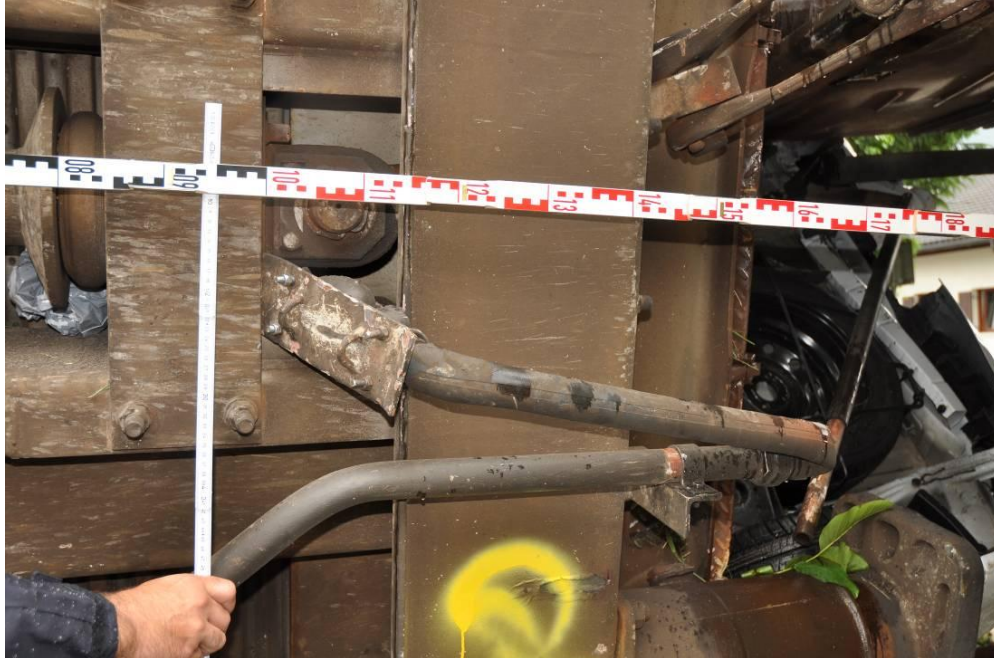
In the following section of the wagon, the brake hose together with the coupling and metal plate was bent back (in terms of the direction of travel). The brake coupling was wedged in a 16 cm wide gap between the buffer beam and the covering of the spring element of the draft gear and hence the brake hose was kinked.

Figure 38 Brake coupling of the following section of the wagon

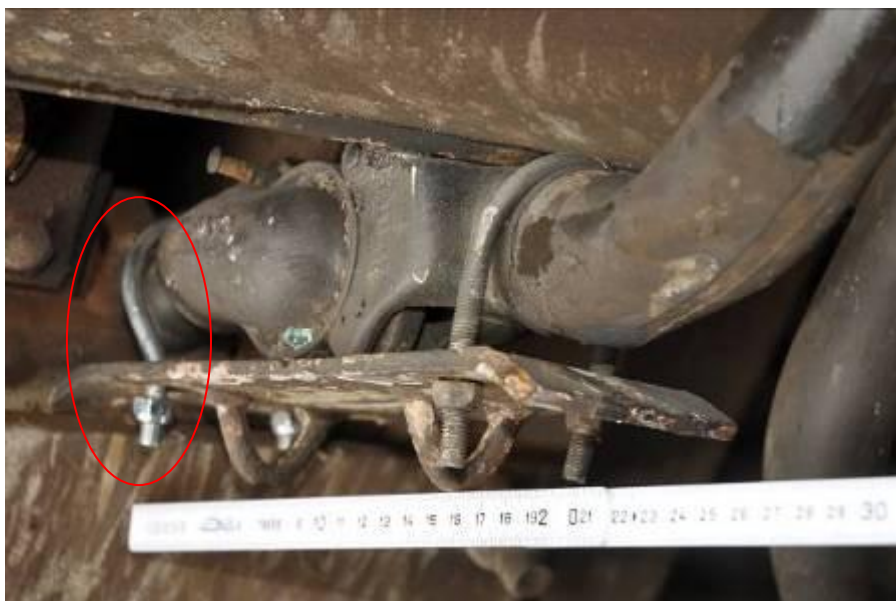
Noticeably, a new U-bolt was bolted to the metal plate on the brake coupling. This U-bolt showed no signs of rust or brake dust at all. This pointed unambiguously to maintenance work having been done on this brake coupling in the last workshop visit.

Figure 39 Metal plate with a new U-bolt

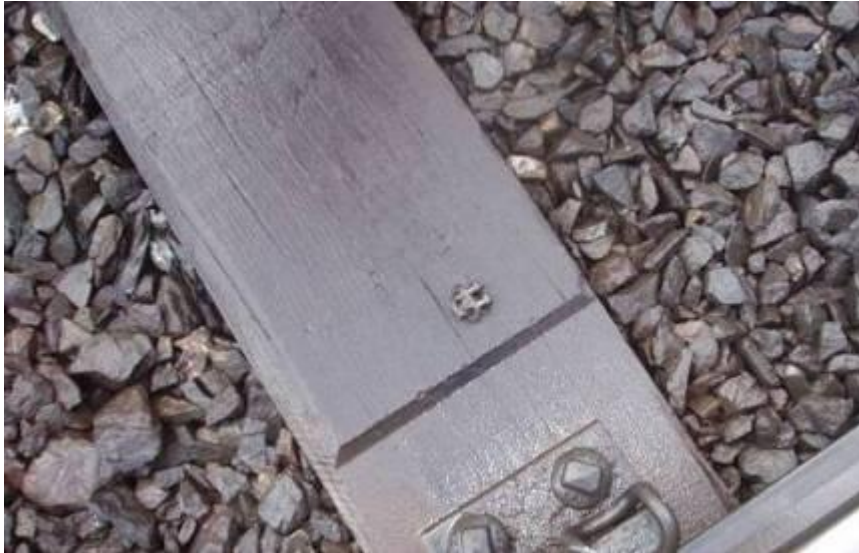
The continuous impacts and the dynamic movement of the brake coupling caused the securing cable to come completely out of the cable grip. The cable grip came off in Wald am Arlberg station between the last set of points and the entrance signal for the opposite direction; it was recovered at km 116.633.

A cable grip from the securing cable from wagon 372-4 was recovered on 17 June 2010 in Wald am Arlberg station at 116.633 km.

Figure 40 Cable grip

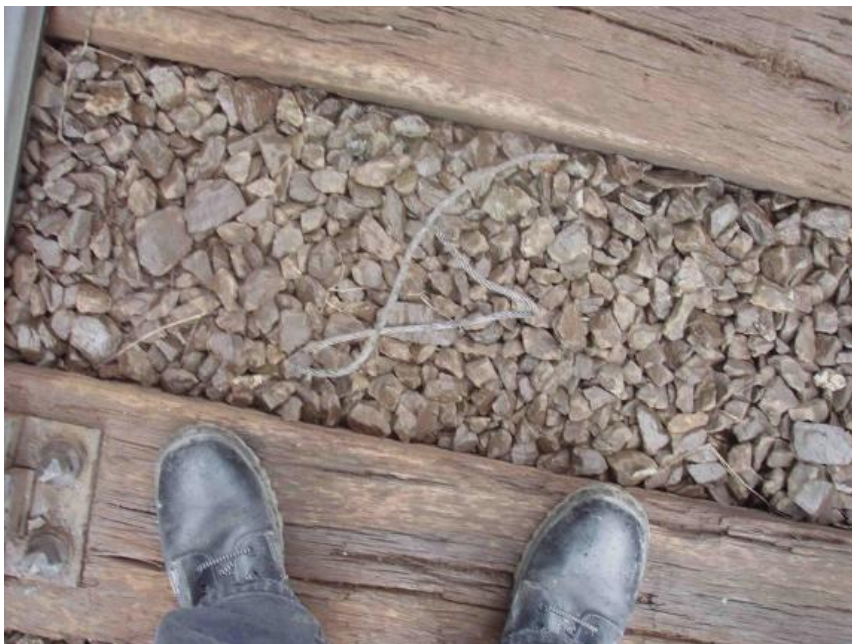
The securing cable from the brake coupling was recovered on 17 June 2010 in Da-laa-s station at 120.620 km. These components were assumed to have come from wagon 372-4.

Figure 41 Securing cable

It was possible to establish from the visual examination of the damaged cable that it had been in use in various fittings and had been worn out by the scuffing and chafing of its fabric and the relative movements which are to be expected on vehicles. The consequent loss of tensile strength cannot be assumed to be a potential risk because of the low tensile strength required.

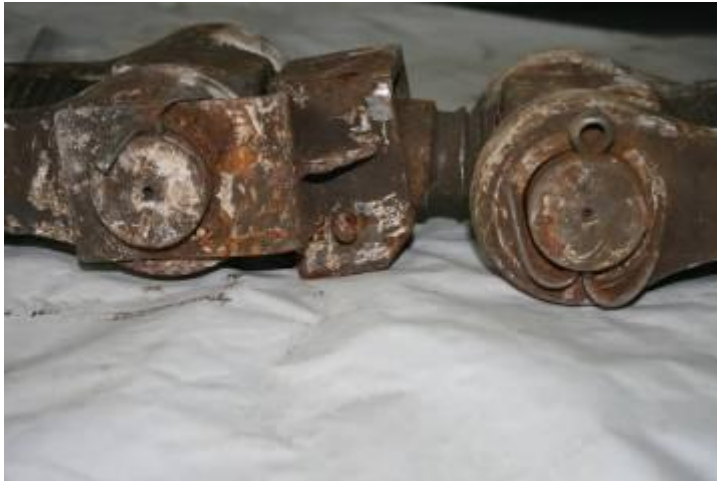
The screw coupling was recovered by the Bregenz Criminal Investigation Department but examined in the Federal Office of Transport. In doing so, the three securing pins of the anti-rotation device were removed. No clear conclusions on the securing pins time in service could be drawn.

Figure 42 Screw coupling in the middle of the vehicle

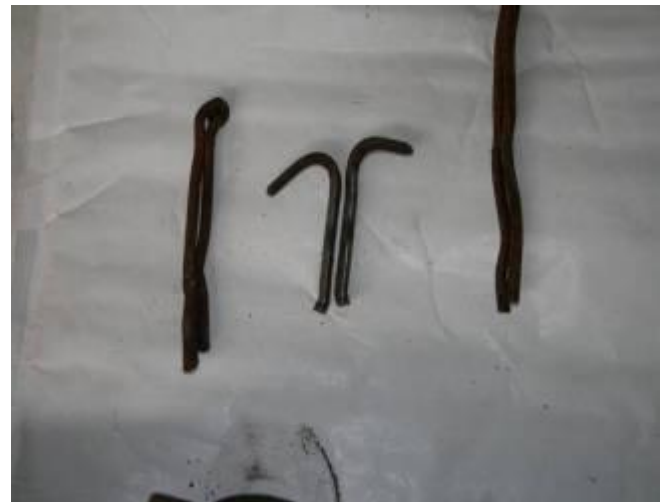
Figure 44 Securing pins extracted

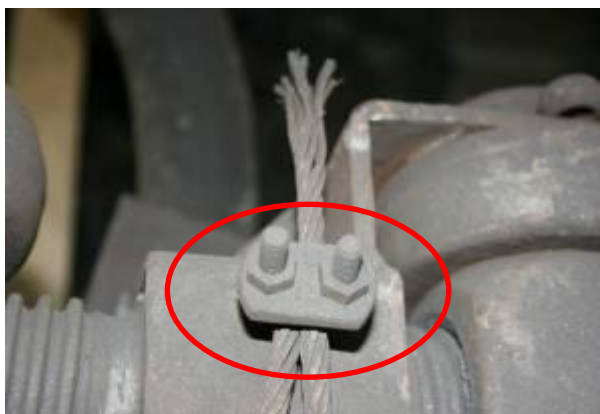
In the technical examination of the coupling points in the middle of the wagons, it was noted that in the case of 10 of the 16 wagons examined, the cable grips and securing cables were identical to the components recovered from wagon 23 87 437 2 372-4 involved in the accident to train 46676. On the remaining six wagons, various cable grips, sometimes with CE markings and various securing cables to secure the brake coupling were found. In addition, large differences were sometimes found in the measured distance between rail level and the lowest point on the brake coupling. The values measured extended from 160 mm to 280 mm above rail level.

Figure 45 Cable grip with CE marking

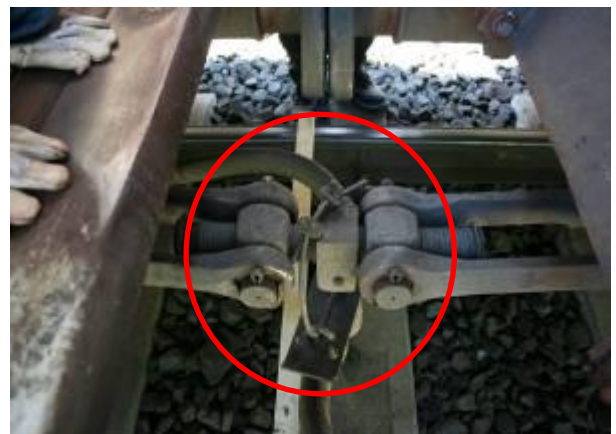
Figure 46 Securing cable with plastic sleeving

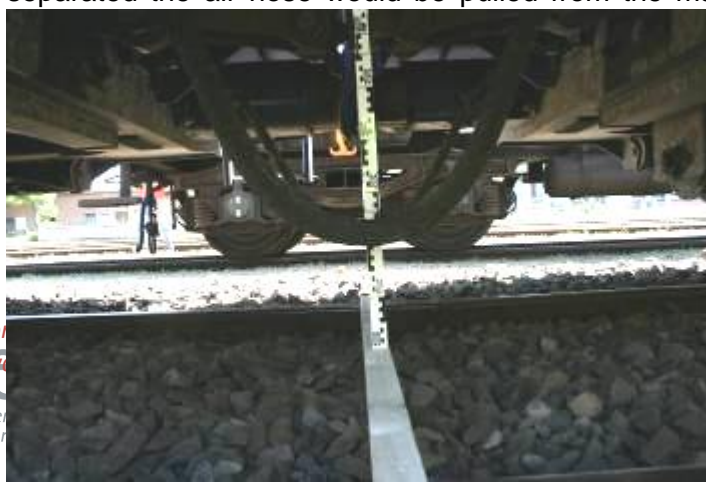
In doing so, it was noted that instead of the construction air-hose, brake coupling, metal plate, securing cable and so on, a continuous air-hose was used for the main brake pipe link between the two sections of the wagon. With that construction, if the train separated the air hose would be pulled from the main brake pipe and an automatic brake application initiated. A distance of 230 mm was measured between the rail head and the lowest point on the brake hose.

A distance of 230 mm was measured between the rail head and the lowest point on the brake hose.

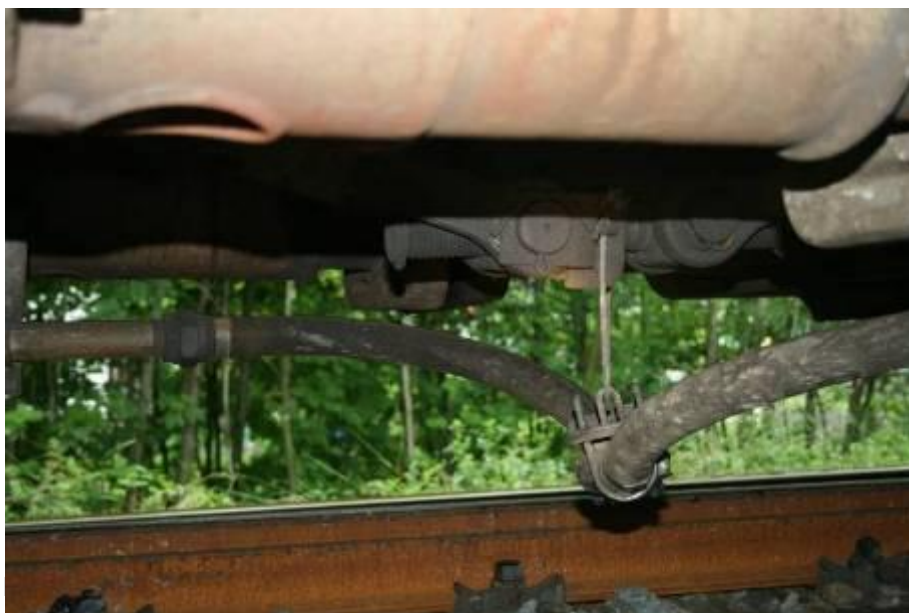
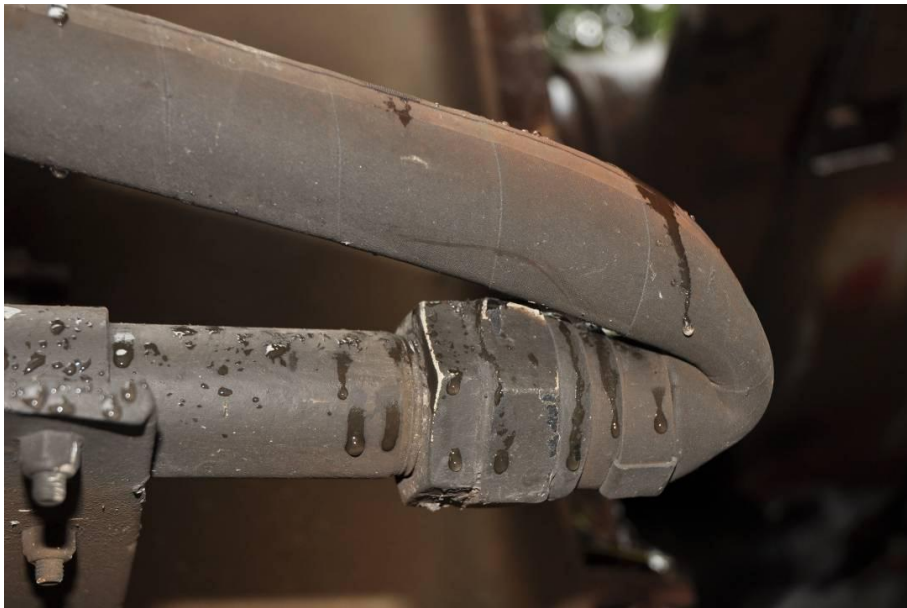
The construction of the brake coupling with a metal plate bolted over it and the positioning of the screw flange (the place where the main brake pipe joins the brake hose) in the underframe of the wagon allowed the brake coupling which had been pulled off to become wedged in the underframe of wagon 372-4. Because the screw flange is free-standing in the underframe, the air hose could be bent back by almost 180° at that point and hence compressed such that brake air in the following part of the train was prevented from escaping.

Figure 52 Kinked brake hose wagon 372-4
