**"AIRCRAFT, MARITIME AND RAILWAY ACCIDENT  
INVESTIGATION UNIT" DIRECTORATE  
(AMRAIU)**

**FINAL REPORT**

technical investigation of railway accident, which took place on 20.07.2011 around 17:20 hrs.  
with train № 2615, served by electrical locomotive № 44.089.1 in the stage Shunting Post (SP)  
Lesichery - Resen.

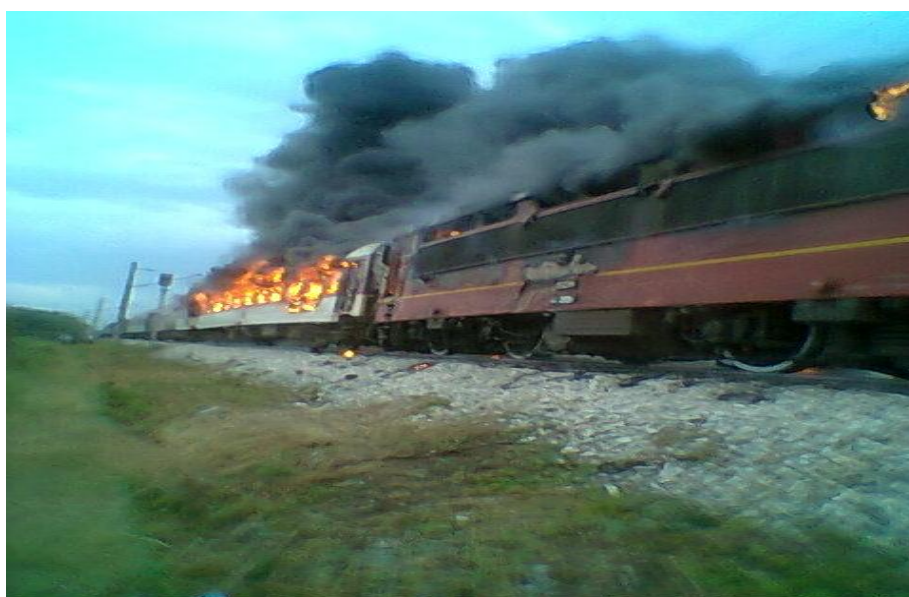
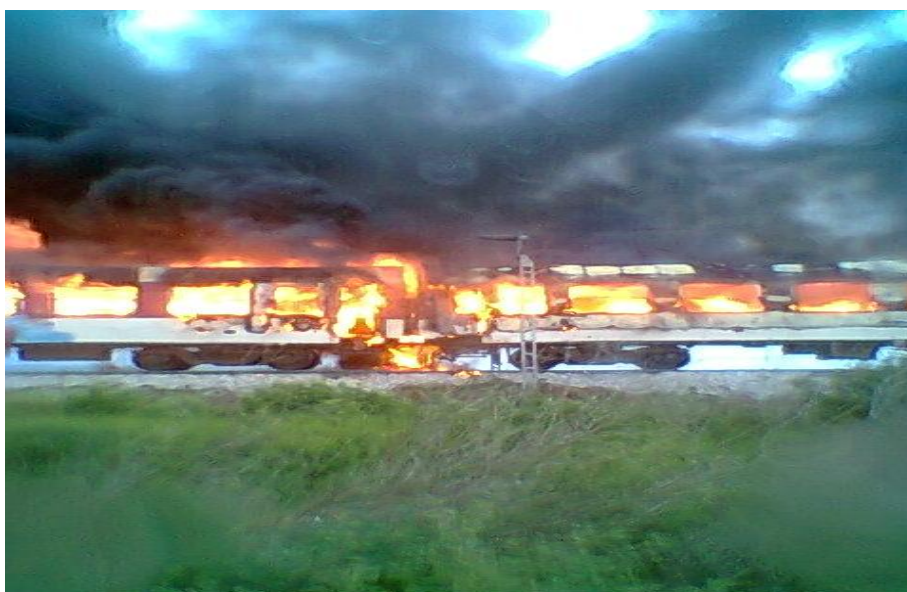
Moments from the fire in train № 2615

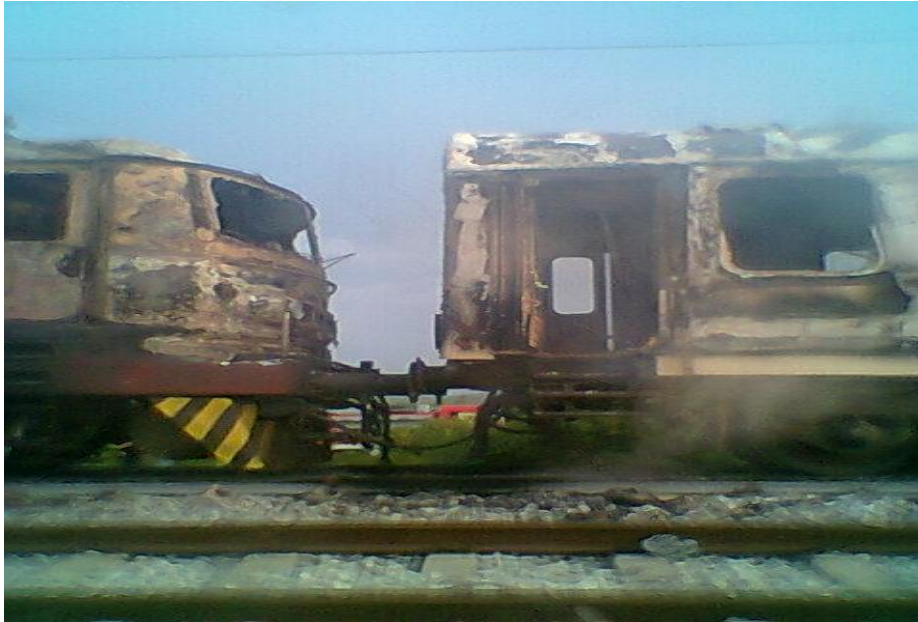
*Inspections of the burned locomotive and wagons*

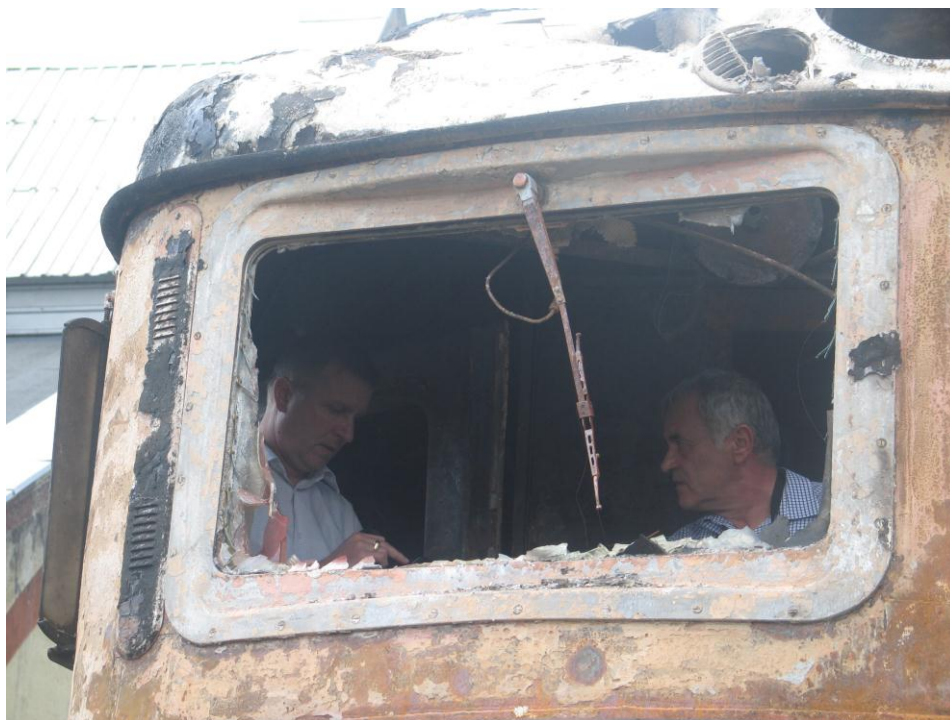
*Inspections of the burned locomotive*

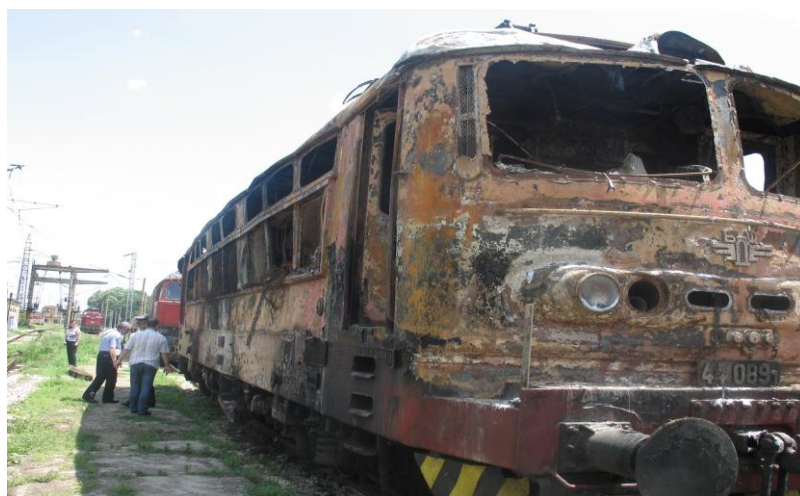
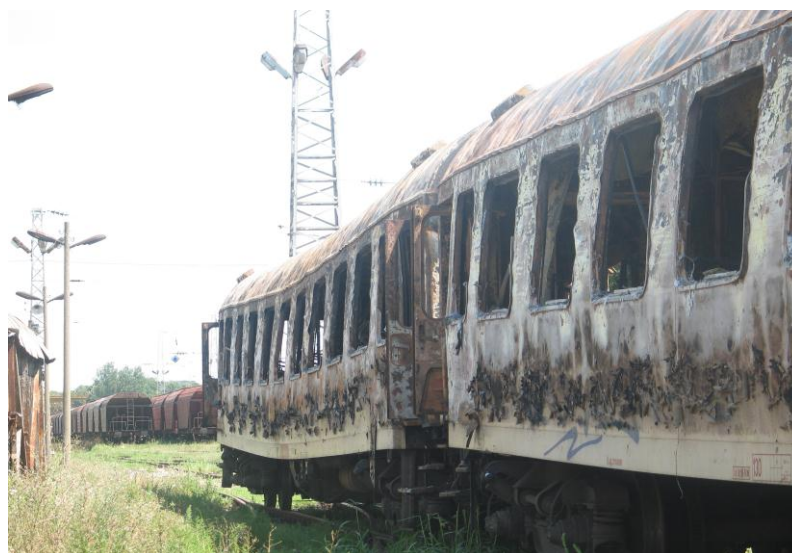
As a result of the fire the electric locomotive № 44-089.1 and the first two wagons № 505229741390 and № 505229742984 from the composition of the train are destroyed. No injuries and fatalities.

*Burned locomotive and wagons*

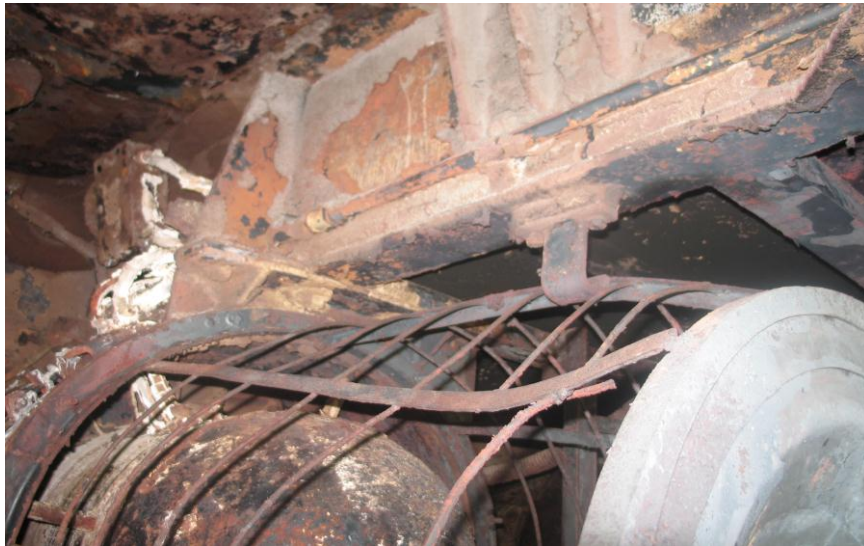
Follows the conclusion **that the most likely source of fire is the accumulated oil-dust layer on the electric motor of the air ventilator, located on the left side in the direction of movement of the locomotive, as the ignition is in result of the intensive sparking from the collector of the electric motor. The probable cause for the occurrence of the fire in the electric locomotive is confirming the conclusion from the carried-out Fire-technical Expertise and technical opinion.**

*The burned horizontal sub-baskets ventilator*

- Greasing of the details of fans motors and the formation of oil-dust coating on their ducts;
- Lack of thermal protection in the air ducts of the locomotive, to signal for the increasing of the temperature in them above a certain value;

- upgrading the fire alarm installation of the electric locomotives of the same series;
- timely correction of any leaks or loss of oil from the links and aggregates of the locomotive;
