KÖZLEKEDÉSBIZTONSÁGI
SZERVEZET

FINAL REPORT
2015-0320-5
Railway Accident
Nógrádszakál Station
8 April 2015

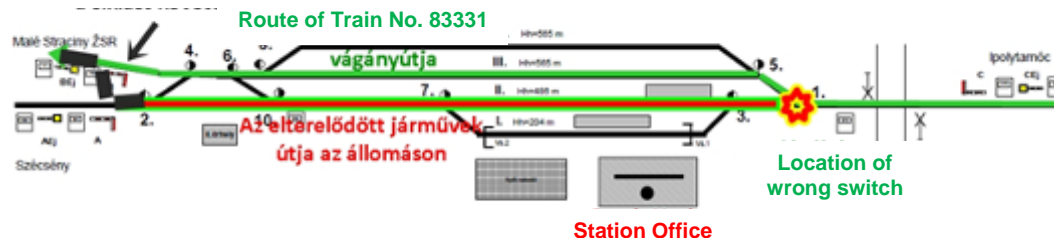
On the way out, still within the switch zone, the last but one wagon (an empty four-axle freight wagon) was routed wrongly. The front bogie of the wagon ran on Track III and the rear bogie ran on Track II until the wagon derailed in the exit-side switching zone at the other end of the station.

Trailing wagons of the train
after the derailment

Figure 2: Location of accident (Nógrádszakál Station)

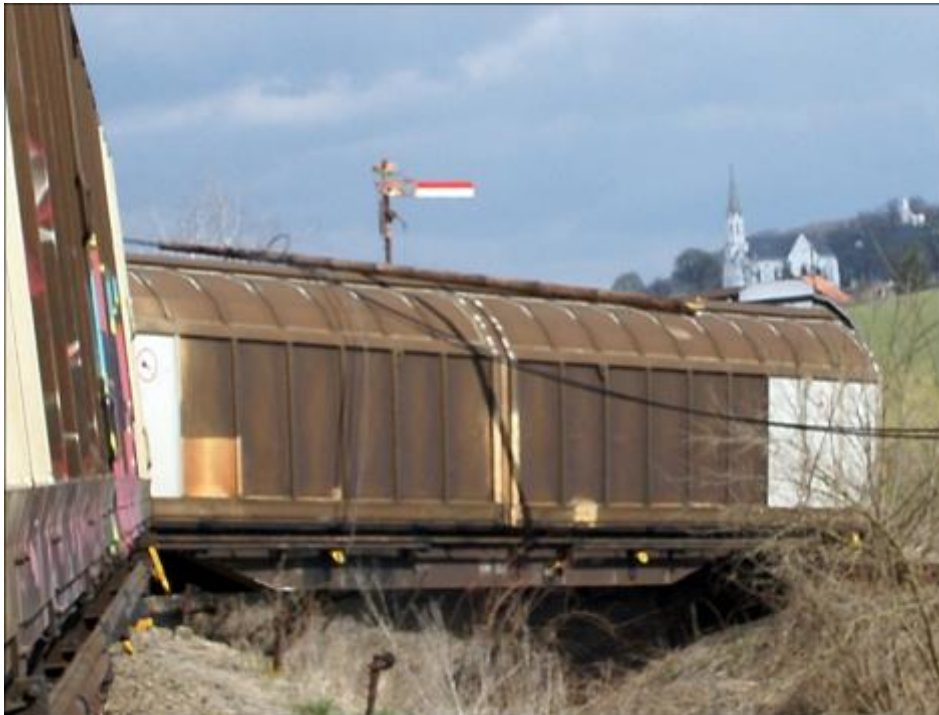
The empty freight wagons No. 31 56 2772 004-0, 31 56 277 2073-5 and 31 56 2772 079-2 affected in the accident were damaged as a consequence of the derailment.

Figure 3: The derailed and damaged vehicle at the scene of the occurrence

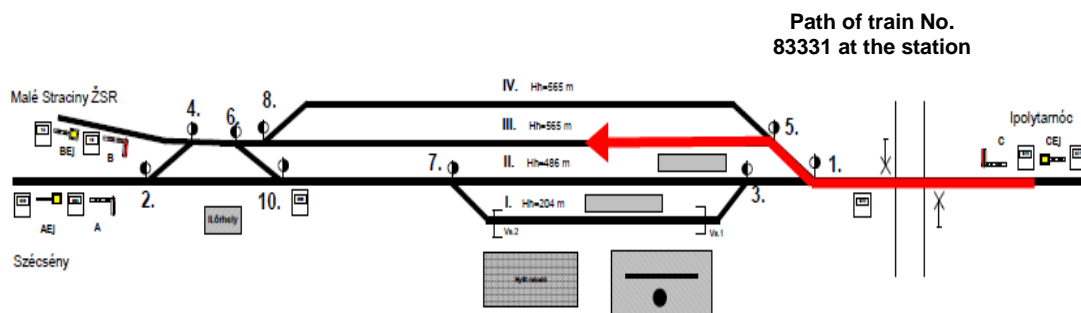
If the train had accessed the station fully, Track III would have fitted all of its vehicles as the available length of that track is 565 metres.

According to information available to the IC, the train crew had not been notified that the train would be stopped at a different spot, no Stop! signal was issued to the accessing train, it was the locomotive crew that choose the spot of stopping.

Figure 6: The route of the train at the station

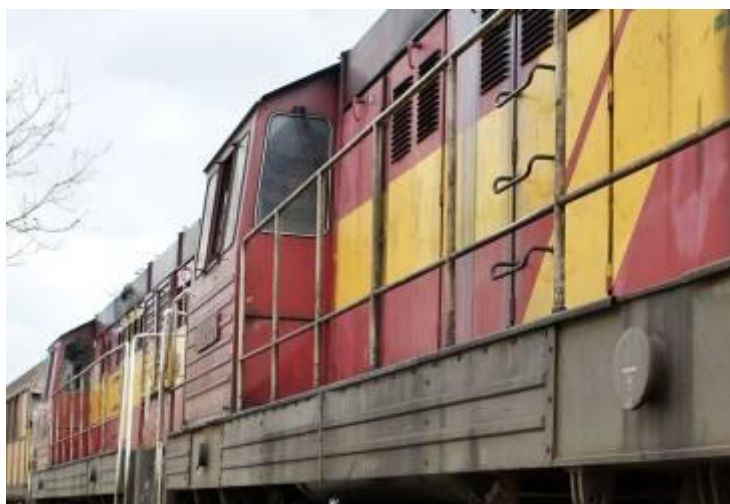
The crew of the departing train did not detect the switching error and the fact that some vehicles were running on a separate track. They did not look back after departure. The observation of the train and the signals by looking back from the locomotive was hindered by the fact that locomotives of the series 742 have no rear-view mirror or camera system.

Figure 7: Series 742 locomotives are not equipped with rear-view mirrors

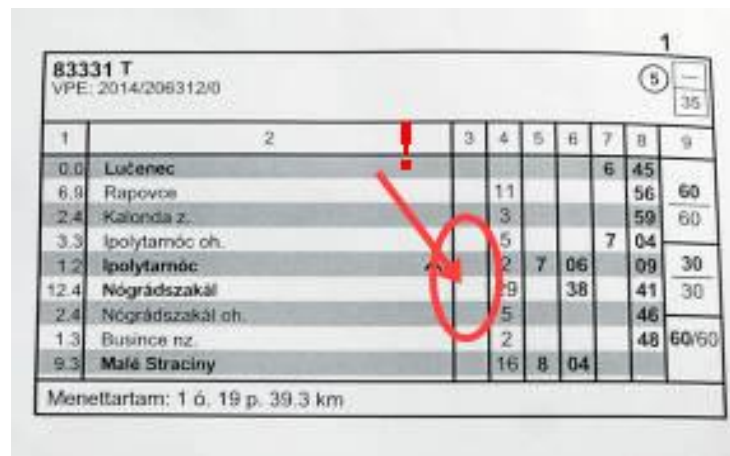
Taking a look at the service timetable of the train No. 83331, one can see that Column 3 (Entrance) is empty at the line for Nógrádszakál station, which means that the train must be allowed to access a station not protected by interlocking in straight direction. (The IC wishes to note here that, in the case of access in straight direction, the sign ● is missing from Column 2 [stations], which sign is indicated for those stations along a single-track or double-track line where straight access is followed by moving off in diverging direction, and the exit signal does not indicate the speed of moving off. Nógrádszakál Station is that kind of station from the aspect of the movement of the train.)

The TSB of Hungary recommends the Hungarian Transport Authority to review the harmony between “Station Instructions for traffic management on the Malé Straciny/Nógrádszakál – Ipolytarnóc/Lucenec shared (peage) railway line used by MÁV Ltd. and ŽSSK CARGO a.s.” and the F.2. Train Loading and Running Regulations in effect in Hungary, and to call MÁV Ltd. to upgrade the Station Instructions.

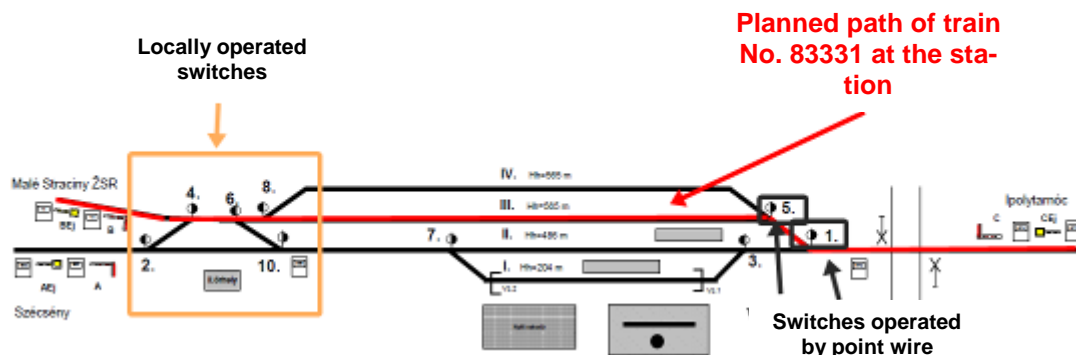
The switches No. 1 and 5 located at the down side of the station are operated by point wire while the switches at the up side are all operated locally. As a result, it is

significantly easier to set the path for the freight trains at the down side. (That is the reason why the switches were reconstructed to provide operation by wire in 1970.)

Figure 9: Switches operated locally or by point wire at Nógrádszakál station

This extra service (provided by switch operation by point wire) lies in the background of the decision that the train running towards Malé Straciny (Kishalom) was allowed to access in diverging direction instead of the straight direction specified in the timetable. According to the log-book of the station, this is procedure is regularly used at the station.
