FINAL REPORT (EXTRACTION)

2020-0304-5
(HU-10007)

Railway Accident / Derailment
Püspökladány, 22 March 2020

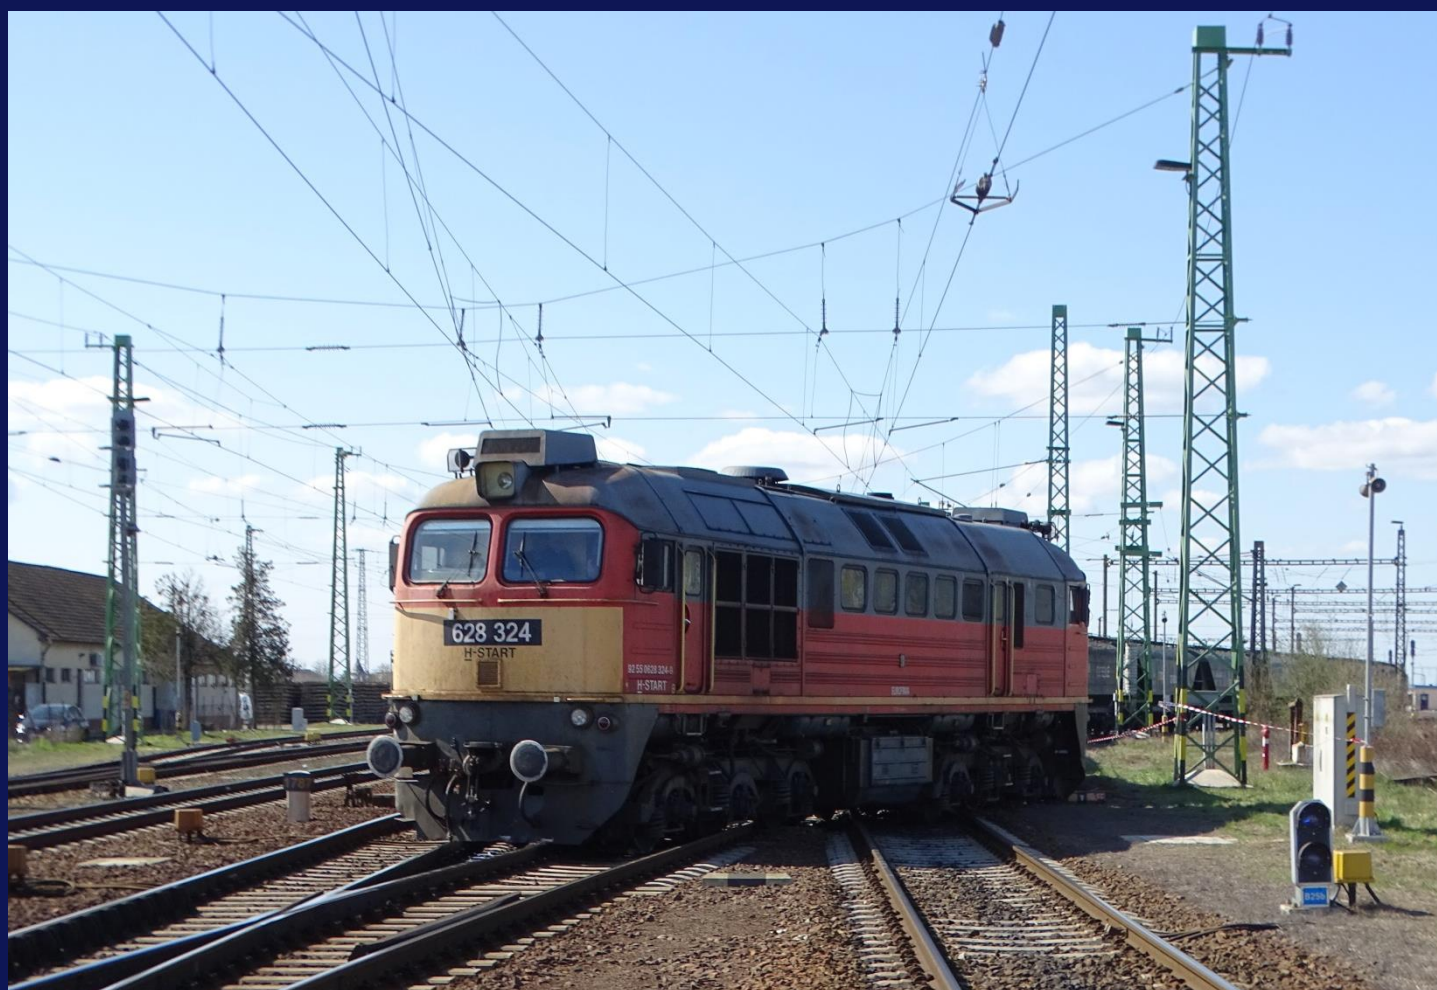
The locomotive and 5 wagons of the freight train № 47481-2 from Miskolc-Rendező station to Dej (Romania), scheduled to cross the state border at Biharkeresztes, derailed in the switching zone of Püspökladány station during departure.

The investigation found that the direct cause of the derailment was the fracture of a rail of the track which had probably originated in an earlier crack in the railhead. There is an examination method which is able to demonstrate superficial cracks, but, in line with track supervision requirements, that method is not used at the turnout concerned.
