## FINAL REPORT

2020-0789-5  
(HU-6321)

**Railway Accident / Fire in Rolling Stock**  
Biatorbágy, 14 August 2020

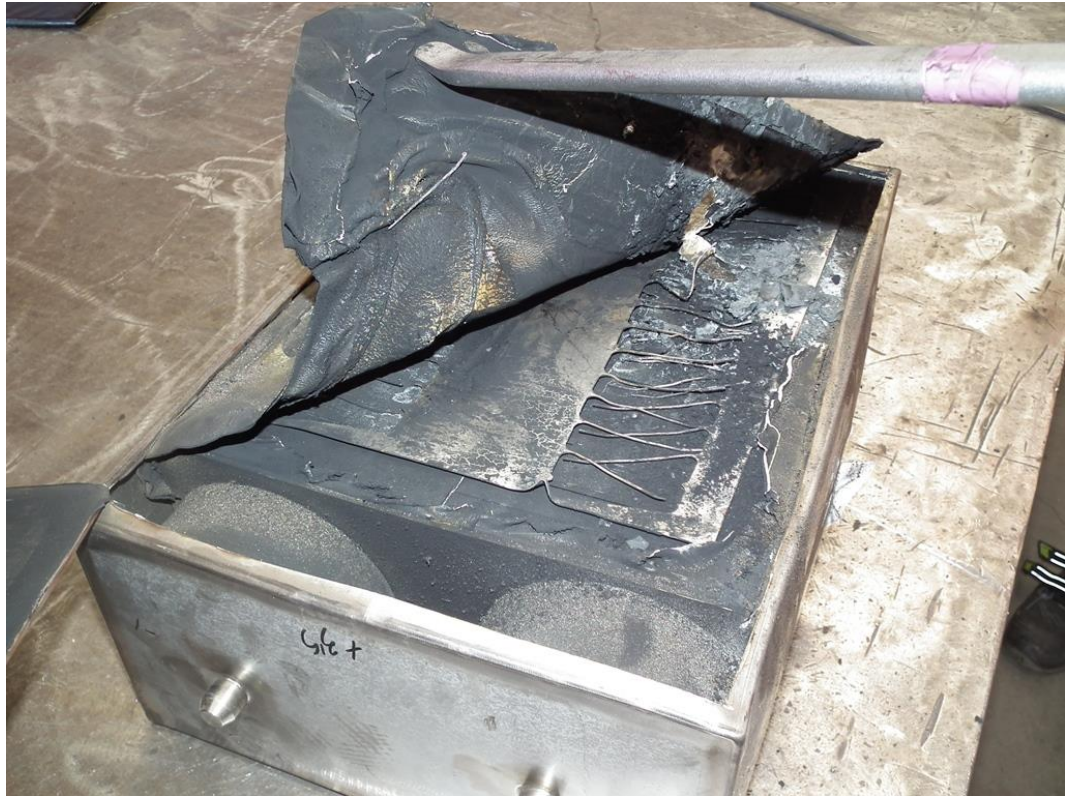
The construction of these capacitors is such that if – due to the deterioration of the dielectric strength – a minor puncture occurs between its armatures, the capacitor will be capable of self-healing, which maintains serviceability of the capacitor despite the defect, but its capacity will decrease. However, if such self-healing process takes place too often, it will lead to harmful overheating.

The capacitor test showed a lot of traces of this self-healing process (Annex 1. Annex 3), which, according to the person who tested it, but in a much higher number than normal in a capacitor of this type.

The dielectric of the capacitor is a polypropylene film that decomposes into combustible gases in the case of overheating (Annex 1). After the capacitor was opened it was clearly visible that overheating had occurred, i.e. combustible gases had also been present.

**Figure 2: The inside of the capacitor**

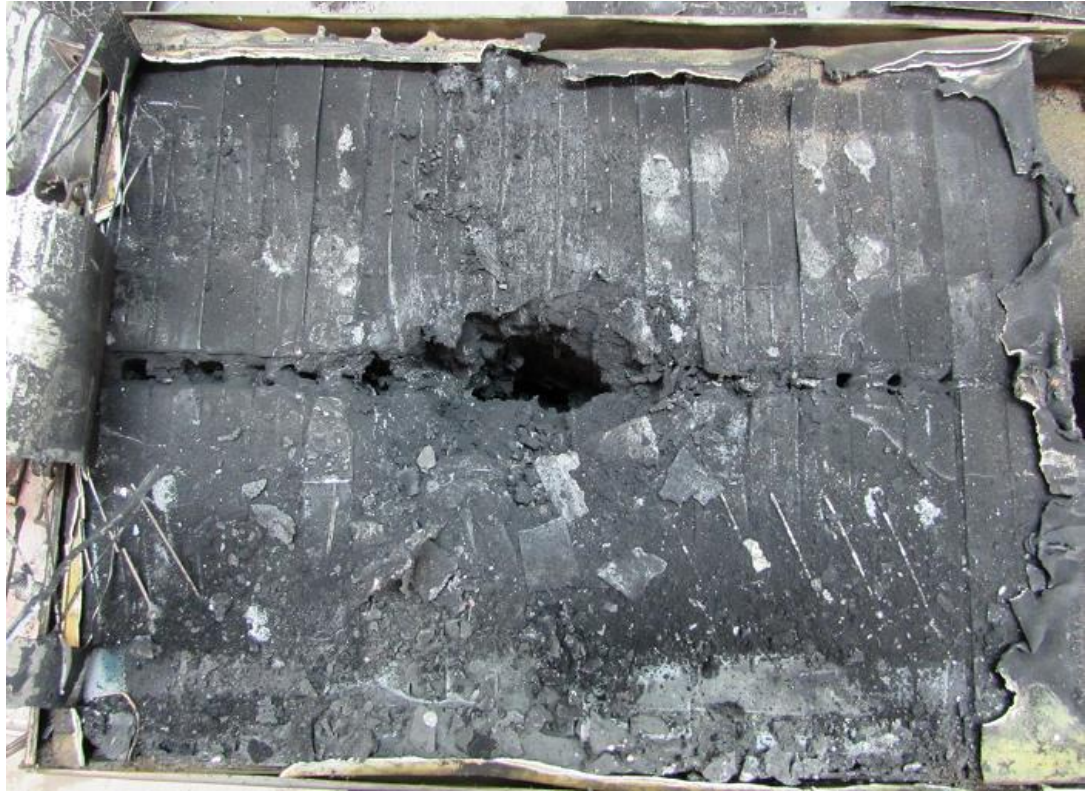
The C2 capacitor was deformed in several places, and it was also dented, but the capacitor body did not open. The insulation between the windings and the house melted in several places and was partially carbonised. A couple of windings in the middle melted, and a big hole was formed.

**Figure 3: The state of the C2 capacitor**

The melting of the capacitor's circuits may have been caused by the voltage increase due to a particularly high number of self-healings and the loss of the safety function of segmentation. In parts with more leaks, the internal serial connection may have resulted in an avalanche effect. The reason for this is that when the value of a serial capacity is suddenly reduced, then the related voltage will rise. Because of higher voltage, new holes form, and in turn, voltage will continue to rise. This process took place fully for all windings in each nF-capacity range. As a result, the total voltage in the serial capacity was present over a longer period of time, which corresponds to twice the planned voltage load.

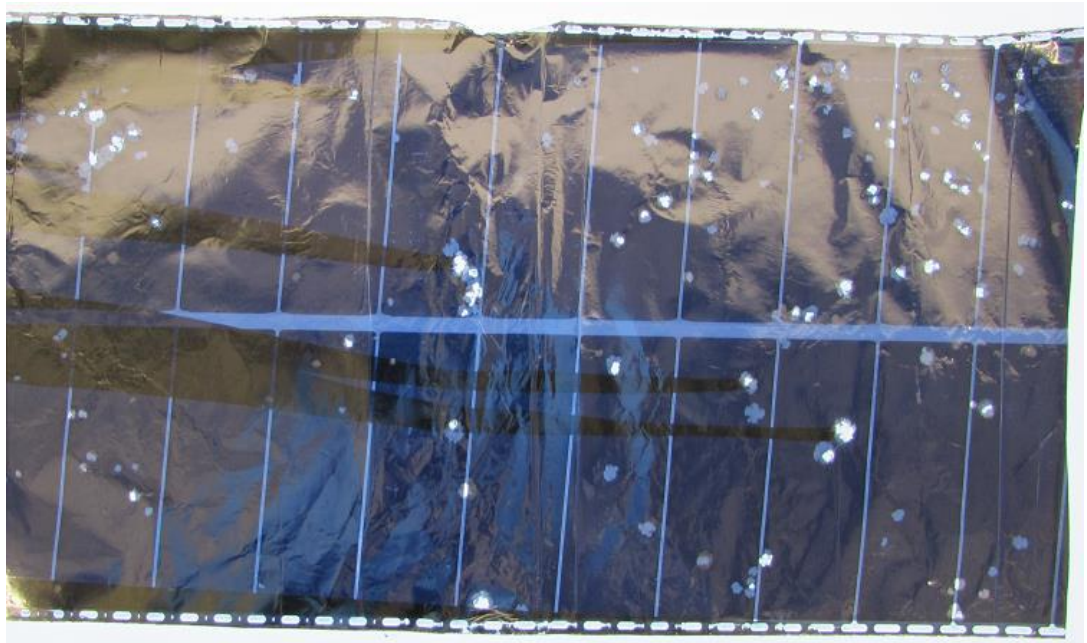
The film from the C2 windings shows a lot of self-healing marks in both the flat and the round areas. Such self-healing marks were present in both rows, but there were much more of them in one row than in the other; almost all safety elements of the segmentation were fused at the side which showed the worse damage.

**Figure 4: Capacitor film with marks of self-healing**

In view of the fact that the same degree of perforation and a similar decrease in capacity was observed in capacitors produced by the producer during the same period but with a film layer other than the film layer used for the capacitors concerned, the fault probably lies in the manufacturing technology used at that time.
