# RAILWAY ACCIDENT INVESTIGATION UNIT IRELAND

## INVESTIGATION REPORT

**Investigation into SPADs on IÉ Network,  
from January 2012 to June 2015**

**RAIU Report No: R2016 – R001**

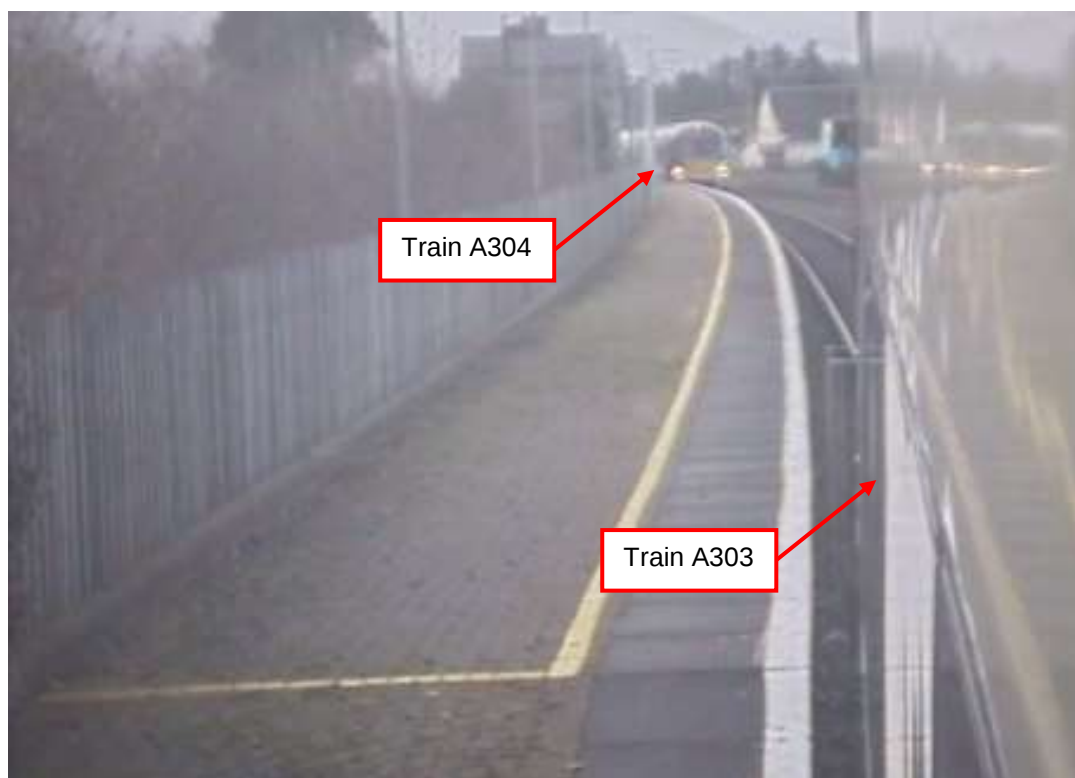
**Figure 19 – Train A303 & Train A304 stopped 175 m apart on Millstreet Station Platform after the SPAD**

165 The drivers of Train A303 and Train A304 both responded with brake applications with the trains coming to a stop 175m apart, facing one another, on Millstreet Station Platform. Train A303 had passed Signal TL223 by 384m and was 56m along the length of Millstreet Station Platform, see Figure 19.

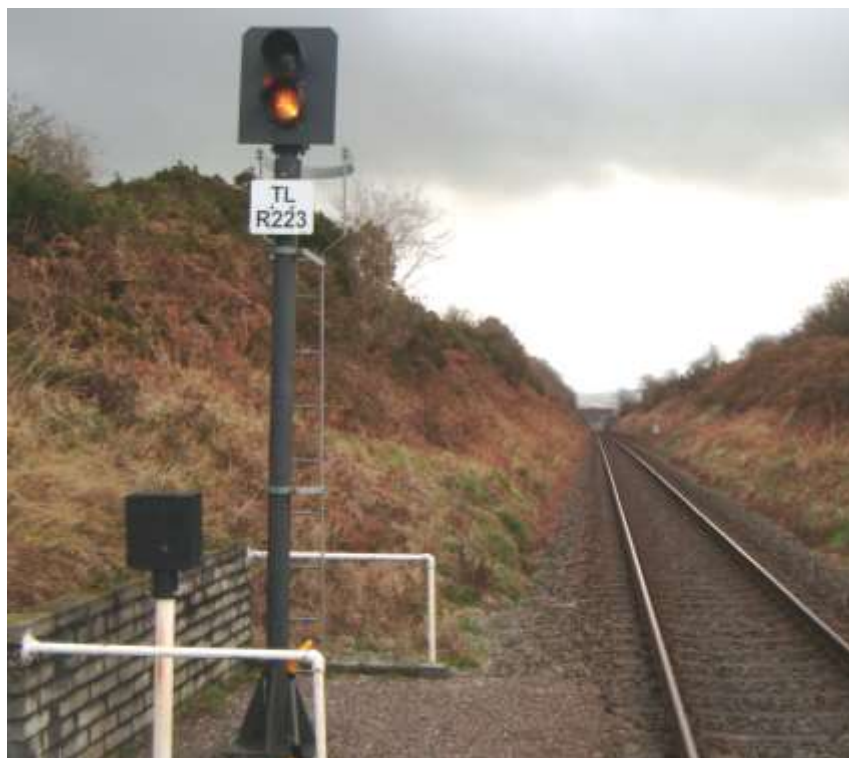
**Figure 24 – Signal TLR223**

192 Signal TLR223 is the *repeater signal* for Signal TL223. It is a two aspect signal mounted on a standard height pole situated on the left hand side of the track, see Figure 24. It is capable of displaying single yellow and green aspects. It is located 2,016 m before Signal TL223. It has a recorded sighting distance of greater than 1000 m as it is located on a straight section of track; therefore this signal also meets the requirement of 286 m sighting distance set out in I-SIG-2043.

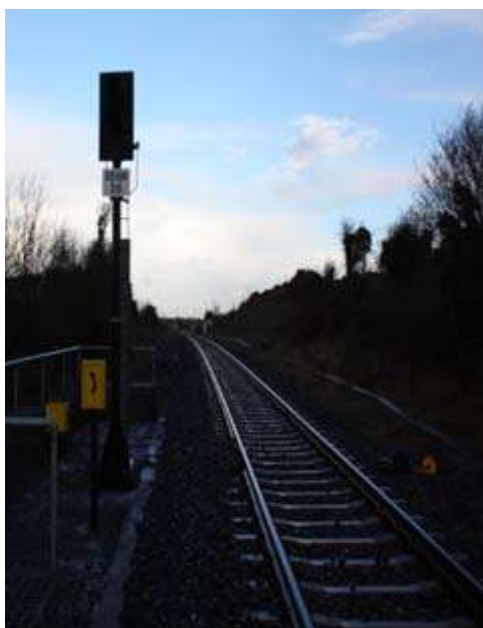
Figure 45 – Distant Signal XE098DS

350 Distant signal XE098DS, the signal that was passed at danger, is a two aspect signal mounted on a standard height pole situated on the left hand side of the track close to the 36 MP. It is capable of displaying single green and red aspects. It is not approach released and normally clears to a green aspect on request from the LCCO at Mallow after the barriers at Level Crossing XE098 are lowered and the crossing is observed to be clear by the LCCO, see Figure 45.

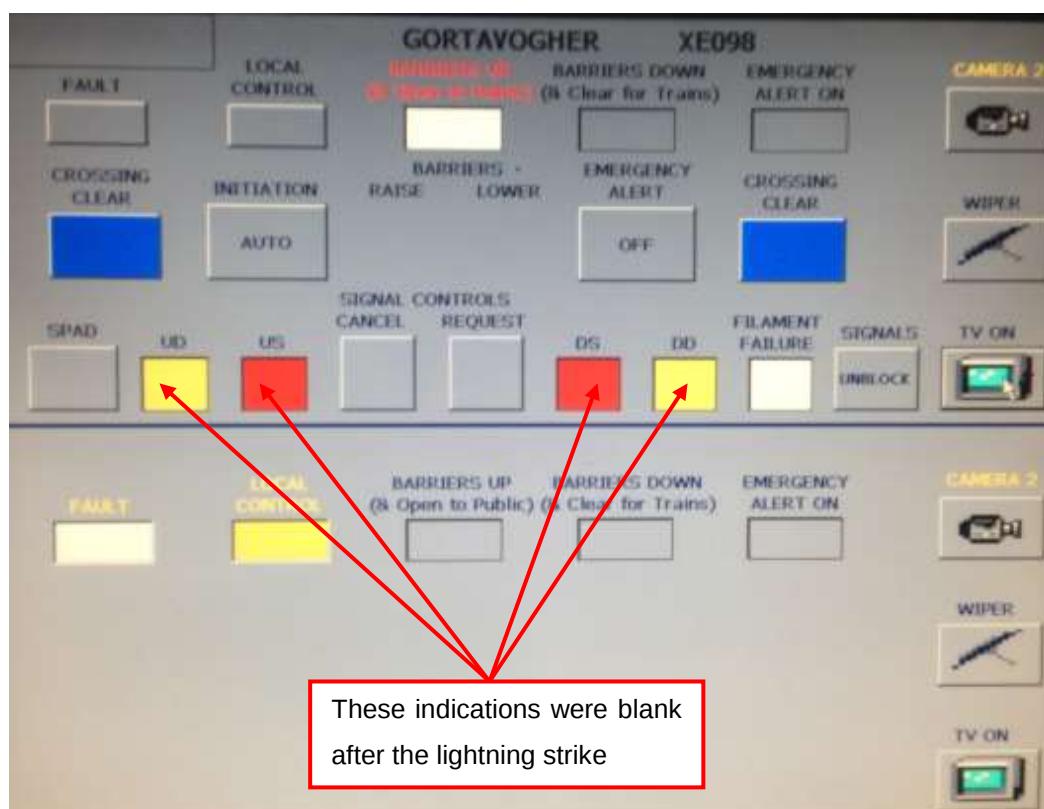
**Figure 50 – The signal information was blank after the lightning strike**

361 However, the specific fault of a failure of controls and indications on the touch screen was not referred to in the table, this is the fault which occurred on the day of the incident, where the UD, US, DS and DD information was blank, see Figure 50.

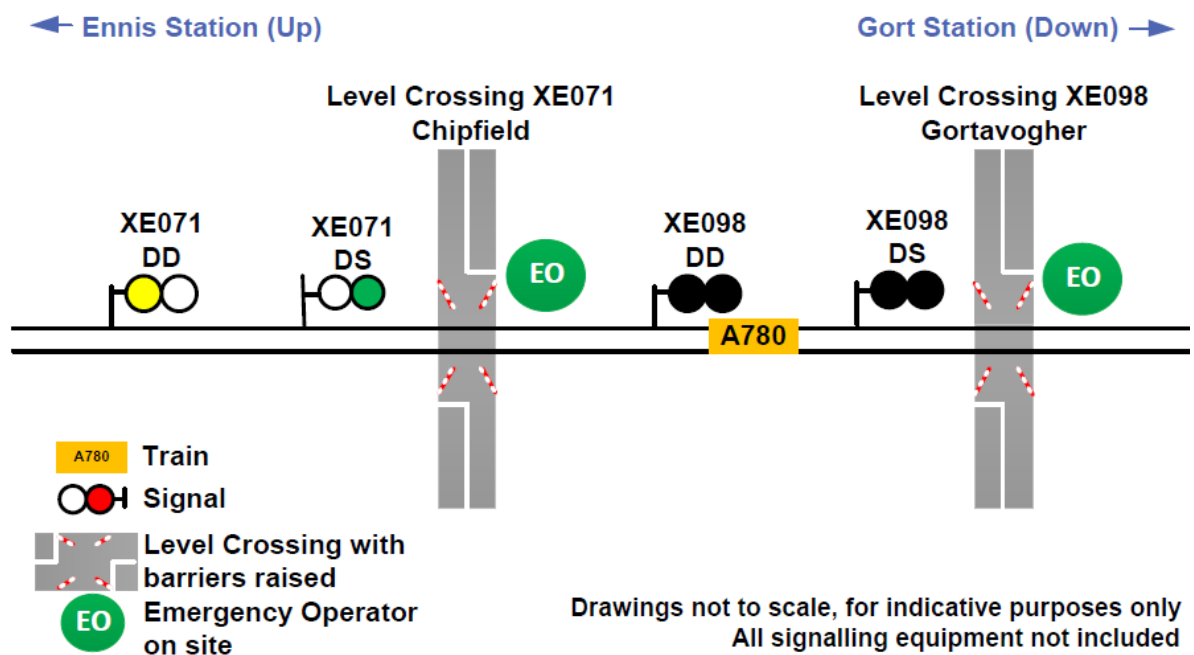
**Figure 55 – Train A780 travels past Signal XE098DD (which is not showing any aspect) without authority**

399 As Train A780 approached Level Crossing XE098, Distant Signal XE098DD was not displaying any aspect. Due to the poor weather Driver A780 did not see the signal and as a result did not slow down; and continued past the signal 'at Danger', see Figure 55.

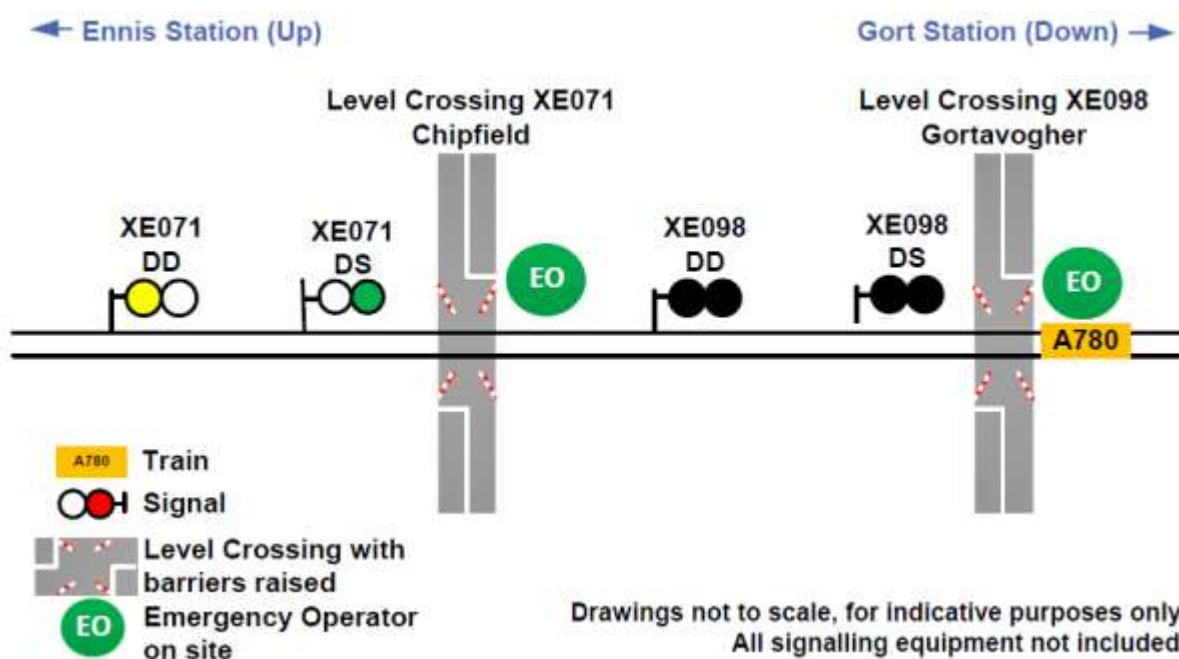
**Figure 56 – Train A780 passes Signal XE098 DS without authority and through Level Crossing XE098 with the barriers raised to road traffic.**

402 Train A780 travels past Signal XE098DS without authority and through Level Crossing XE098 with the barriers raised to road traffic. There is no road traffic using the crossing at the time of the incident. Train A780 is travelling at 58 mph (98 km/h), see Figure 56.

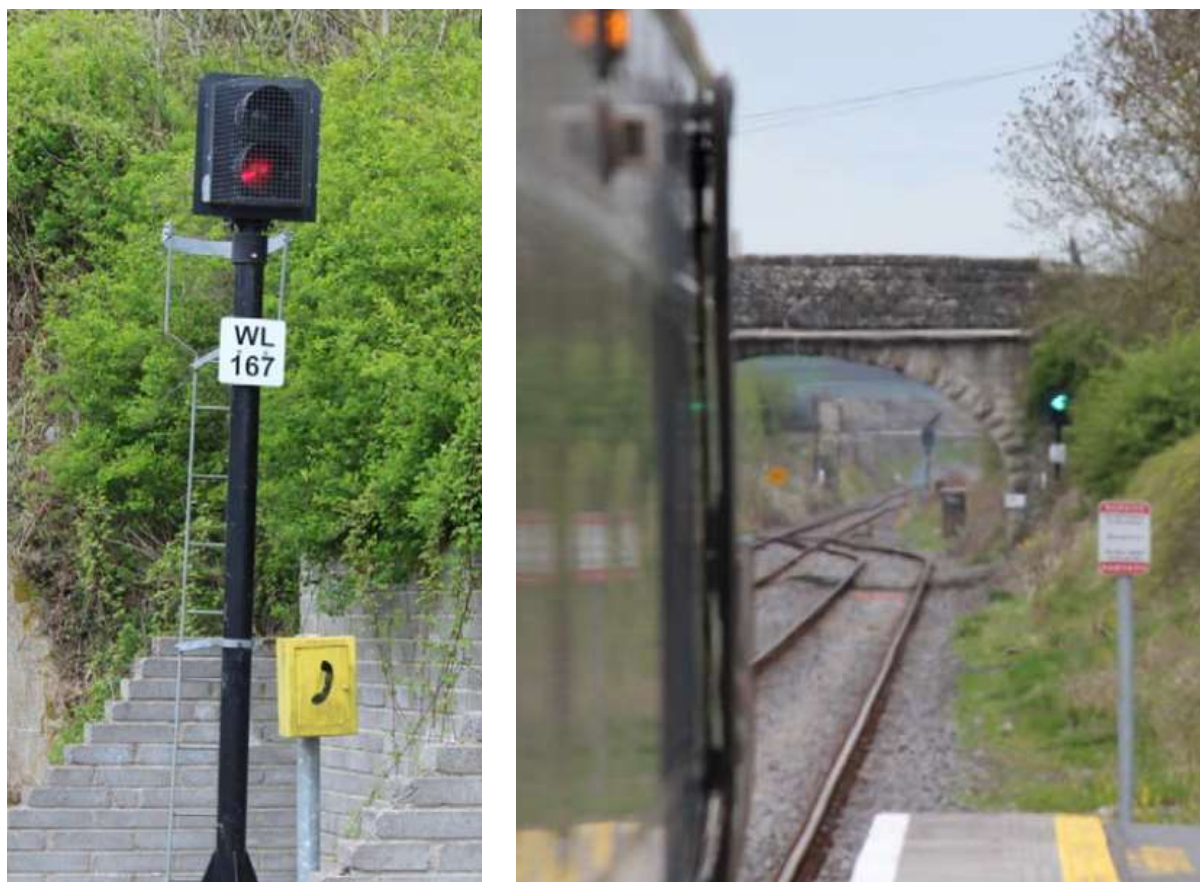
**Figure 59 – Signal WL167 & sighting from cab of Signal WL167**

452 Signal WL167 is located approximately 215 m off the platform on the right hand side exiting Muine Bheag Station. It is a two aspect signal mounted on a standard height pole that can display a red or green aspect, see Figure 59. Signal WL167 is the starting signal for the Muine Bheag to Kilkenny section. The sighting meets the requirements set out in I-SIG-2043.

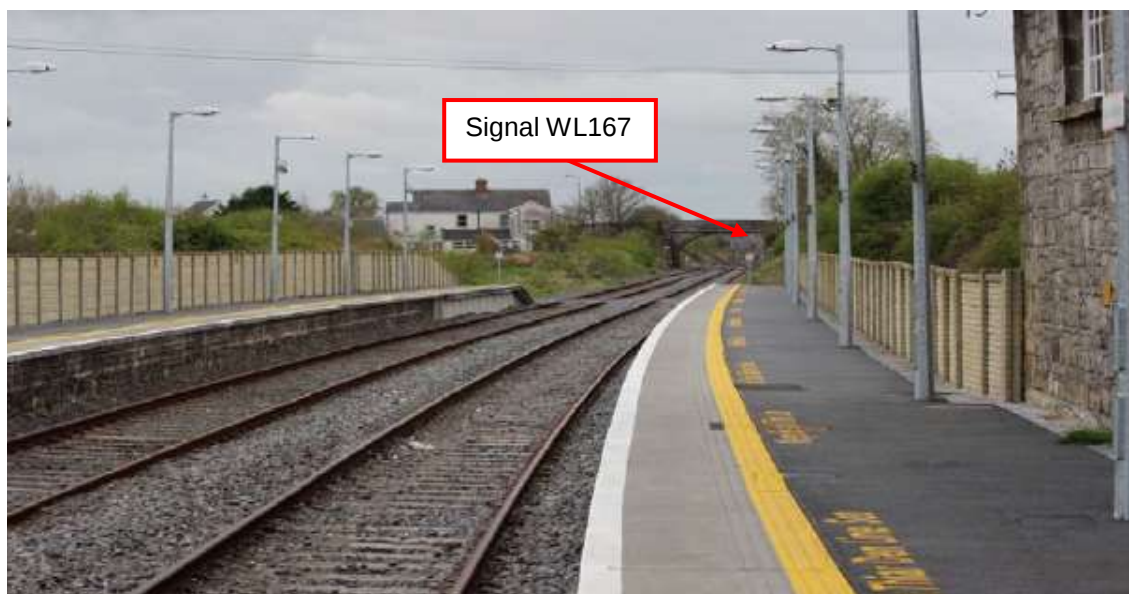
**Figure 60 – PIC's view from platform of Signal WL167**

453 Muine Bheag Station Platform is a curved platform, see Figure 61. As a result the PIC has to be in a position where he/she can see Signal WL167 (Figure 60), and the driver, prior to giving the 'Ready to Start' indication.
