Railway Accident Investigation Unit Ireland

INVESTIGATION REPORT

Derailment of DART passenger service, at Points DL115, Dun Laoghaire, 13th September 2017

**RAIU Report No: R2018 – 001
Published: 15th August 2018**

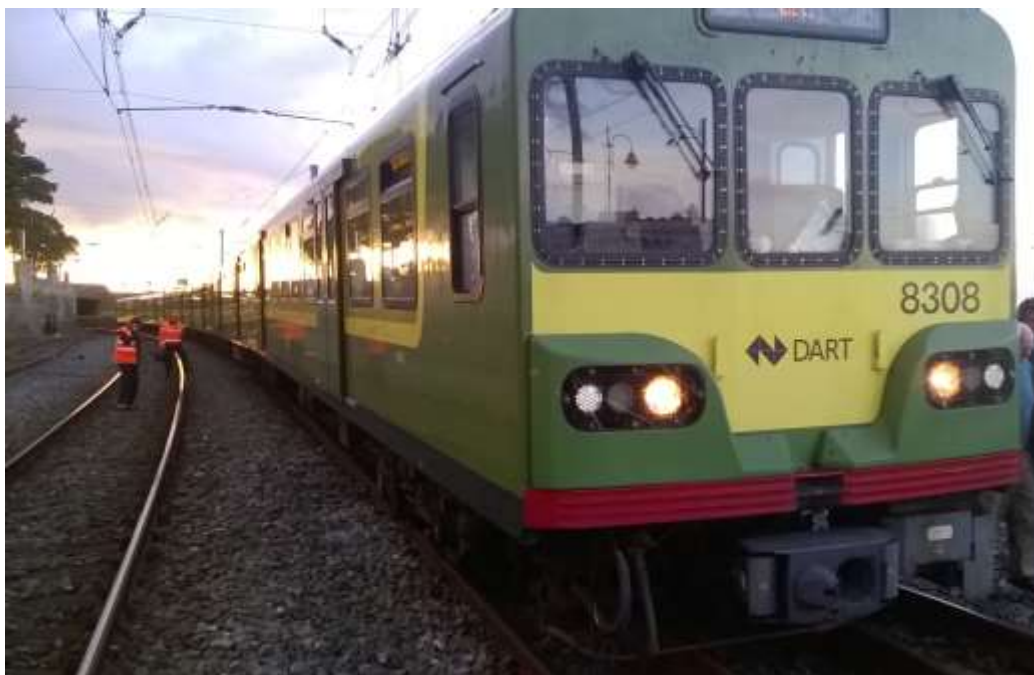
- 3 At approximately 18:04 hours (hrs) the leading bogie of Train E222 derailed while crossing over Points DL115 before coming to a stop approximately 109 metres (m) from Dun Laoghaire Platform 2 (Figure 1). Driver E222 immediately reported the accident to the Controlling Signaller who arranged signal protection to both the *up* and *down* lines.

Figure 1 – DART passenger service derailed at Points DL115, Dun Laoghaire

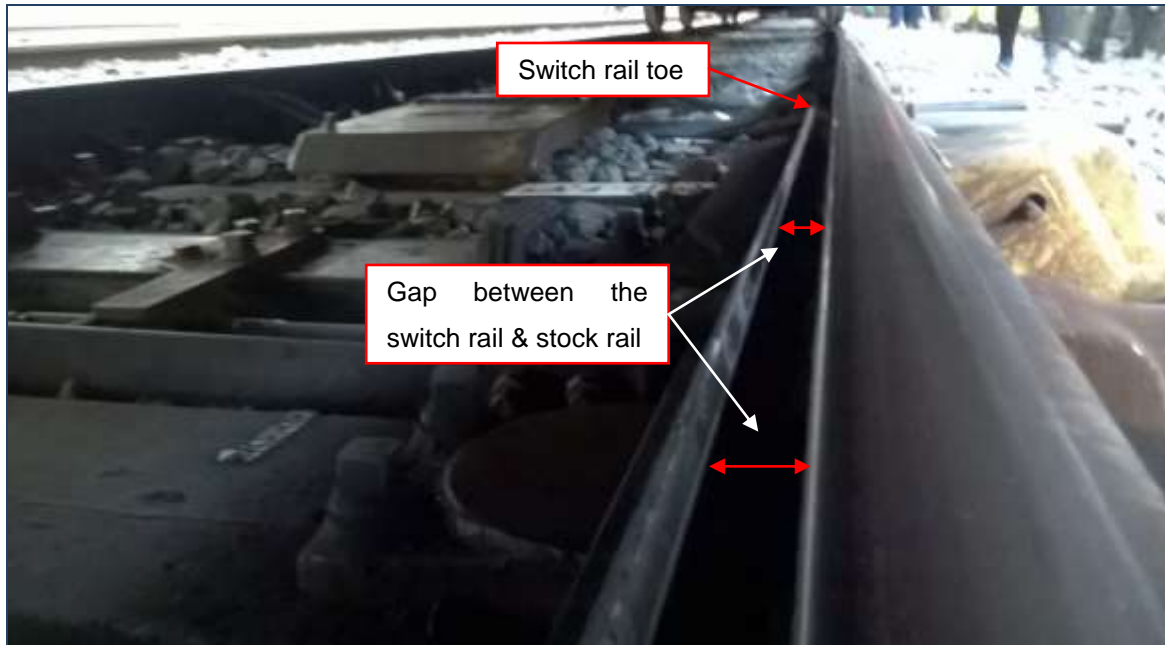
- 57 The post derailment inspection of Points DL115 identified that the power supply had not been taken from the points before fitting the clip and scotch.
- 58 There was a gap between the toe of the switch rail toe and the stock rail, see Figure 8.

Figure 8 – Gap between the toe of the switch rail toe and the stock rail

136 The immediate cause of Train E222 derailing was as a result of Train E222 travelling over failed Points DL115 which had been incorrectly secured by the Points Operator by leaving a gap between the stock and switch rails.

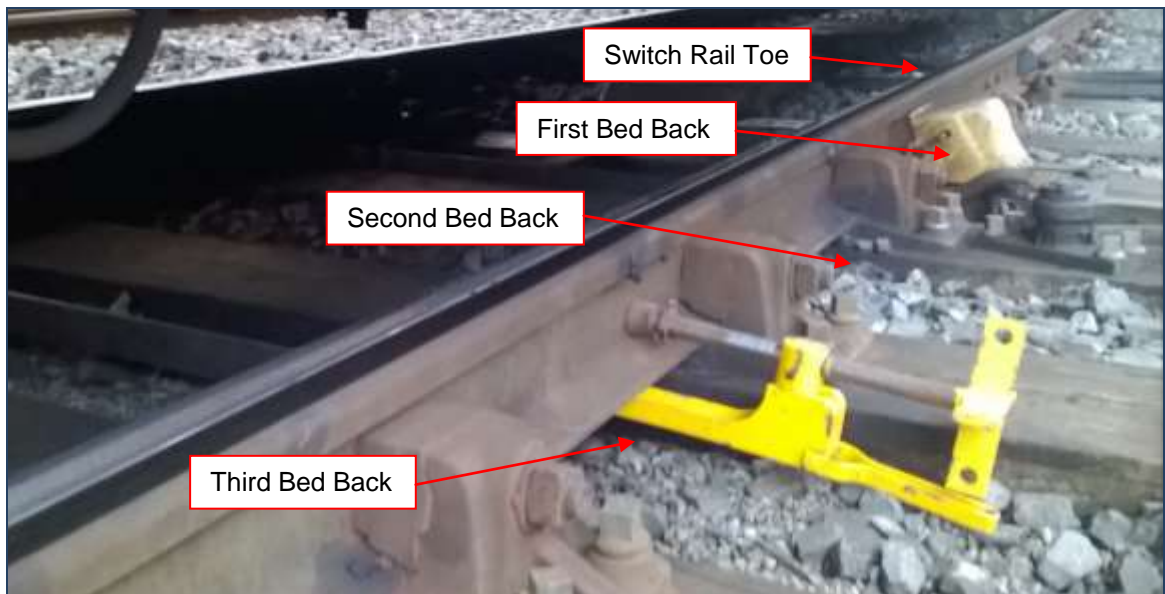
- 59 The points clip was applied in the third bed back from the toe of the switch rail. The points clip collar, which restricts the loosening of the clip, had not been applied; and the points clip had not been locked with a padlock, see Figure 9.

Figure 9 – Placement of the Points Clip

- Ensure that the clip fully clamped the points, this was as a result of the Points Operator placing the clip too far away from the toe of the points (paragraph 92), although it should be noted that the IÉ Rule Book or General Appendix does not identify where the clip should be placed (paragraph 54);

- Apply the padlock to the clip (paragraphs 49, 51, 89); meaning that there was potential for interference by a third party if left unattended, or, loosening of the clip from vibration in the event of movement of trains over the points;

147 The IÉ Rule Book and the General Appendix does not specify where the points clip should be fitted (AO-02); as a result the RAIU make the following safety recommendation:

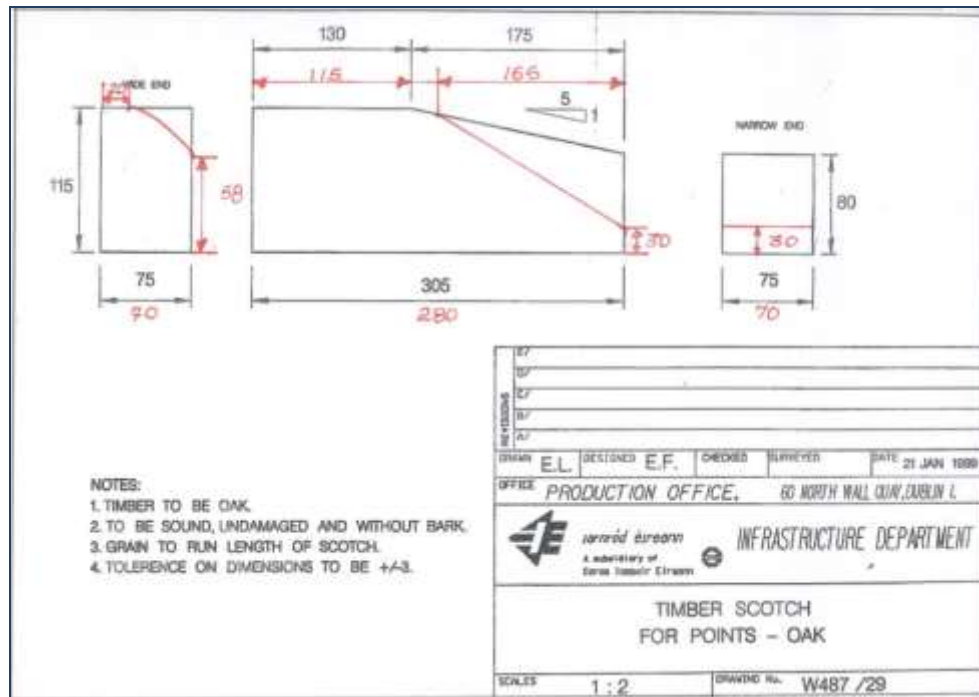
- 60 The scotch was not manufactured to the dimensions set out in IÉ Drawing No. W487 / 29, 'Timber Scotch for Points – Oak'. Figure 10 illustrates the required dimensions (in black) of the timber scotch under drawings number W487/29 in comparison with the actual dimensions of the timber scotch used on the day of the accident (in red). It should be noted, that the incorrect dimensions did not contribute to the accident.

Figure 10 – Required (black) versus actual (red) dimensions of Timber Scotch

149 The scotch used at points DL115 was not manufactured to Infrastructure department drawing W487/29 (AO-04); as a result the RAIU make the following safety recommendation:

- IÉ IM should review the drawing and specification requirements for points scotches and ensure only scotches manufactured to the required drawing and specification are made available to points operators;

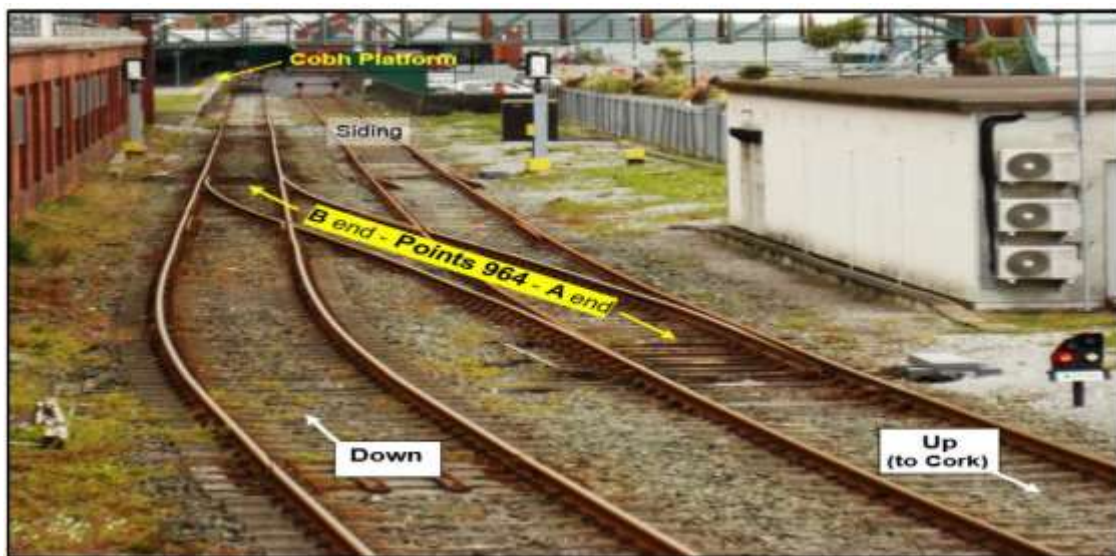
Figure 11 – Points 964 set to the normal position

112 POC contacted CSC and confirmed to him that Points 964 were scotched and clipped in the reverse position. CSC then authorised Train P239 (09:00 Cobh to Cork) to depart Cobh. The driver of Train P239 departed Cobh and observed Points 964B were correct but heard an unusual noise coming from underneath the train and brought the train to a stop. On examination the driver identified that Points 964A (trailing end) were not correctly set for the direction of travel.

113 As a result of the incident the following recommendation was issued by IÉ: The Head of Health and Safety IM should conduct a review of the assessment documentation used for Points Operators. The review should focus, but not be confined to, include a more robust practical / operationally realistic element to the assessment process.
