**Railway Accident
Investigation Unit
Ireland**

INVESTIGATION REPORT

**Collision with track equipment between Newbridge
and Kildare,**

RAIU Report No: 2023 – R002

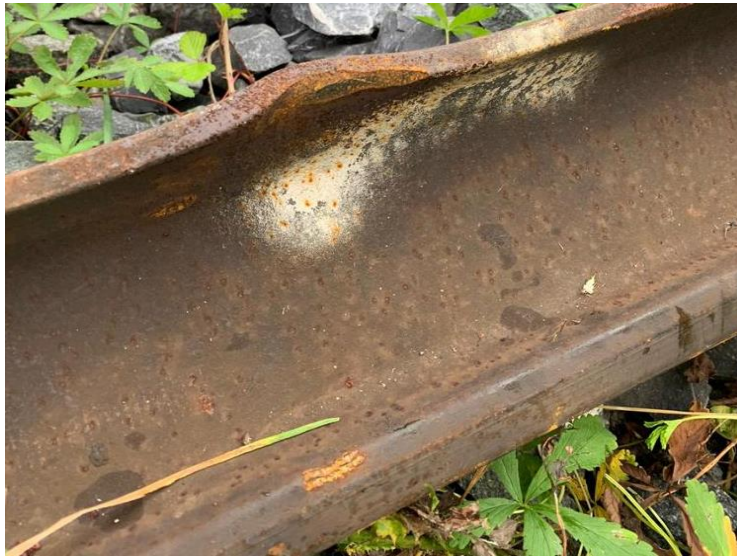
Figure 6 – Damaged rail

- 46 The section of rail where the clamp was attached was significantly damaged, see Figure 6; this section of rail was replaced immediately after the accident.

135 It should be noted, that when the clamp was struck, the wheel, rail and the clamp were significantly damaged (paragraphs 46 and 47, Figure 6, Figure 7); although the damage was not obvious to Driver J283.

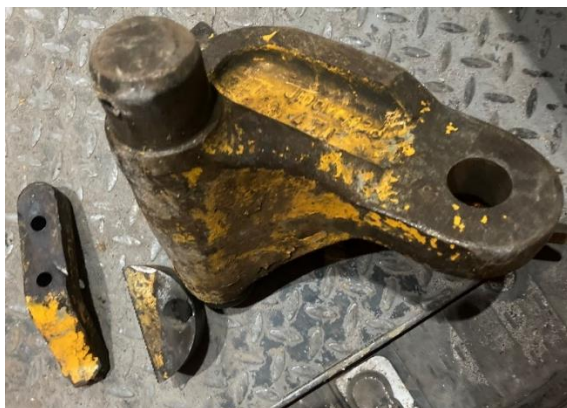
Figure 7 – Damaged clamp

- 47 The clamp was also damaged, see Figure 7. Figure 8 shows how the clamp would have attached onto the rail.

- 164 Further investigation located the holding clamp that had been used on the night of the 27th August, it was clearly damaged and corroborated that it had been bolted to the track and struck by the train.

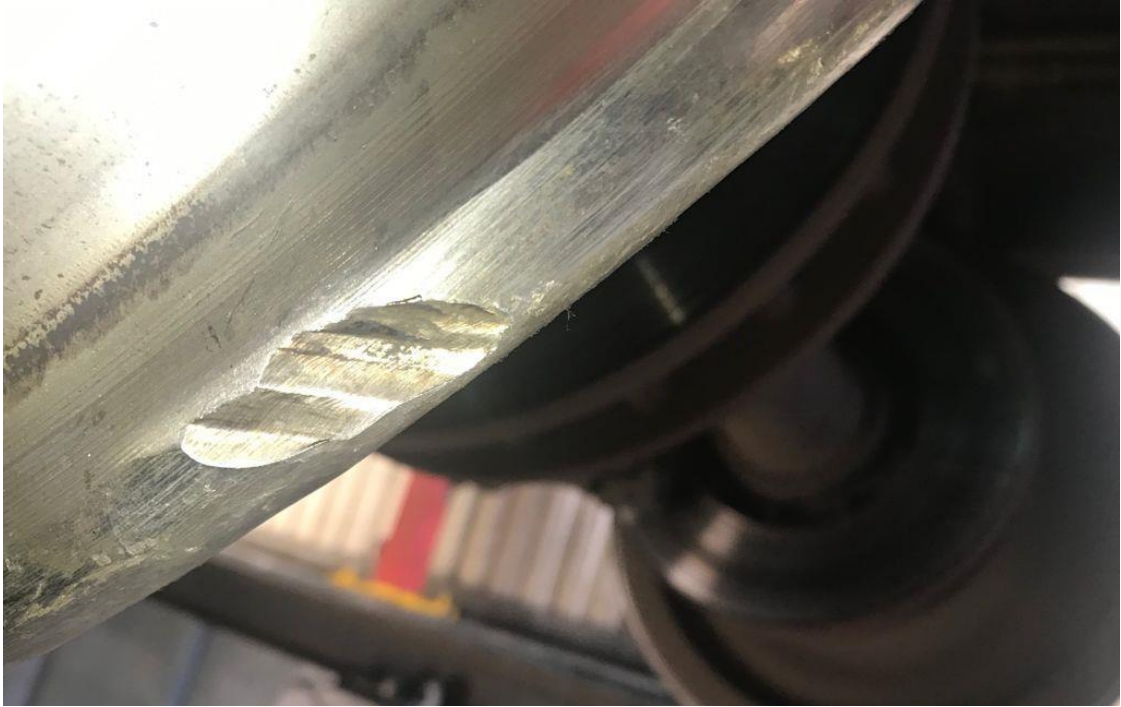
Figure 9 – Damage to wheel (4003)

48 Initial inspections and examinations (five in total) of Train J283 found no faults, however, on determination that the accident was more severe than initially reported, a more thorough examination was conducted by the CME Department on the 22nd September 2021 (three weeks after the accident); which found damage to a sander bracket and substantial damage to the front right wheel of control car 4003 (Figure 9). This is discussed in further detail in paragraphs 176 to 179.

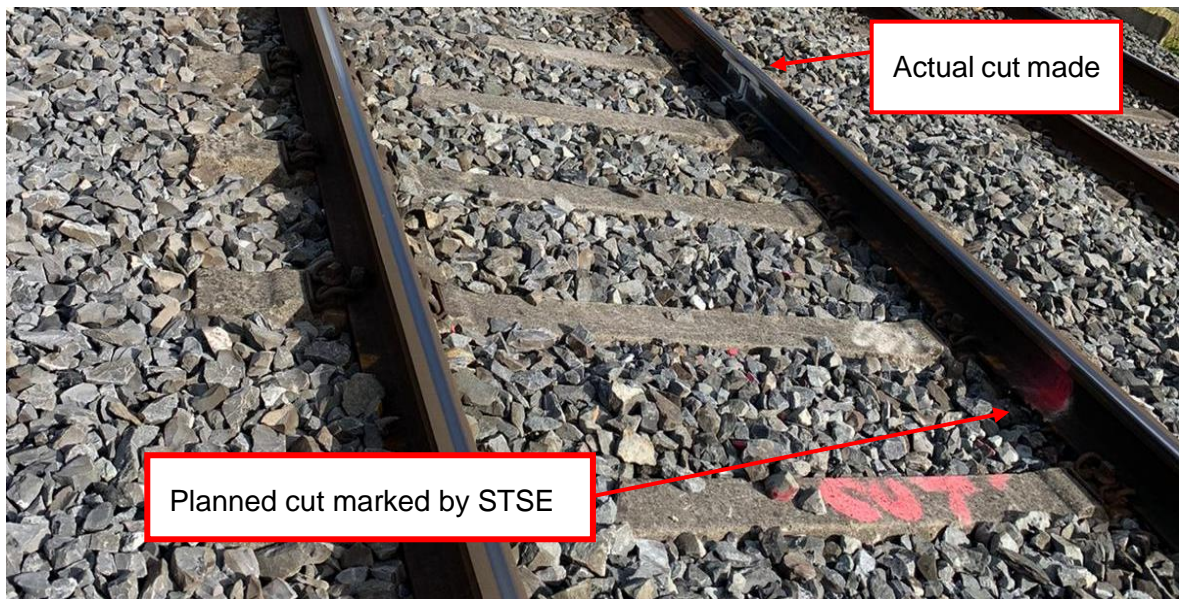
Figure 17 – Planned cut and actual cut

- 169 The PIC made the decision to move the cut positions of the rail, locations which had been marked by STSEs prior to the T3 Possession, see Figure 17, to allow for the removal of the section of rail with the Class 2 defect and the damage as a result of the clamp being struck by the train.

180 The IÉ-IM Head of Health & Safety arranged to visit the site of the accident on the afternoon of the 27th August, accompanied by the PWI where it was evident the position of the cuts was moved by 1.9 m (Figure 17).

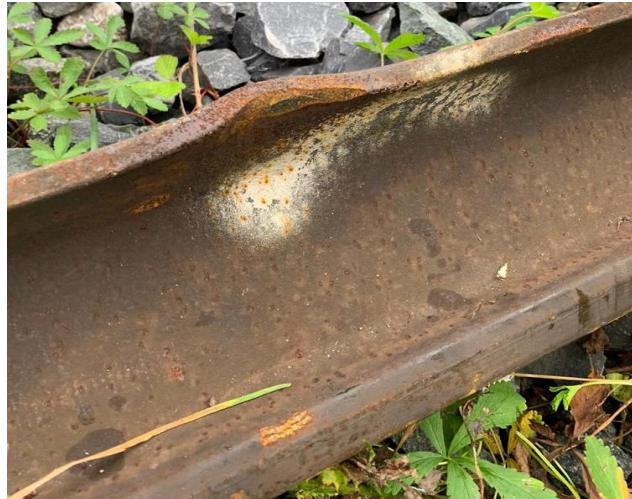
Figure 18 – Damaged rail

181 A decision was made to identify the scrap/damaged rail which had been replaced on the night. On the 15th September the IÉ-IM Head of Health & Safety received a photograph (see Figure 18) from the CCE Safety Manager which showed the rail concerned with some damage to the bottom of the rail, the rail was transported to Portlaoise Rail and Sleeper Depot the following day under strict loading instructions for further analysis.

182 On the 21st September, the IÉ-IM investigation team along with CCE staff with expertise in stressing equipment convened in Portlaoise Rail and Sleeper Depot and carried out a reconstruction with identical equipment to that which was struck on the night of the accident. The reconstruction confirmed, that in all likelihood, the stressing equipment had been clamped to the rail when it was struck by Train J283.
