RAILWAY ACCIDENTS
INVESTIGATION COMMISSION

Investigation of Serious Accident
No 0054/2013, of 24.07.2013

FINAL REPORT ON
SERIOUS RAILWAY ACCIDENT NO 0054/2013
OF 24.07.2013
NEAR SANTIAGO DE COMPOSTELA STATION (A CORUÑA)

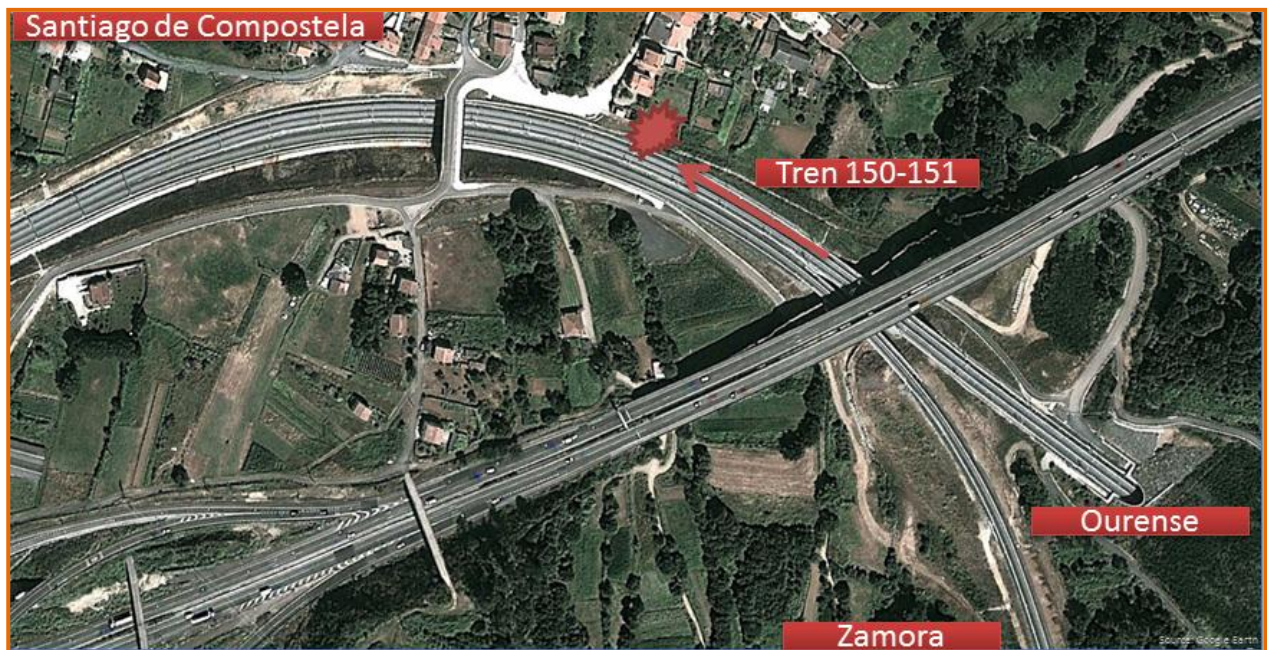
Train 150-151

Train 150/151 was already very near the start of the curve (PK 84+228). It derailed on the curve, 185 metres from the start, at PK 84+413, while travelling at 179 km/h.

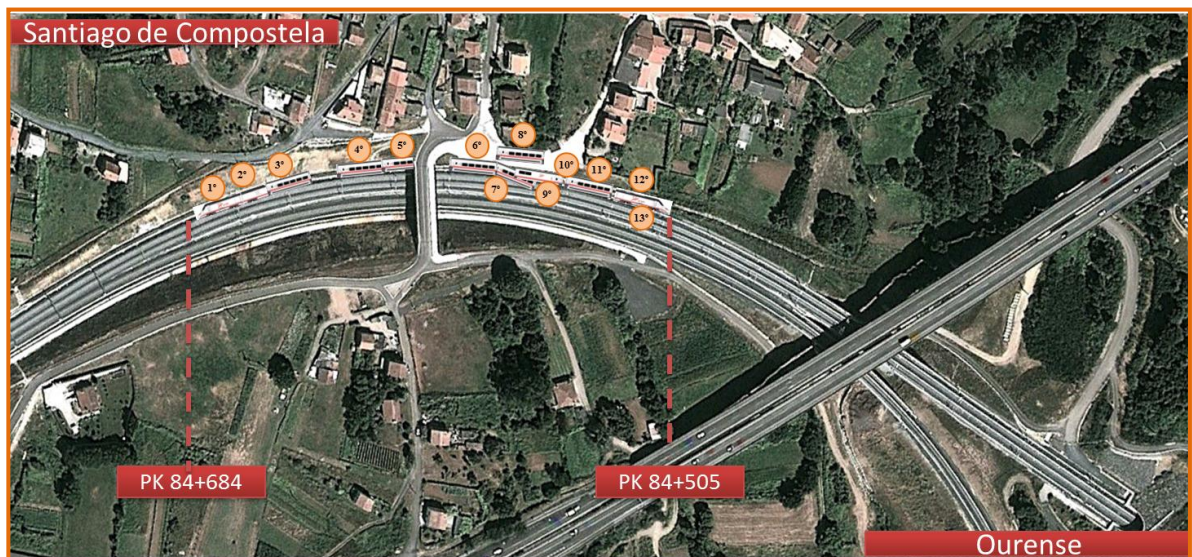
According to Renfe Operadora, the vehicles running in positions 1, 2, 3, 4, 7, 8, 10 and 11 were damaged, with serious damage to those in positions 5, 6, 9, 12 and 13.

Most of the vehicles were pushed into a drainage ditch which runs along the track. The concrete wall and the raised embankment in the area also prevented the total overturning and sideways displacement of the vehicles. **Annex 2.3.2.1** contains pictures of the final state of the trainset after the accident.

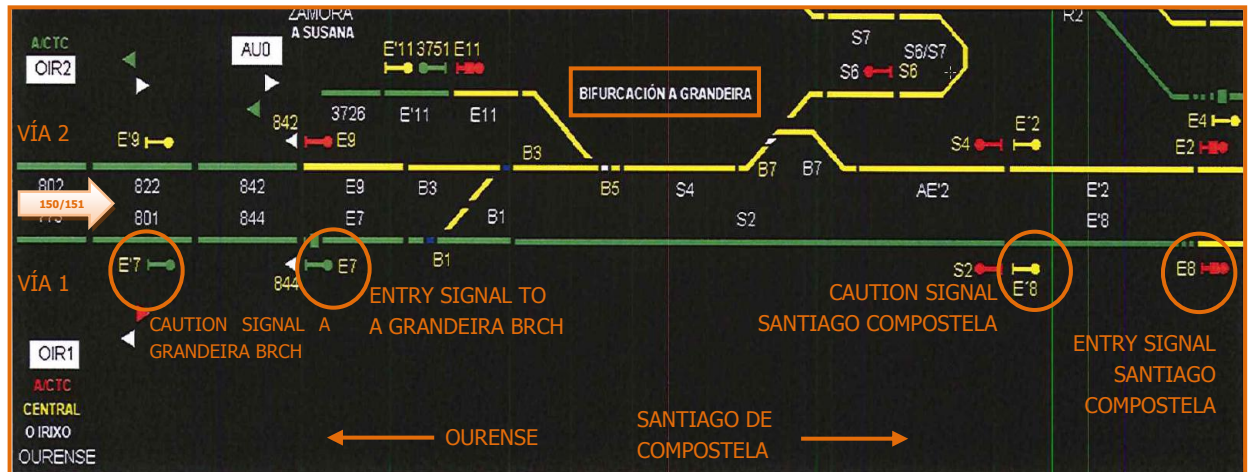
1.- 20:40:00 hours: initial situation

However, train 150/151 did not get near caution signal E'7. That is why none of the circuits in the picture is occupied. The path of entry to Santiago de Compostela station via track 1 is already established, with signals E'7 and E7 at green, E'8 yellow and E8 red.

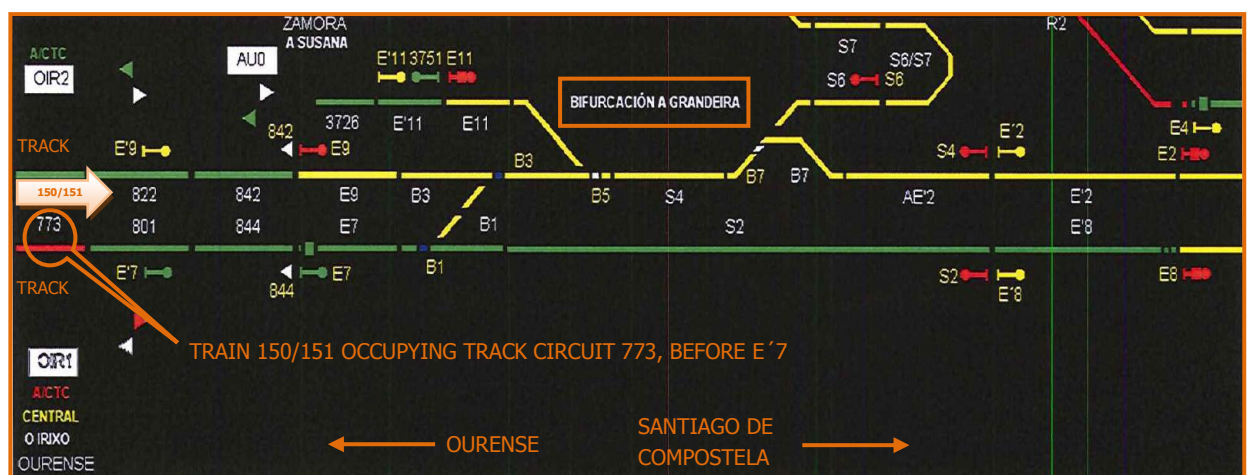
2.- 20:41:28 hours: approach to caution signal E'7

The train is occupying track circuit 773, before caution signal E'7. Signals E'7 and E7 are at green, E'8 at yellow and E8 at red.

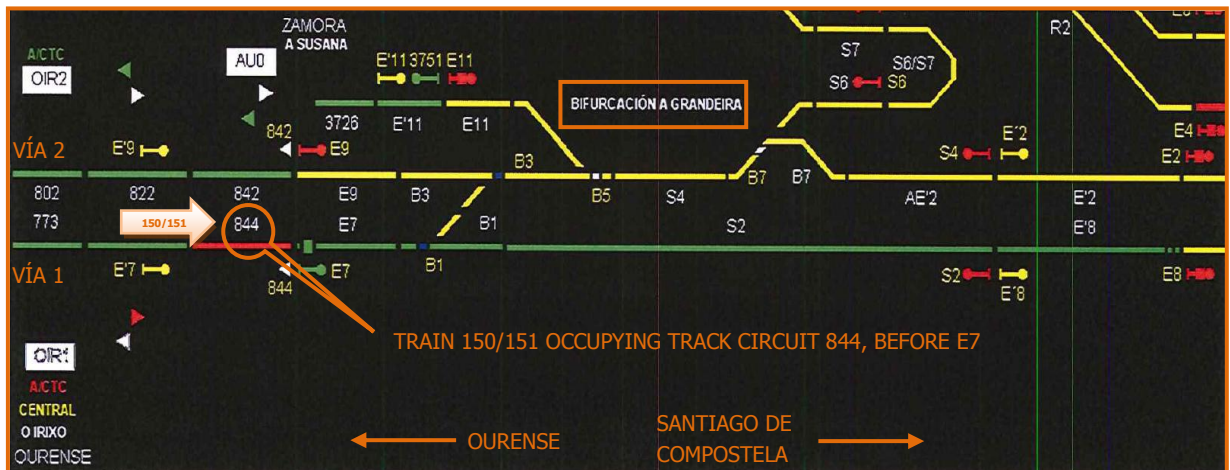
3.- 20:43:03 hours: approach to entry signal E7

The train is occupying track circuit 844, before entry signal E7. Signal E'7 switches to yellow (because this signal has already been lowered for the train) while E7 remains on green; E'8 on yellow and E8 on red.

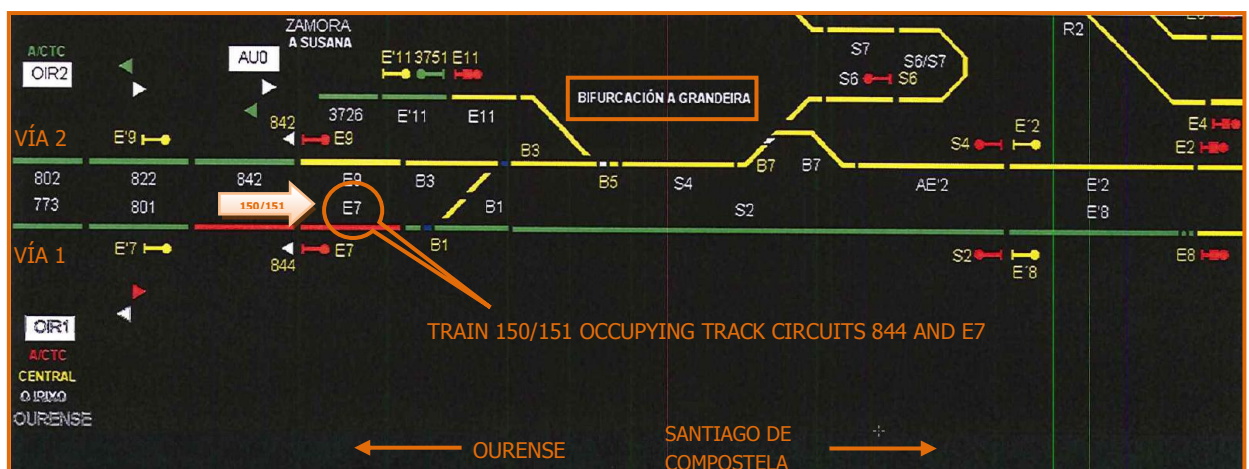
4.- 20:43:29 hours: passing signal E7

The train is occupying track circuit E7, while still occupying 844 (before E7). Signals E'7 and E7 are at yellow and red respectively (because the train has passed them). E'8 is at yellow and E8 at red.

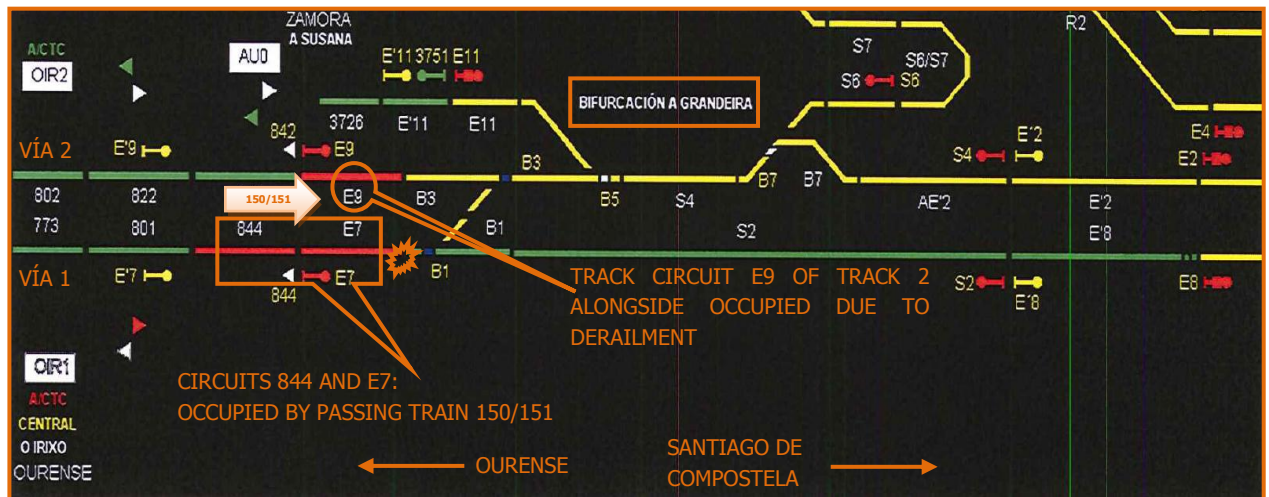
5.- 20:43:38 hours: Derailment

The train is still occupying track circuits 844 and E7 as it leaves the rails. The damage also causes occupation of circuit E9 on the adjacent track 2. Signals E'7 and E7 remain at yellow and red respectively (both already passed). Signal E'8 is at yellow and E8 at red.

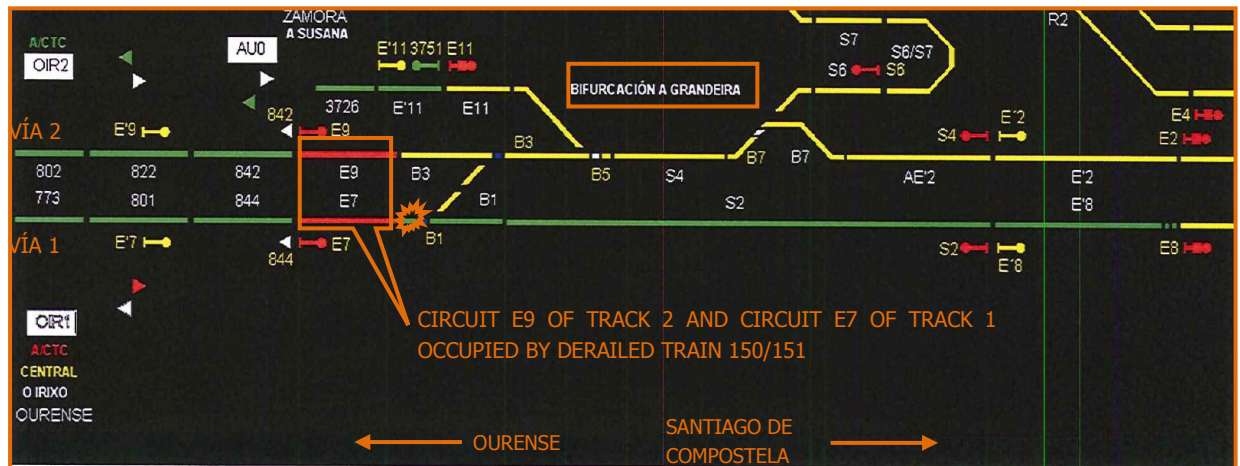
6.- 20:43:39 hours: final situation

The train, now derailed, frees circuit 844 but continues to occupy circuits E7 of track 1 and E9 of track 2. Signals E'7 and E7 remain at yellow and red respectively. E'8 is on yellow and E8 on red.
