ROMANIAN RAILWAY INVESTIGATING BODY

INVESTIGATING REPORT

of the railway accident happened in the railway station Aiud,
on the 18th of July 2010

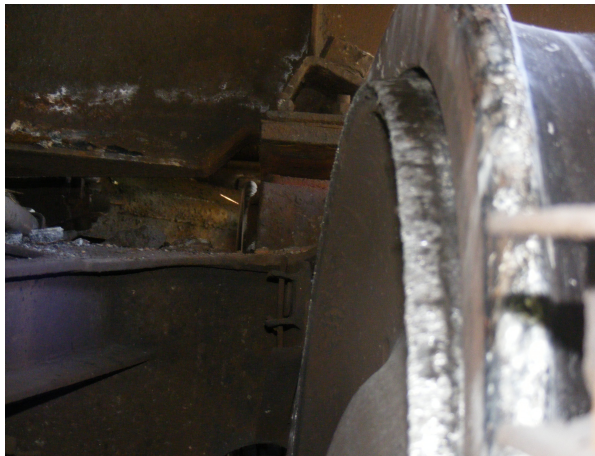
PHOTO 1

- the second bogie of the wagon no. 84535451255-8, the 19th from the locomotive, was derailed, in the running direction (the bogie corresponding to the axles 3-4), (photo 2);
- at the wheel no. 6 (from the first axle in the running direction of the derailed wagon) one found out that the tyre was axially displaced on the wheel rim and between the tyre and the wheel rim there were important friction traces (metallic luster) (photo 1);

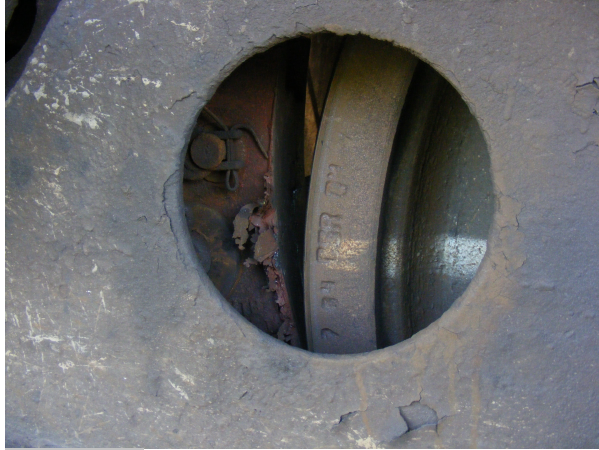
PHOTO 3

- also, at the same wheel, the axle guard and the guard connection from the bogie, afferent to the axle journal no. 6 were distorted to the outside of the bogie (photo 4);
- at the wheels no. 1,4,5,6, all the brake shoes were missing and on the brake shoes wearing there were old friction traces, following the direct braking on the brake shoes wearing (photo 3);
- at the wheels no. 2,3 and 8, a brake shoe was missing.

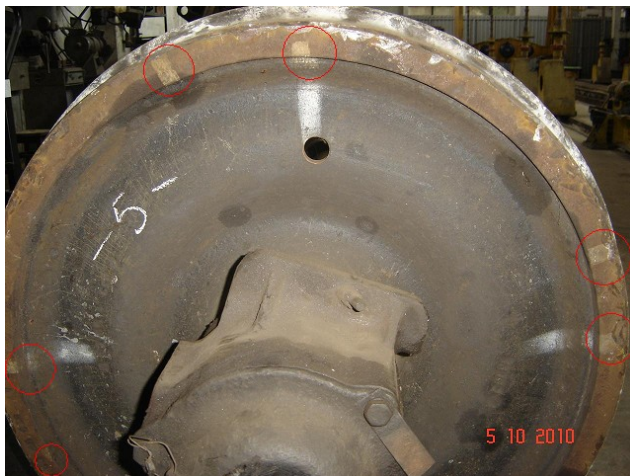
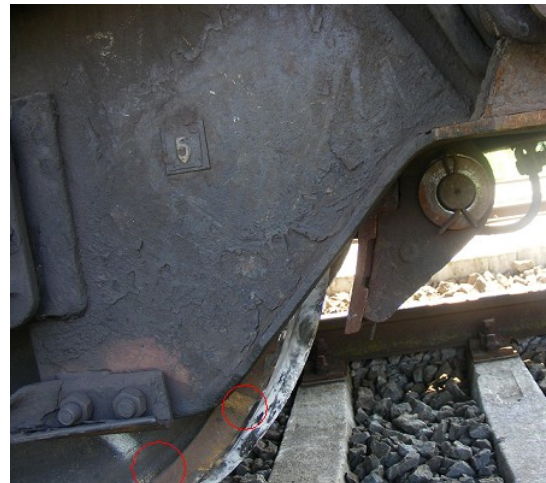
- Marking of the tyre position against the wheel:
 - at both wheels one can not observe the marks made with the mandrel either on the lateral surfaces of the wheel rim and tyre or on the cylindrical part of the stop flange;
 - at the wheel no. 5, on the outside one can observe the paint mark both on the wheel rim and on the tyre, but on the tyre can be observed that the mark was made twice on two areas situated at about 250 (photo 5 unbound axle, photo 6 from the 19th of July 2010 in the railway station Aiud – the axle was under the wagon);
- The rolling circle diameter of the wheel no. 5 – 919,5 mm;

The existence of the paint mark in two different places, situated at 30° one from another, at the wheels 5 and 6 and the lack of mechanical marks on the wheel rim and on the tyre are inconsistent both with the Instructions on the technical inspection and maintenance of the wagons in operation no. 250/2005, at art. 87, tabel 1, point 20 and with the Instruction no. 931/1986 for the repair of the pair of wheels art. 29.

5. Romanian Railway Notified Body check, during the technical inspections at Compania de Transport Feroviar Bucuresti SA – Bucuresti Working Place, the observance of the provisions of the art. 29 (concerning the marking of the tyre position against the wheel) from the Instruction for the repair of the railway vehicles pair of wheels no. 931/1986, especially at the pair of wheels manufactured before 1986, in the technological flow.

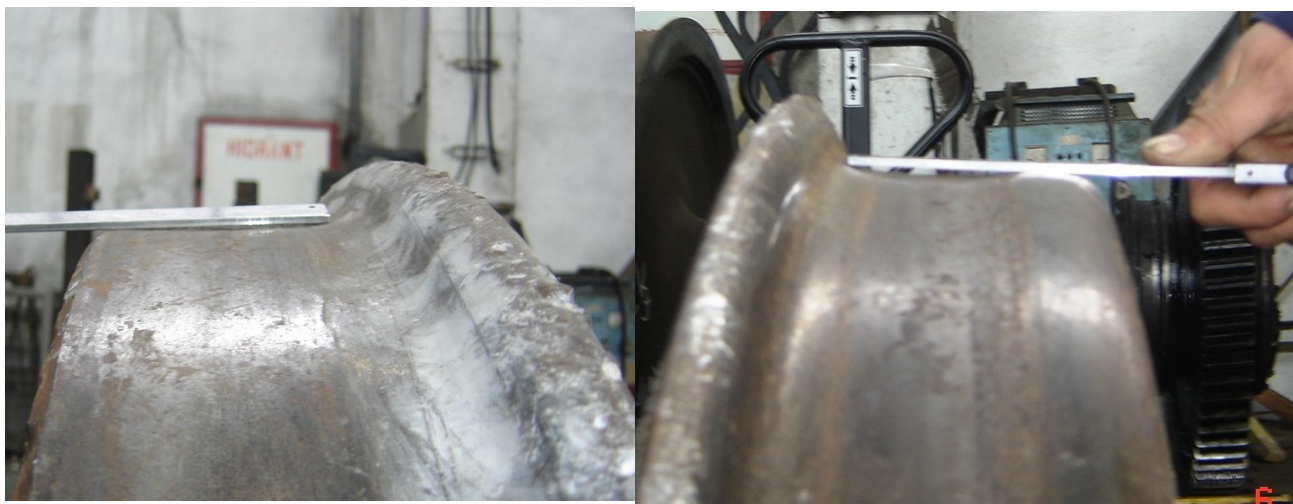
- One can not measure the rolling circle diameter of the wheel no. 6 with the special device, because the tyre was displaced axially on the wheel rim and did not allow to put this device at 70 mm from the inner surface of the wheel rim.

The measurement was empirically made with the sliding calipers, getting a wear of about 6-8 mm in diameter, in the rolling circle diameter, visible wear and from photo 7.

From the checking at wheelset, after its detachment from the wagon, one found out a wear of about 6-8 mm as diameter, in the rolling circle diameter and small exfoliations at the tyre of the wheel 6, these elements corroborated with those above mentioned lead to the conclusion that the wagon run with the automatic brake in operation and after the wear beyond the accepted limit for the brake shoes at this wheel, the brake was directly on the brake shoe (made from a harder material than that of the brake shoe).

The thickness of the tyre in the rolling circle diameter close to the minimum value stipulated in the Instructions no. 250/2005 on the technical inspection and maintenance of the wagons in operation, corroborated with the braked running, operation time of the pair of wheels (43 years) lead to the de-pressure of the tyre from the wheel rim.

4. Romanian Railway Safety Authority analyze, together with the economic agents, that repair the rolling stock, and with the railway undertakings the opportunity to complete the Instructions 931/1986 with the compulsoriness to limit the use wheelset with tires.
