ROMANIAN RAILWAY INVESTIGATING BODY

INVESTIGATING REPORT

On the accident occurred on the 13th April 2010 in the railway station Arad

Final edition

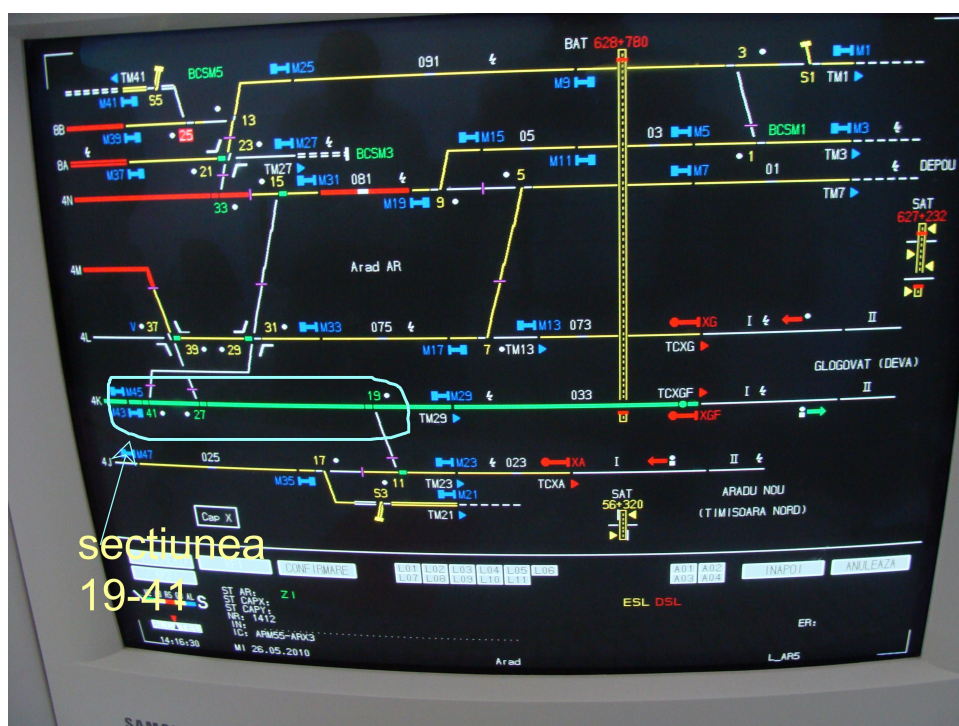
After about 65 seconds from the making and locking of the exit route (signal Y1 with the position „green”, and the indication of the figure „3” and the direction „G”) for the train 473-2, on the display of the electronic system was signaled the wrong occupation for about 1 second of the switch section 19-41 (section situated in the exit route of the passenger train no. 473-2). Following it, at 01:01:49 hour, the exit signal Y1 passed on non-permissive position (red).

Photo 1 – The display on the monitor of the electronic interlocking system of the switch section 19-41
