MINISTRY OF TRANSPORTS AND INFRASTRUCTURE  
ROMANIAN RAILWAY AUTHORITY - AFER

ROMANIAN RAILWAY INVESTIGATING BODY

## INVESTIGATING REPORT

on the non-conformity happened on the 18<sup>th</sup> of March 2010  
between Banita and Merisor railway stations  
consisting in the exceeding of the maximum accepted speed by the line in the running of the  
freight train no. 50503

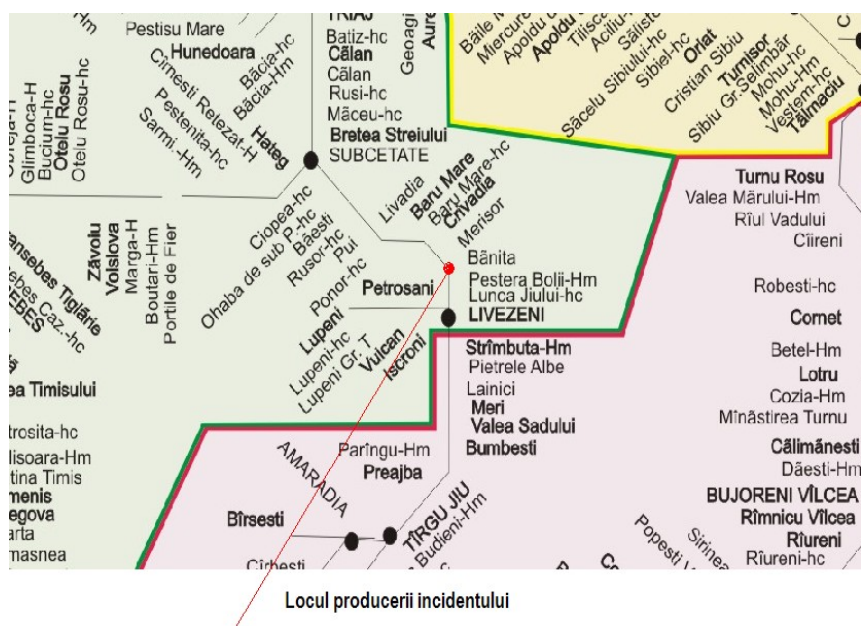
The place is situated in the Branch of the Railway County Timisoara, track section Livezeni – Subcetate, on the line I between the railway stations Banita and Merisor (km. 58+916), the track configuration being with a down-grade of 17,9‰ from the railway station Banita to the railway station Merisor, in the running direction of the freight train no. 50503.

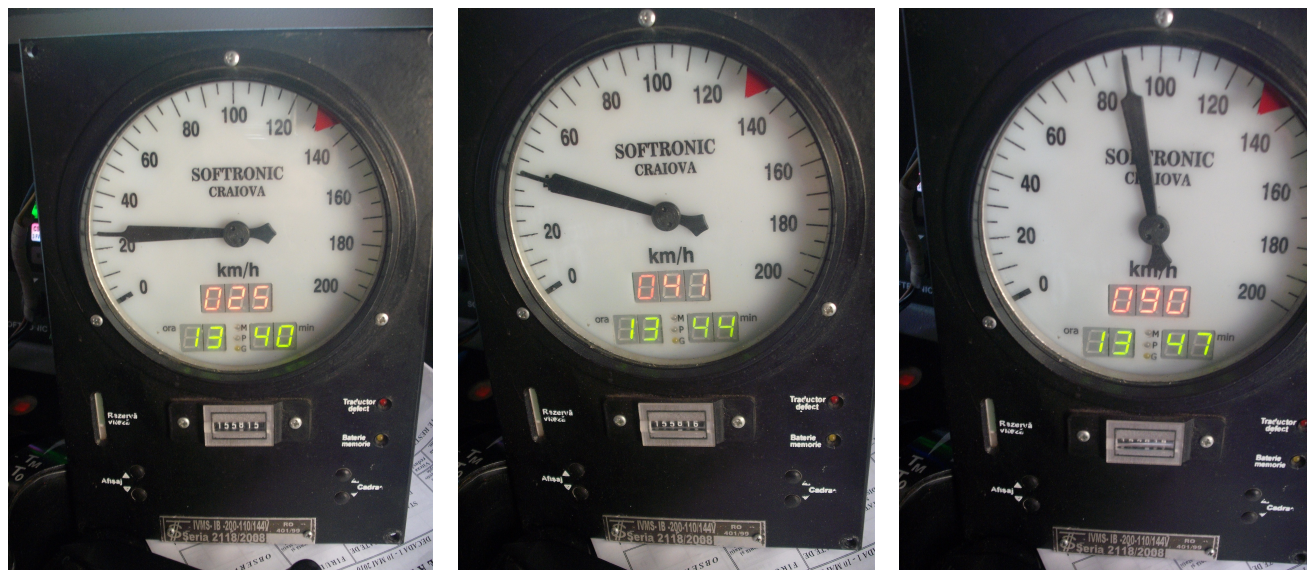
Following the checking performed on the 4th of May 2010 concerning the conformity of the speed record/indication by the ITSMR equipment fitted up on the locomotive EA 531 and its use by the indicator (both in digital and analogues mode), one did not find any differences or deviations at the speeds of 25 km/h, 41 km/h and 90 km/h. The digital speed display is made with a resolution of 1 km/h and the indication of the speed on the display of the analogue instrument is made from 5 to

5 km/h. Following the and of the checking (performed in the presence of SC SOFTRONIC SA Craiova) there was drawn up the Minute no. 3C/1312/04.05.2010.

Taking into account that the real value of the wheel diameter (1241 mm) is smaller than the value of the maximum wheel diameter (1250 mm), introduced as reference element in the memory of the ITSMR equipment, results that the real speed of the locomotive was under that registered in the memory of the ITSMR equipment of the locomotive.
